OCONEE NUCLEAR STATION

REACTOR BUILDING

POST-TENSIONING SYSTEM

END ANCHORAGE SURVEILLANCE

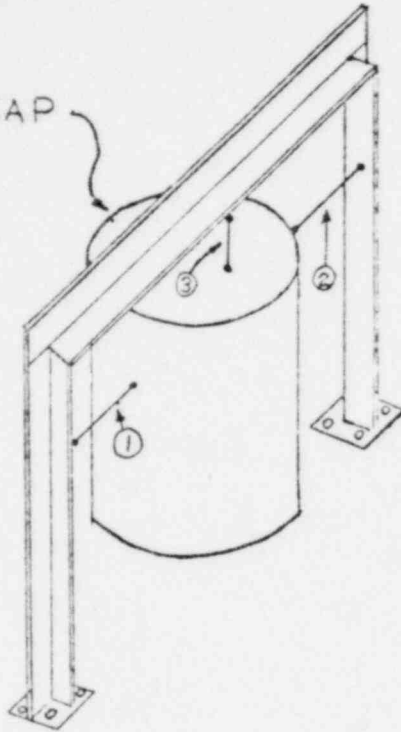
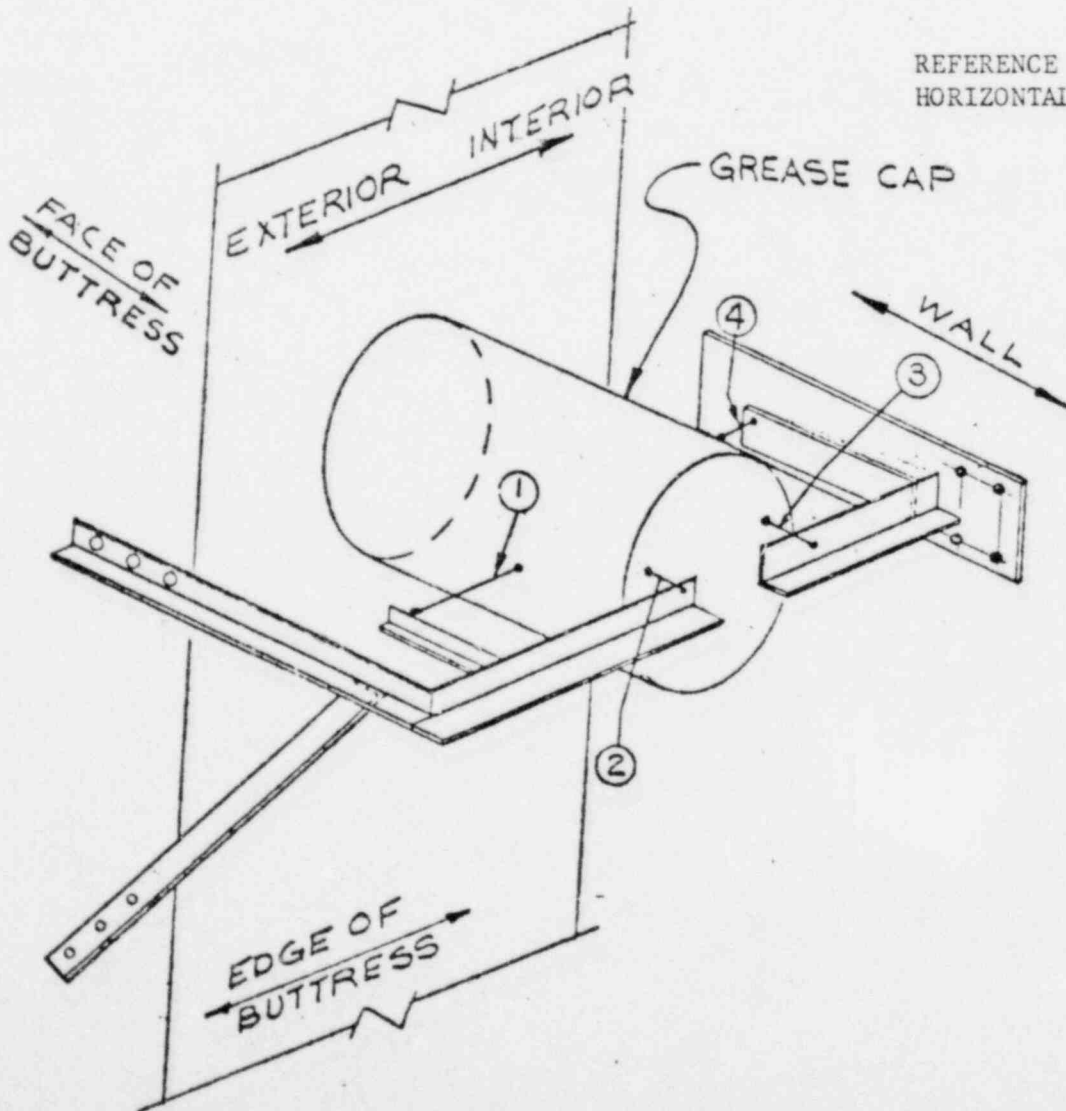
Figure 1

Position measurements for three of the tendon anchors were made during the Reactor Building Structural Integrity Test and at the one-half year and one year intervals following initial operation. Results of these measurements are given in Table 2. Details of the demountable reference frames and the location of measurements are shown on Figure 1.
