## FINAL REPORT

### SAFETY INJECTION SYSTEM PIPING DEFICIENCY

May 30, 1980

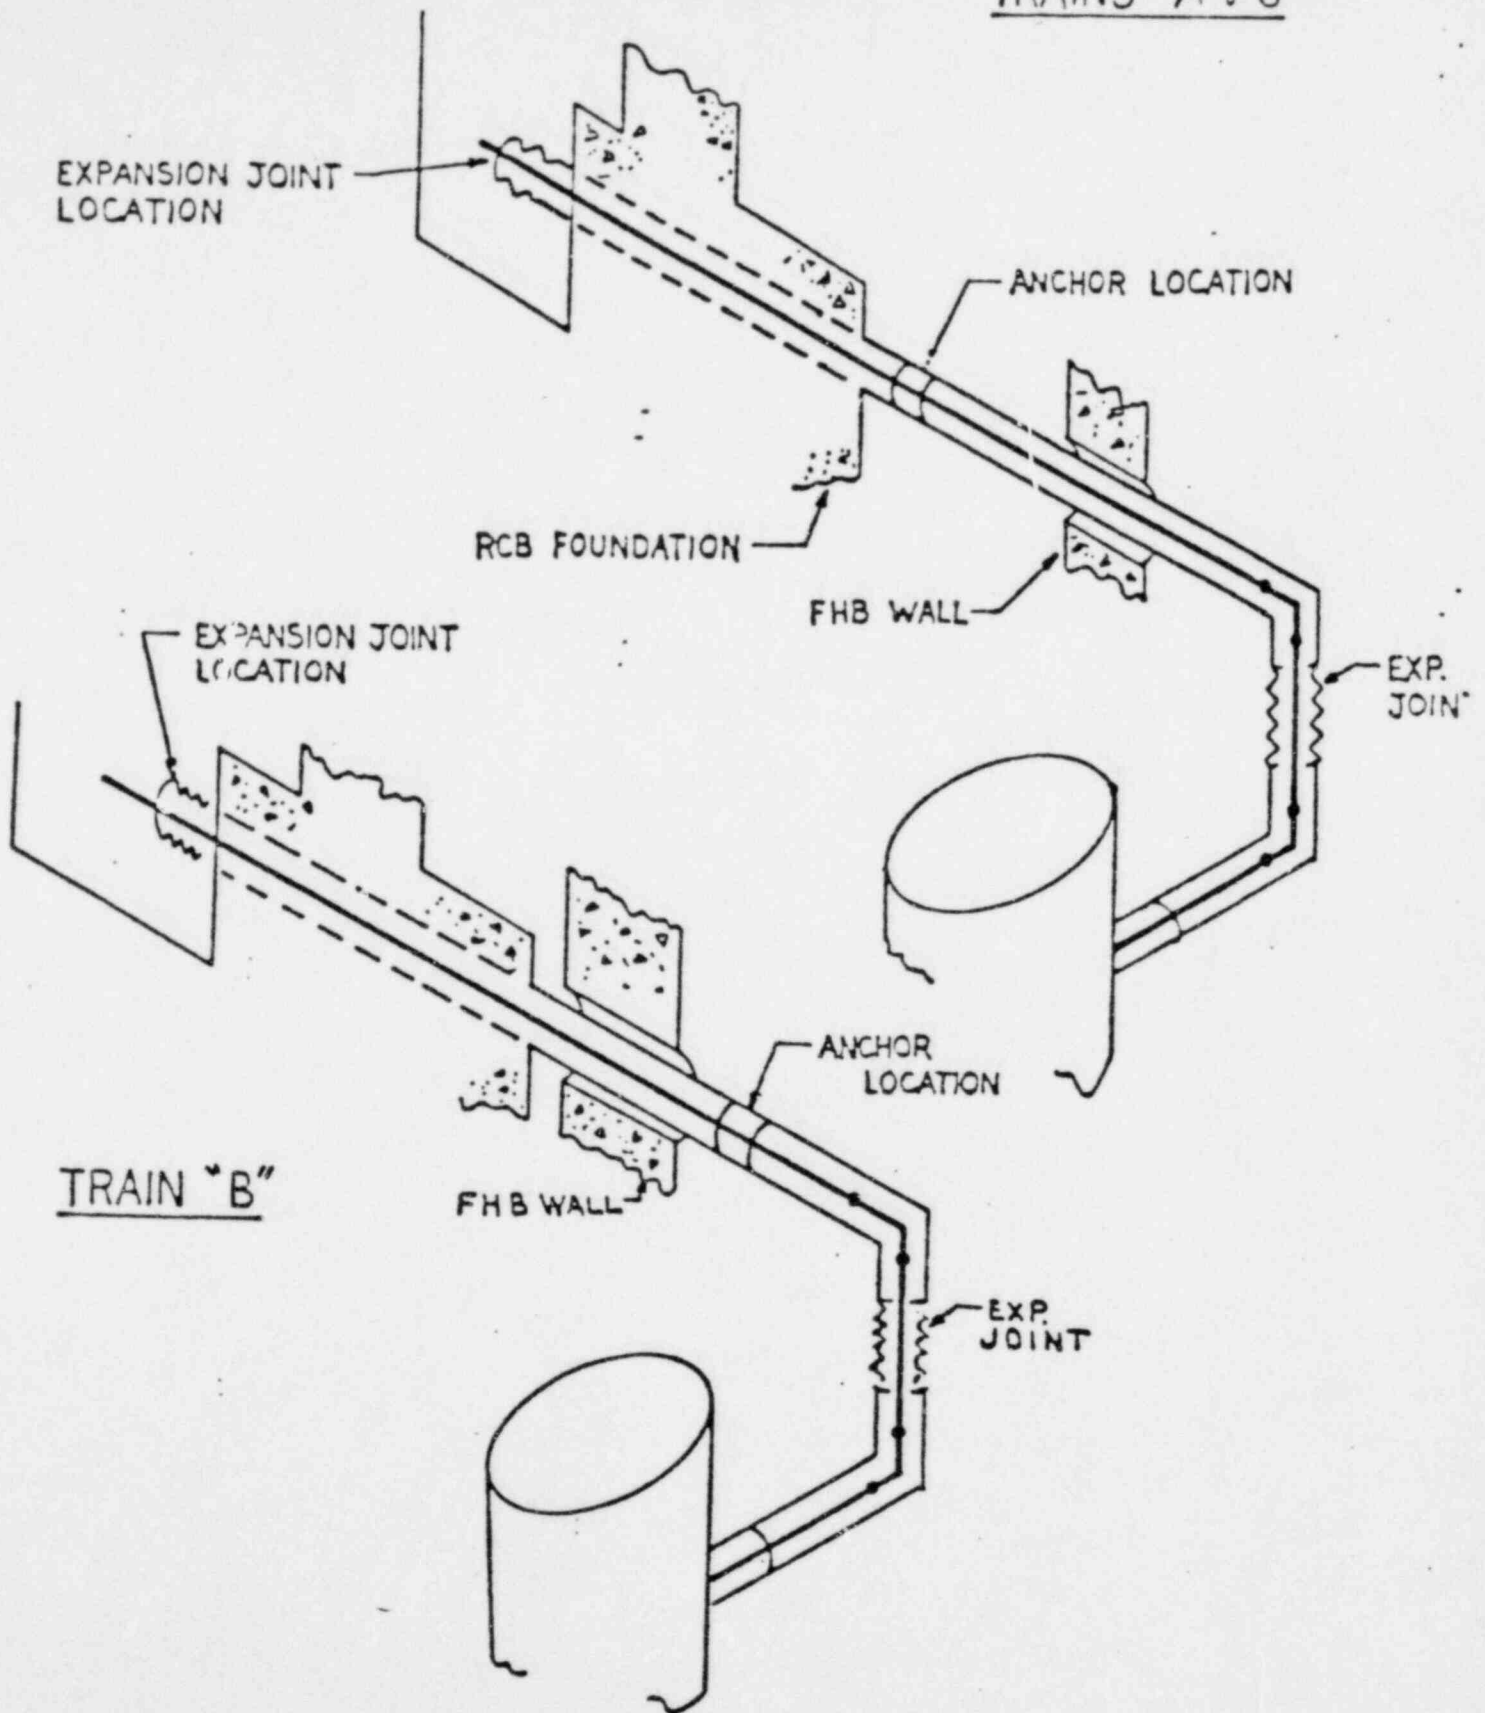
FIGURE - 1

During a routine review, a design deficiency was discovered which, if left uncorrected, could have adversely affected the safety of operations. The joint between the 16 inch Safety Injection System piping and the emergency sump liner was shown on the construction drawing to be a one-quarter inch seal weld, which does not meet the design load criteria.

This deficiency will be corrected by anchoring the process pipe to the guard pipe outside the containment building and adding an expansion joint to the process pipe inside the emergency sumps (see Figure 1).
