DUKE POWER COMPANY  
OCONEE UNIT 1

Report No.: AO-269/75-3

Identification of Occurrence: Defects in a fuel rod of Spent Fuel Assembly  
1A10

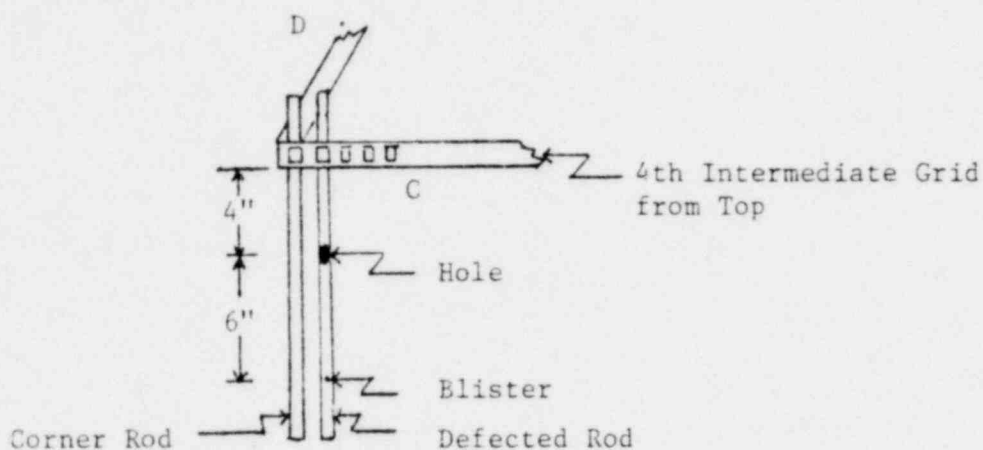
Location of Defects in Spent Fuel Assembly 1A10

The defected fuel rod, a peripheral rod of Fuel Assembly 1A10, has two defects located between the fourth and fifth intermediate spacer grids (see Figure 1). One defect is in the form of a hole in the cladding (approximately  $\frac{1}{2}$ " in diameter), and the other in the form of a small blister. The defected fuel rod did not show any gross outward bow, and no abnormalities were seen in any other fuel rods of the entire fuel assembly during visual examination. Visual examinations were not able to confirm the presence of fuel at the location of the main perforation.

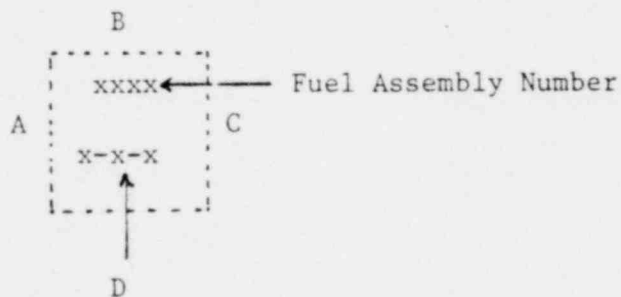
Location of Fuel Assembly 1A10 in Cycle 1 Core

Fuel Assembly 1A10 contained an in-core detector string as well as a control rod of Control Rod Group 1 (safety group), which was fully withdrawn throughout Cycle 1 power operation (see Figure 1). The in-core detector readings indicated that the power density of Fuel Assembly 1A10 was within normal operating limits during Cycle 1 operation and that there was no abnormal power condition that could have affected the integrity of the fuel rods in Fuel Assembly 1A10.
