UNITED STATES
NUCLEAR REGULATORY COMMISSION
OFFICE OF INSPECTION AND ENFORCEMENT
WASHINGTON, D. C. 20555

IE Circular No. 80-15

LOSS OF REACTOR COOLANT PUMP COOLING AND NATURAL CIRCULATION COOLDOWN

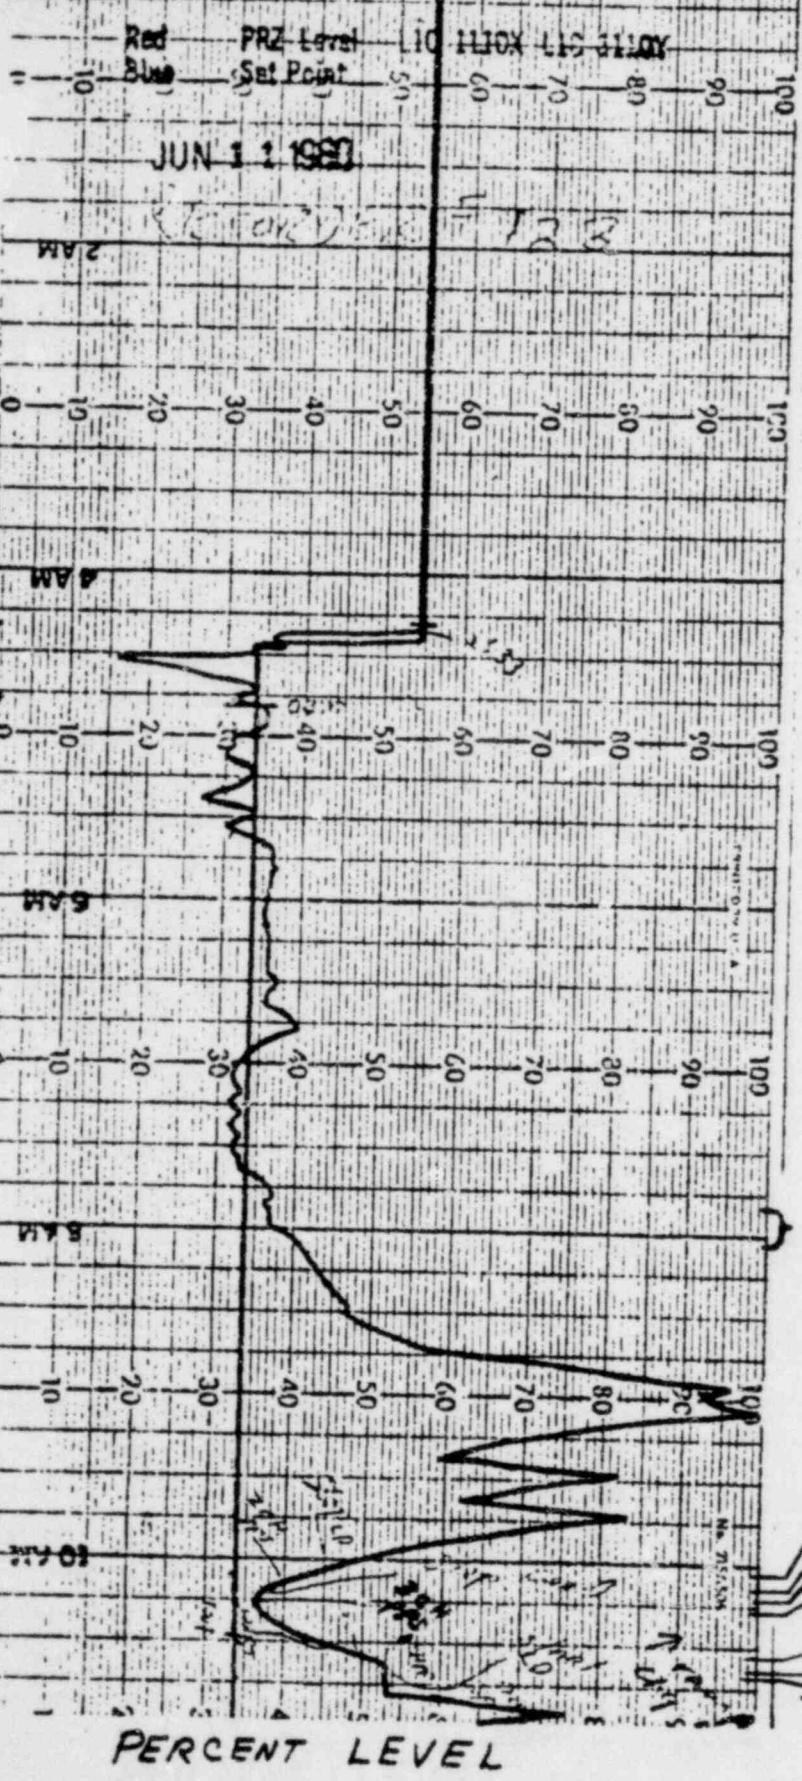
SHEET 1 of 2

The natural circulation cooldown continued uneventfully until after time 0600. The highest cooldown rate achieved was approximately 65 to 70 F per hour. Between 0600 and 0630 RCS pressure was reduced from 1140 to 690 psi by charging water through the pressurizer auxiliary spray line. Pressurizer level increased rapidly around 0700 while charging via the auxiliary spray line. Pressurizer level continued variations for approximately five hours while the cooldown and depressurization continued. When charging was shifted to the RCS loops, pressurizer level decreased at rates lower than the rates of increase in level when charging through the auxiliary spray line. During a two minute interval while charging into the pressurizer auxiliary spray line at 88 gpm, pressurizer level rose at a rate approximately ten times greater than the charging flowrate.

The cause of pressurizer level variations appears to be formation of a steam void in the reactor head area due to a temperature lag with respect to bulk coolant temperature that developed because of insufficient cooling flow in that area during natural circulation cooldown. Gas concentration in a 0730 RCS sample was determined by the licensee to be 32 cc/kg hydrogen and 16 cc/kg nitrogen. These concentrations were not high enough to cause a significant volume of gas to come out of solution. The indicated subcooling margin ($t_{\text{sat}} - T_{\text{hot}}$) ranged between 220 and 150 F when the reactor head steam void developed between 0600 and 0700. The minimum required subcooling of 50 F was not approached during the cooldown until around time 1219 at a pressurizer pressure of approximately 110 psig. An annotated record of pressurizer level is enclosed only to illustrate the high amplitudes and rates of pressurizer level variations. Insufficient information is contained in the enclosure to enable detailed evaluation of the RCS behavior.

11 JUNE 1980
ST. LUCIE
HOT CALIBRATED
PRESSURIZER LEVEL

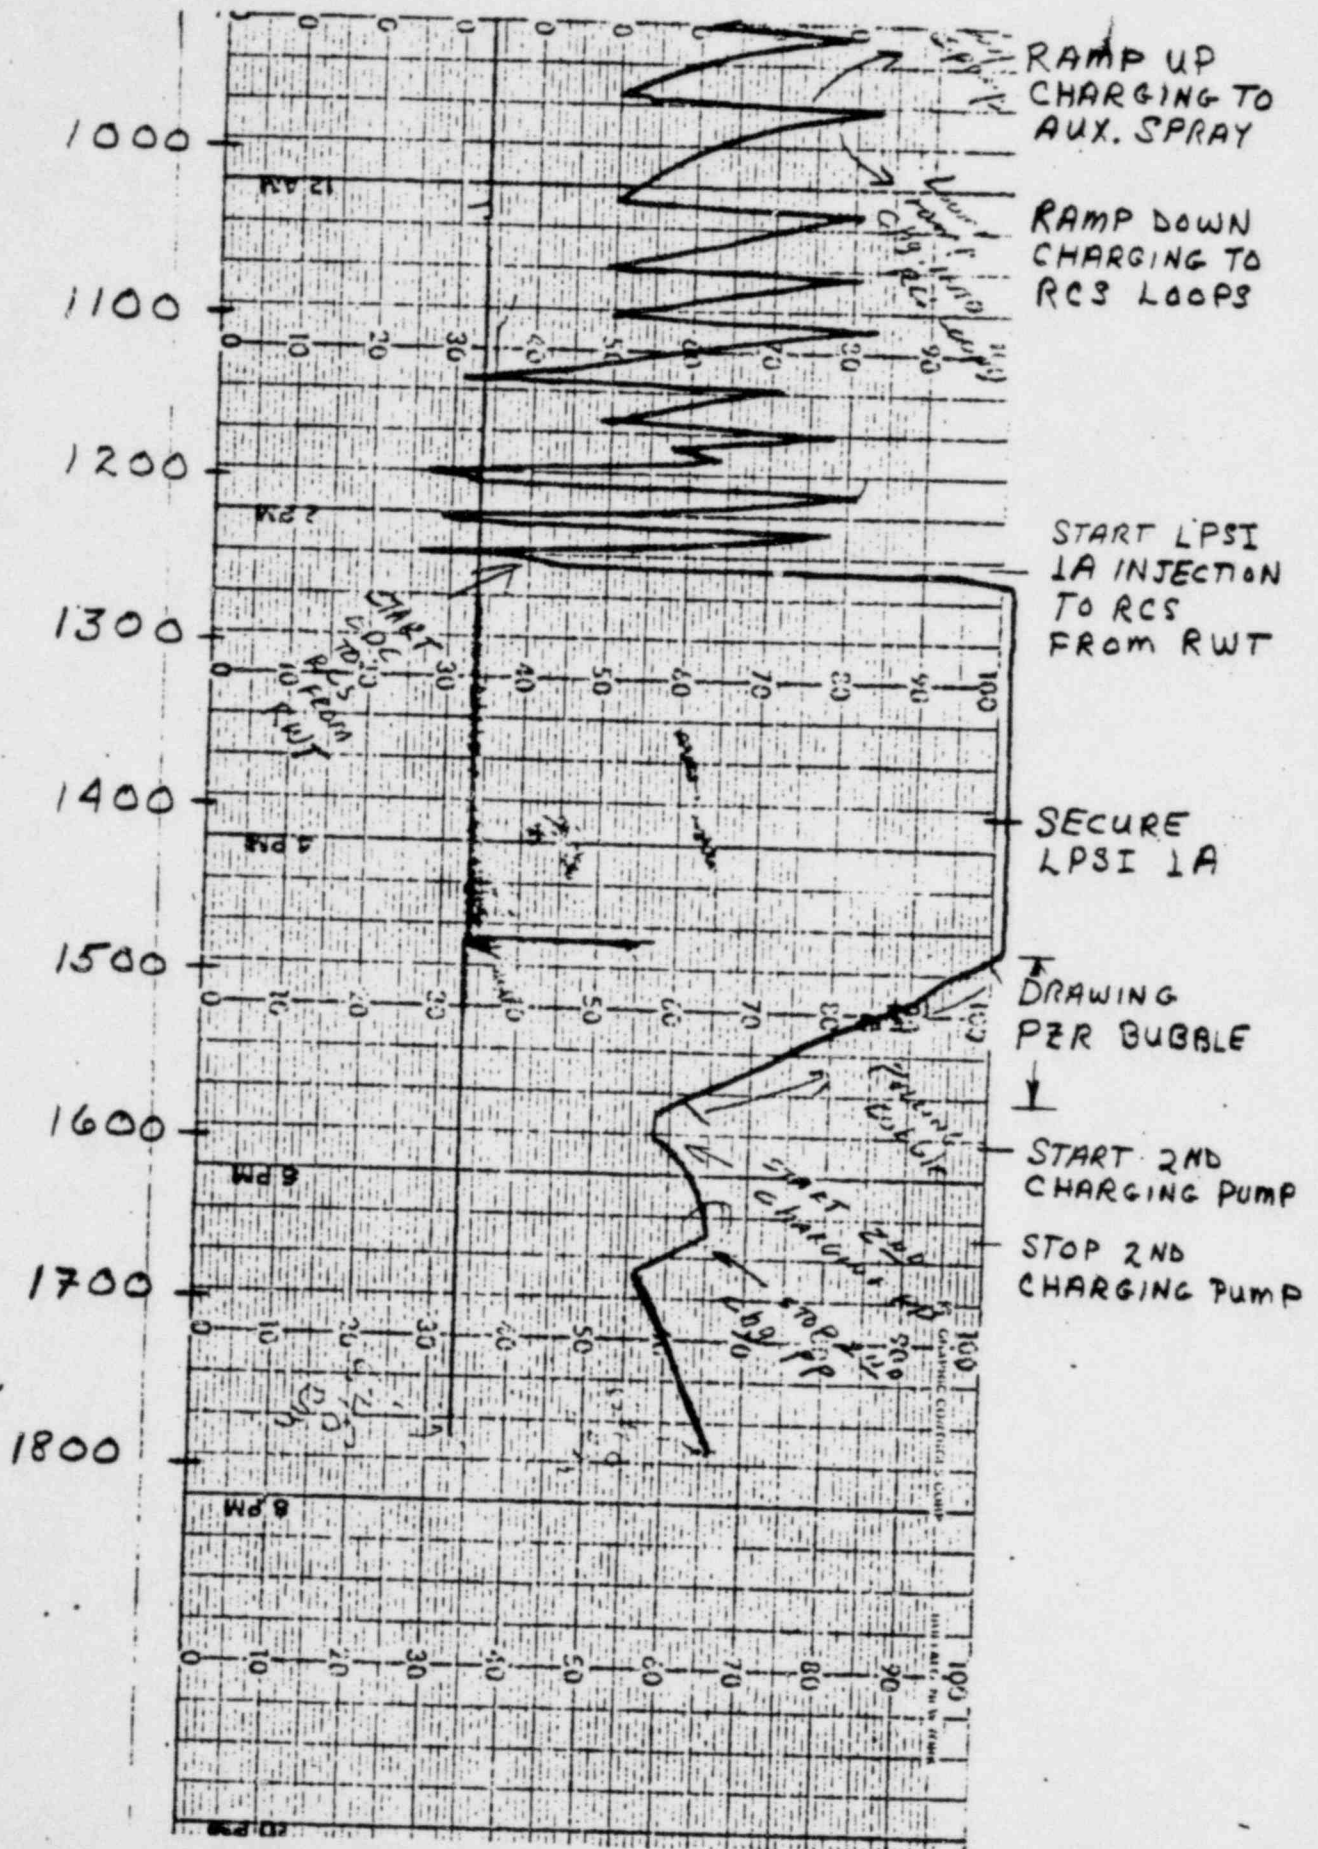
SHEET
2 of 2

The cold calibrated pressurizer level instrument indication rose to 64 percent and remained constant while hot calibrated channels rose to 100% level. Temperature correction data for the cold calibrated level instrument didn't extend to 360 F, which was the approximate pressurizer temperature when the pressurizer indicated full. Constant level on the cold calibrated channel indicated the pressurizer was solid, but continued charging flow at 88 gpm was not causing pressure to rise above 200 psig, as it should have had the RCS been solid. Letdown had been secured while filling the pressurizer. The indications of a steam void in the reactor vessel head were no longer evident after RCS pressure increased although the exact time when the void disappeared has not been established.

miniflow was isolated. Continued charging with two pumps at 88 gpm total flowrate caused a slight rise in both pressurizer pressure (to 260 psig) and cold calibrated pressurizer level. Letdown in excess of charging flowrate was established at 1430, and by 1500 a steam bubble was drawn in the pressurizer with level in the indicating range.

DEPRESSURIZE
1140 psig to 690 psig
