U. S. ATOMIC ENERGY COMMISSION
REGION II
DIVISION OF COMPLIANCE

Report of Inspection

CO Report Nos. 50-269/69-1
50-270/69-1
50-287/69-1

Licensee: Duke Power Company
License Nos. CFFR-33, 34, and 35
Category A

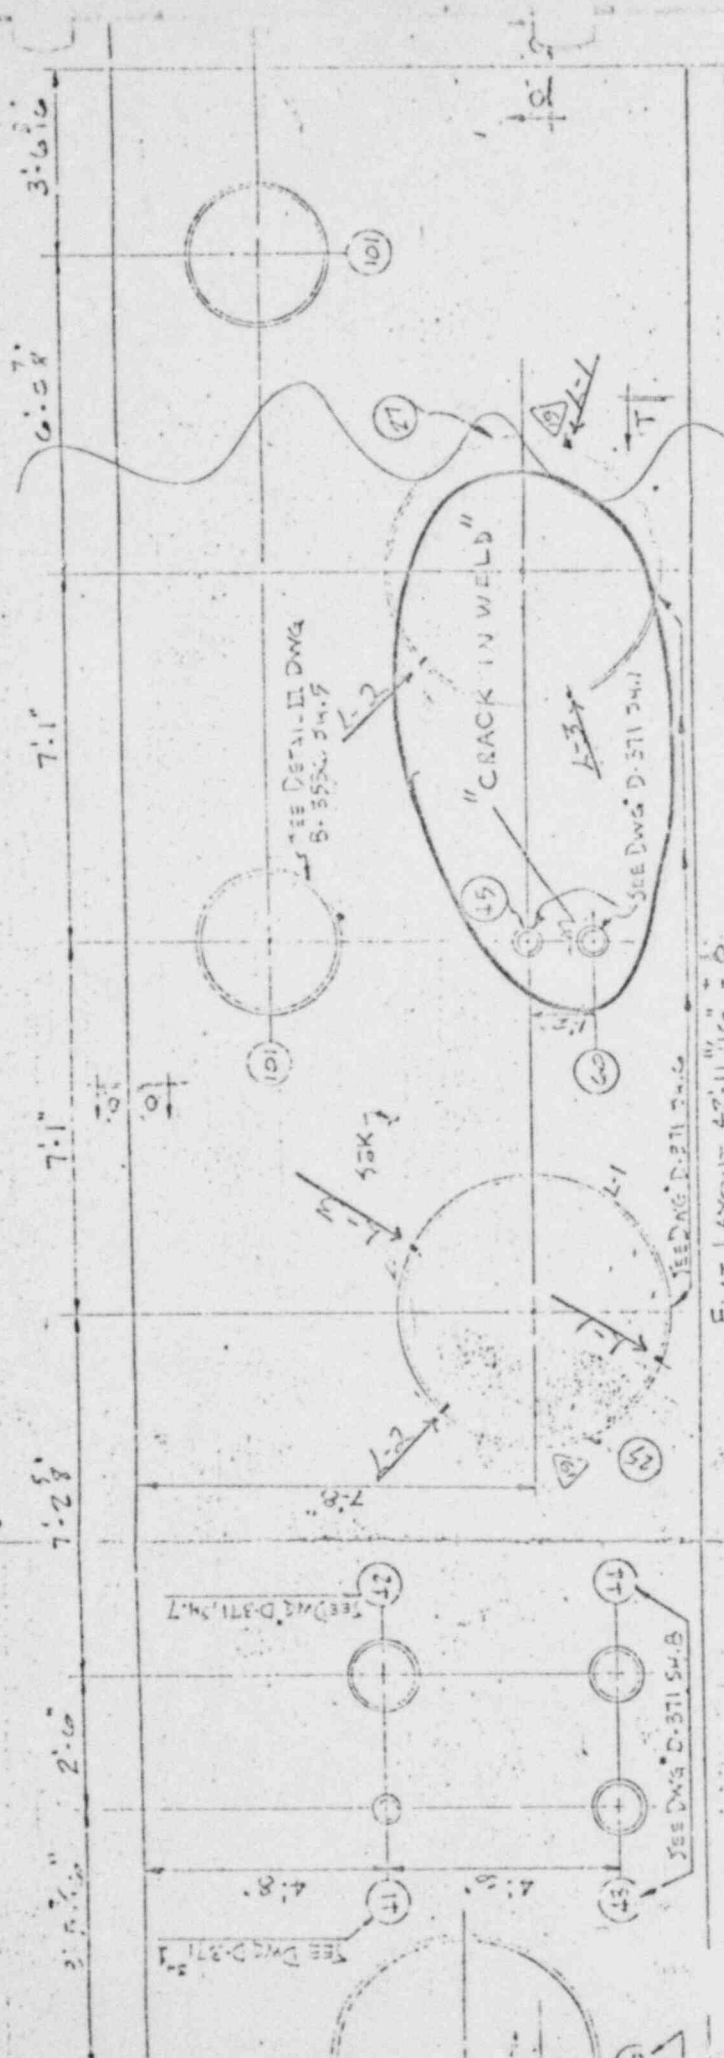
As a follow-up to the penetration weld problem, the inspector talked with Moore to determine if the field QC welding inspectors had noted any recent improvements in the quality of the Southern Boiler Shop welds. Moore stated that he has seen a marked improvement in the quality of the shop welds. When asked if he had observed any significant defects in the welds associated with the eight shop-repaired penetration sections after they returned to the site, he replied that one had been observed. He said that during the erection of penetration section SP-25, a welding inspector visually detected an inch long by 3/8-inch deep crack in a weld connecting a 12-inch ID penetration sleeve to the

thickened liner plate section.^{1/} (The crack location is shown in Exhibit B.) He stated that the welding inspector checked to see if the crack went through the plate by applying dye penetrant to the crack and developer to the opposite side; the crack did not go through the plate. Moore said that later he checked the SP-25 shop radiographs that accompanied the penetration section to the site.^{2/} One radiograph clearly showed the crack defect; a second radiograph taken of the same weld after the repair of a slag defect, per the shop log, revealed the same crack defect as the original film. Moore stated that for some unexplained reason the crack was completely overlooked.
