**Florida  
Power**  
CORPORATION

SUBJECT: Crystal River Unit #3  
Docket No. 50-302  
Operating License No. DPR-72

## Exposure Plan for CR-3 Steam Generator Repairs

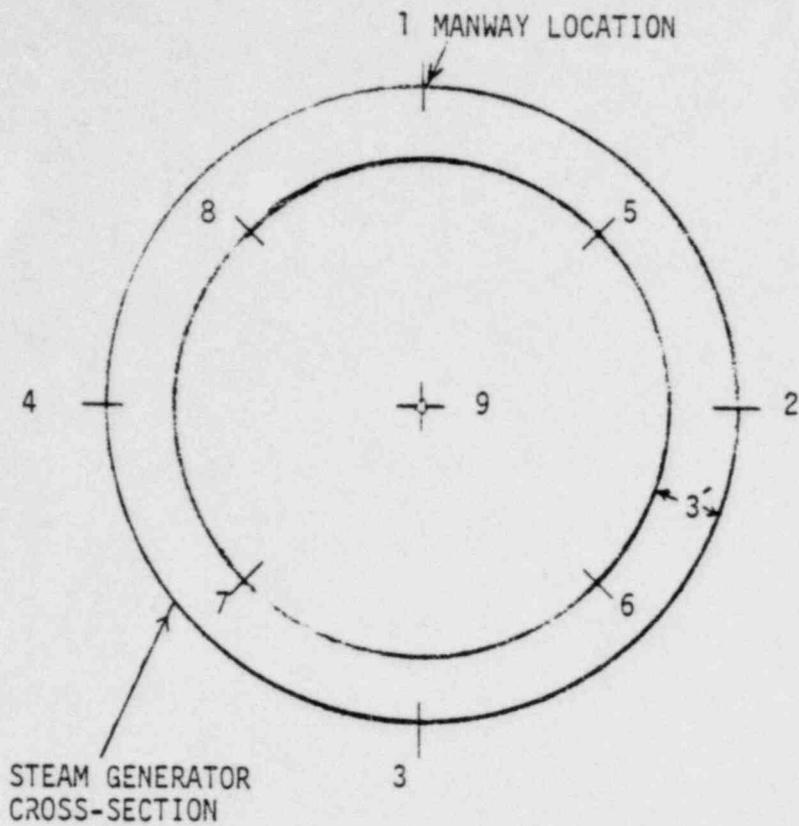
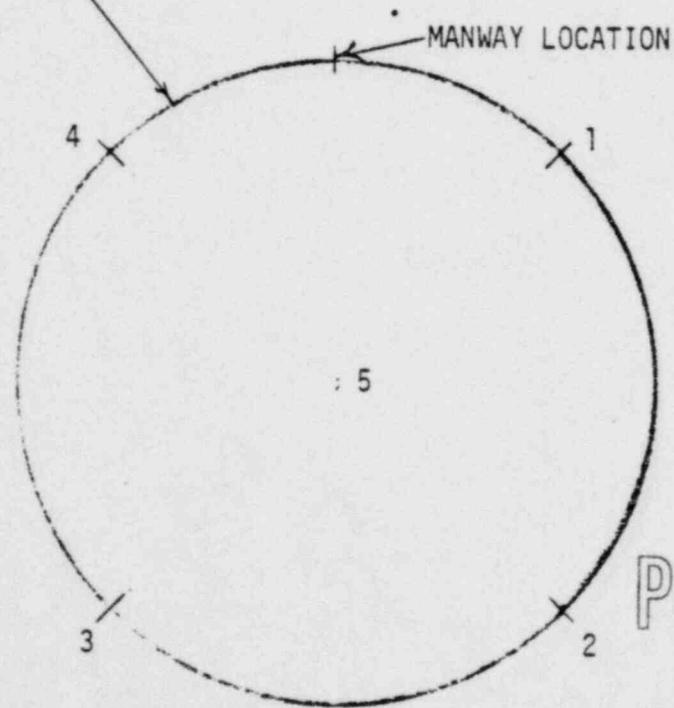
FIGURE 1  
UNSHIELDED RADIATION LEVELS

Table 1 shows the work steps for SG repair, and the estimated time required in the SG for each task. These times are conservative estimates by personnel experienced in SG field repair work; proper training in mockups before task performance is assumed. Figure 1 shows unshielded radiation levels in the B SG upper head.

TUBE SHEET LOCATIONS

DOME LOCATIONS

| <u>Location Number</u> | <u>Distance Above Tube Sheet (feet)</u> | <u>Radiation Level (R/hr)</u> |
|---|---|---|
| 1-9 | 0 | 4.0 |
| 1 | 2 | 3.5 |
| 2-9 | 2 | 3.0 |

| <u>Location Number</u> | <u>Location on Dome</u> | <u>Radiation Level (R/hr)</u> |
|---|--|---|
| 1 | Sample points located at an elevation just above the manway opening at 45°, 135°, 225°, 315° from the manway. Readings taken directly on the dome surface. | 4.0 |
| 2-4 | | 3.0 |
| 5 | Sample point located in the reactor coolant inlet nozzle. | 3.0 |
