S.M.U.D.

August 13, 1979

Acting as chairman of the Babcock and Wilcox (B&W) Users Group Subcommittee on Feedwater Pipe Cracking, IE Bulletin 79-13, the purpose of this letter is to confirm arrangements for a meeting between members of your staff and of the utilities utilizing reactors designed by Babcock and Wilcox (B&W) to discuss the type and extent of examinations required to be performed under the requirements of IE Bulletin 79-13. Participating utilities are Sacramento Municipal Utility District, Arkansas Power and Light, Metropolitan Edison, Florida Power Corporation, Toledo Edison and Duke Power.

Chairman, B&W Users Group Subcommittee on
Feedwater Pipe Cracking, IE Bulletin 79-13

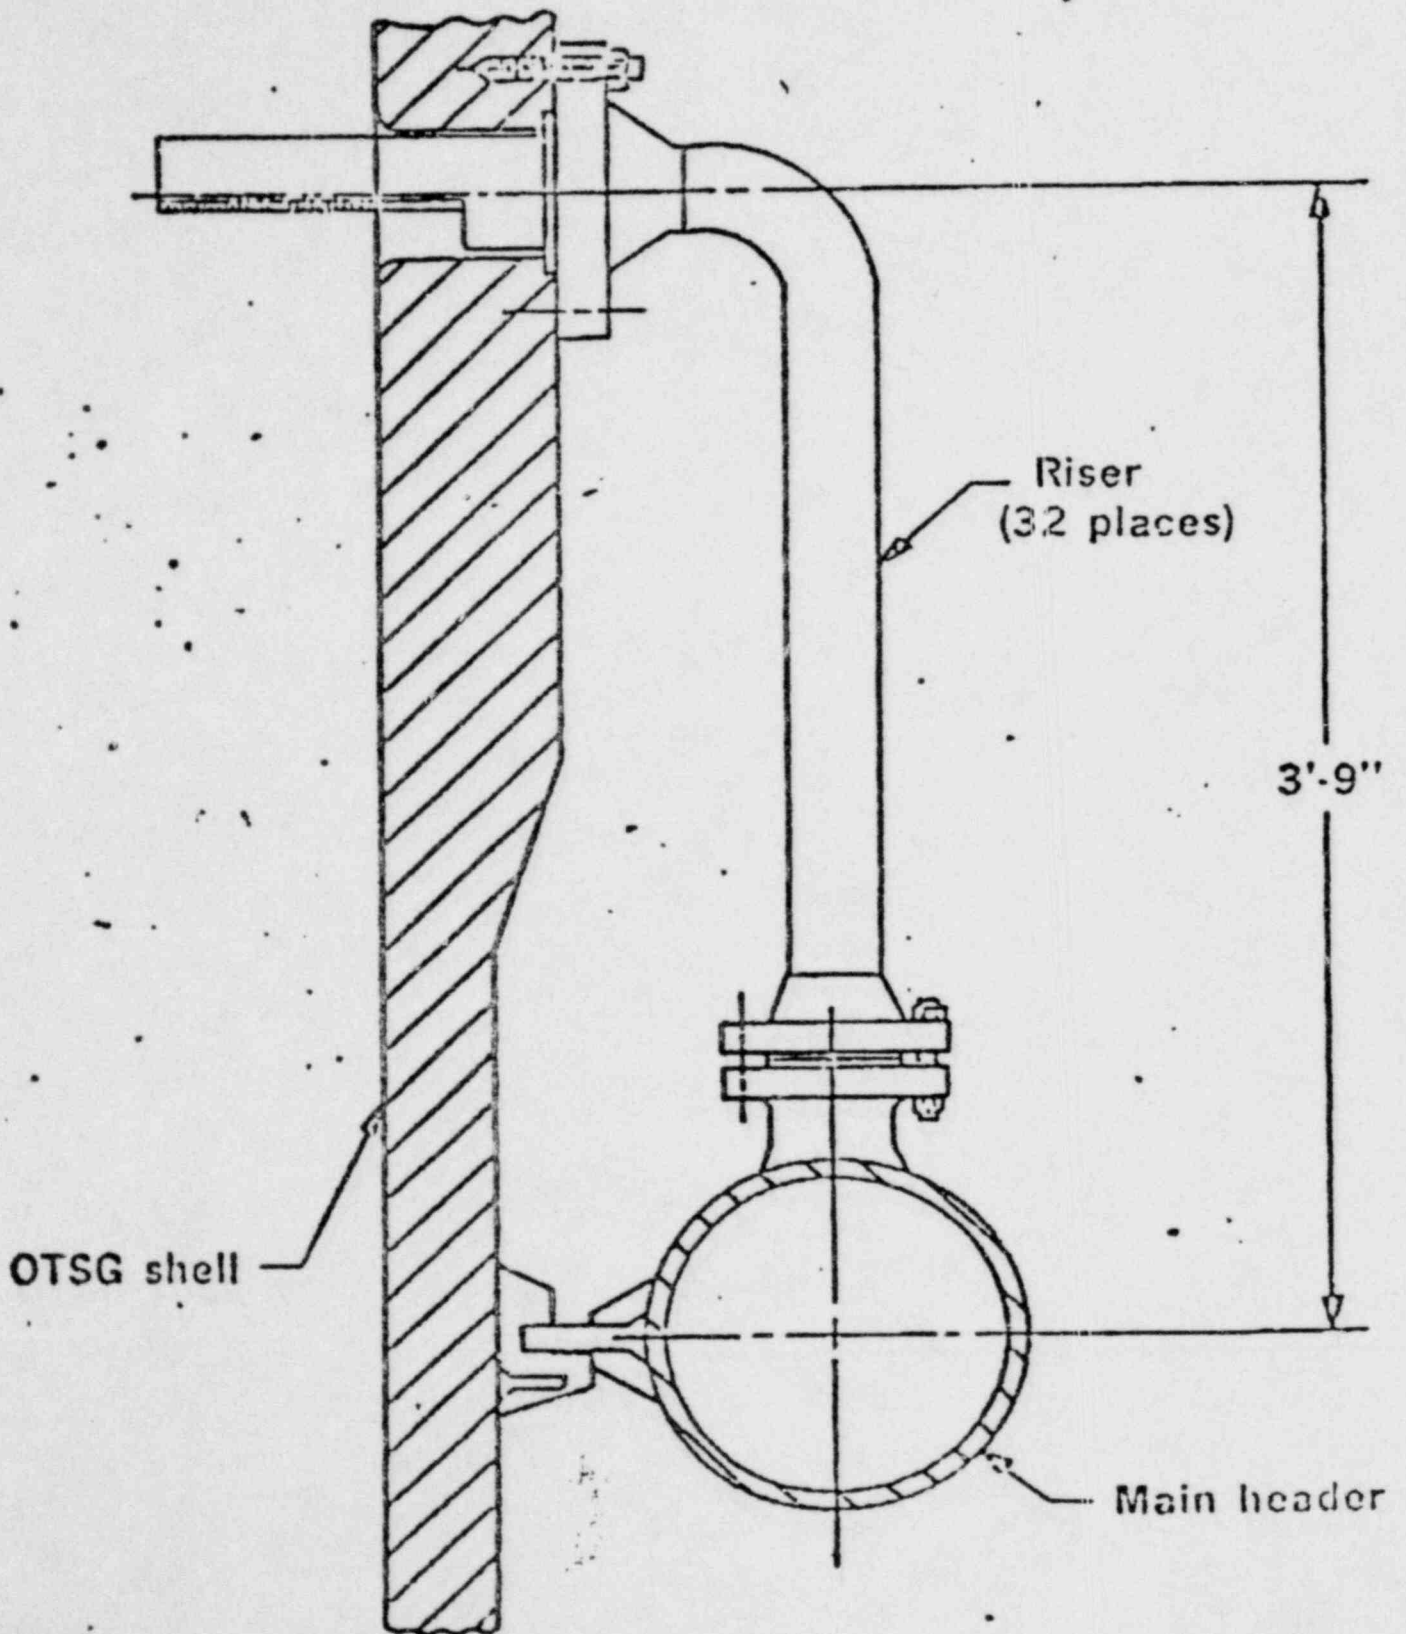
- FIGURE 1. -

- 1) B&W Once Thru Steam Generators (OTSG) do not utilize nozzles for the attachment of Main Feedwater piping to the vessel. Main Feedwater enters the OTSG through a ring header attached to the OTSG by 32 riser pipes with bolted connections (see Figure 1). Auxiliary Feedwater piping is also connected to the OTSG by means of an external ring header attached to the OTSG with 7 risers with bolted connections at all plants except Rancho Seco, Davis Besse, and Oconee 3, where a welded nozzle connection with an internal ring header is used. This design differs from the Westinghouse design where Main and Auxiliary Feedwater enter the steam generator through a single welded nozzle connection.

177 FA OTSG feedwater nozzle assembly

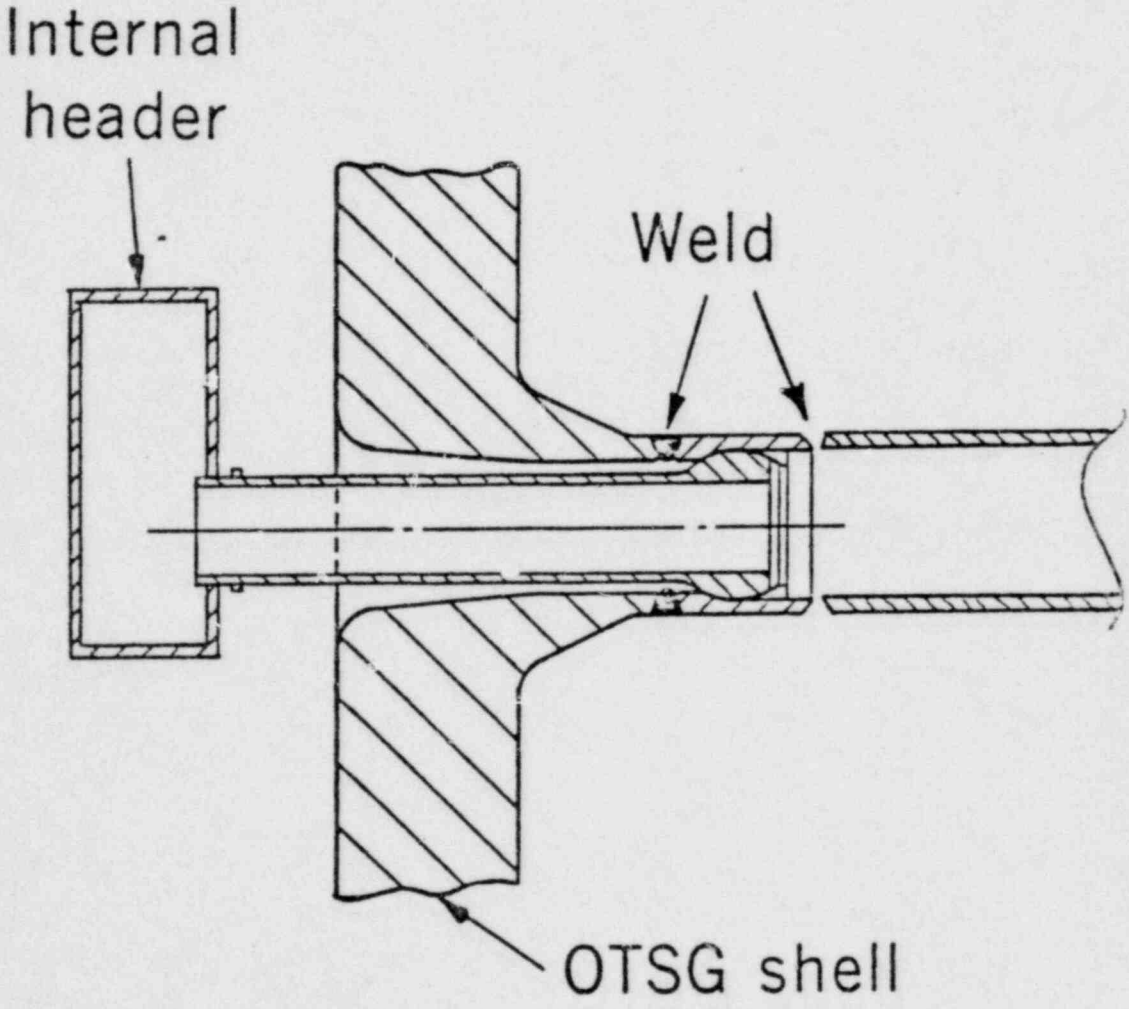
177 FA OTSG auxiliary feedwater Welded nozzle assembly

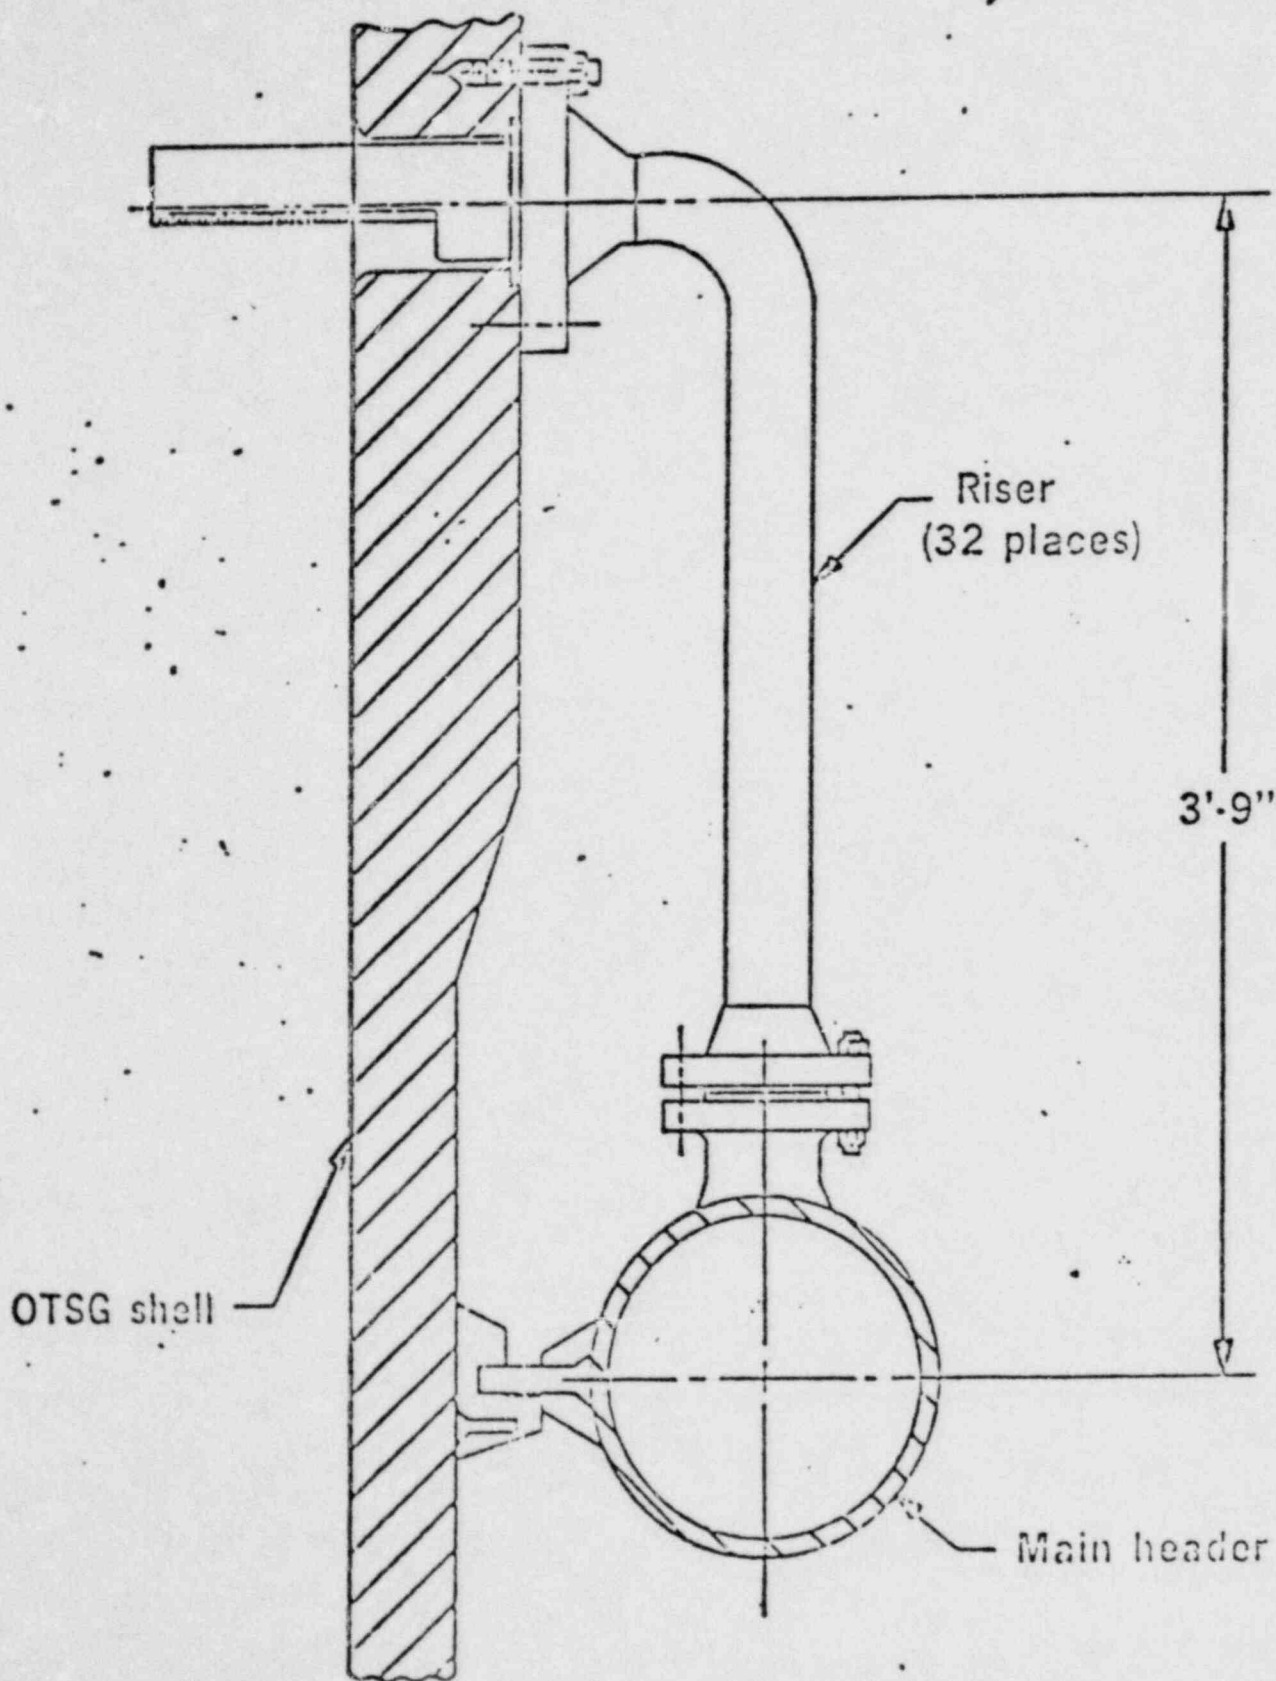
- FIGURE 1. -

177 FA OTSG feedwater nozzle assembly
