IE Circular No. 80-15

LOSS OF REACTOR COOLANT PUMP COOLING AND NATURAL CIRCULATION COOLDOWN

Enclosure:
Annotated record of
 pressurizer level

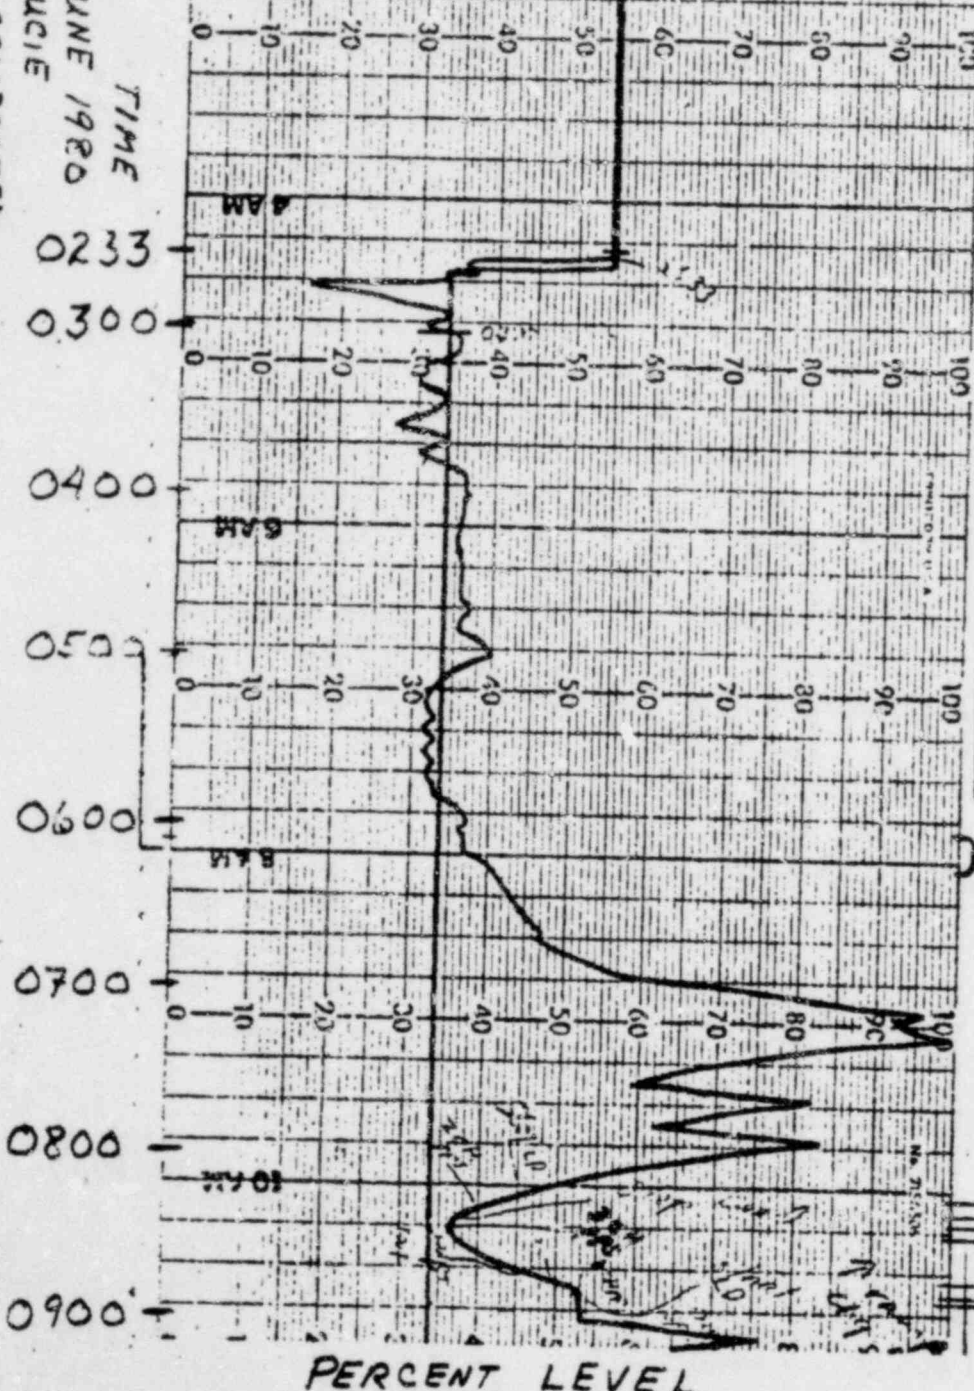
SHEET 1 OF 2

The natural circulation cooldown continued uneventfully until after time 0600. The highest cooldown rate achieved was approximately 65 to 70 F per hour. Between 0600 and 0630 RCS pressure was reduced from 1140 to 690 psi by charging water through the pressurizer auxiliary spray line. Pressurizer level increased rapidly around 0700 while charging via the auxiliary spray line. Pressurizer level continued variations for approximately five hours while the cooldown and depressurization continued. When charging was shifted to the RCS loops, pressurizer level decreased at rates lower than the rates of increase in level when charging through the auxiliary spray line. During a two minute interval while charging into the pressurizer auxiliary spray line at 88 gpm, pressurizer level rose at a rate approximately ten times greater than the charging flowrate.

The cause of pressurizer level variations appears to be formation of a steam void in the reactor head area due to a temperature lag with respect to bulk coolant temperature that developed because of insufficient cooling flow in that area during natural circulation cooldown. Gas concentration in a 0730 RCS sample was determined by the licensee to be 32 cc/kg hydrogen and 16 cc/kg nitrogen. These concentrations were not high enough to cause a significant volume of gas to come out of solution. The indicated subcooling margin ($T_{sat} - T_{hot}$) ranged between 220 and 150 F when the reactor head steam void developed between 0600 and 0700. The minimum required subcooling of 50 F was not approached during the cooldown until around time 1219 at a pressurizer pressure of approximately 110 psig. An annotated record of pressurizer level is enclosed only to illustrate the high amplitudes and rates of pressurizer level variations. Insufficient information is contained in the enclosure to enable detailed evaluation of the RCS behavior.

11 JUNE 1980
ST. LUCIE
HOT CALIBRATED
PRESSURIZER LEVEL

DEPRESSURIZE
1140 psig to 690 psig

- STOP LETDOWN
- 2 CHARGING PUMPS
- STOP FEED
- 3 CHARGING PUMPS

- START FEED
- 1 CHARGING PUMP
- START LETDOWN

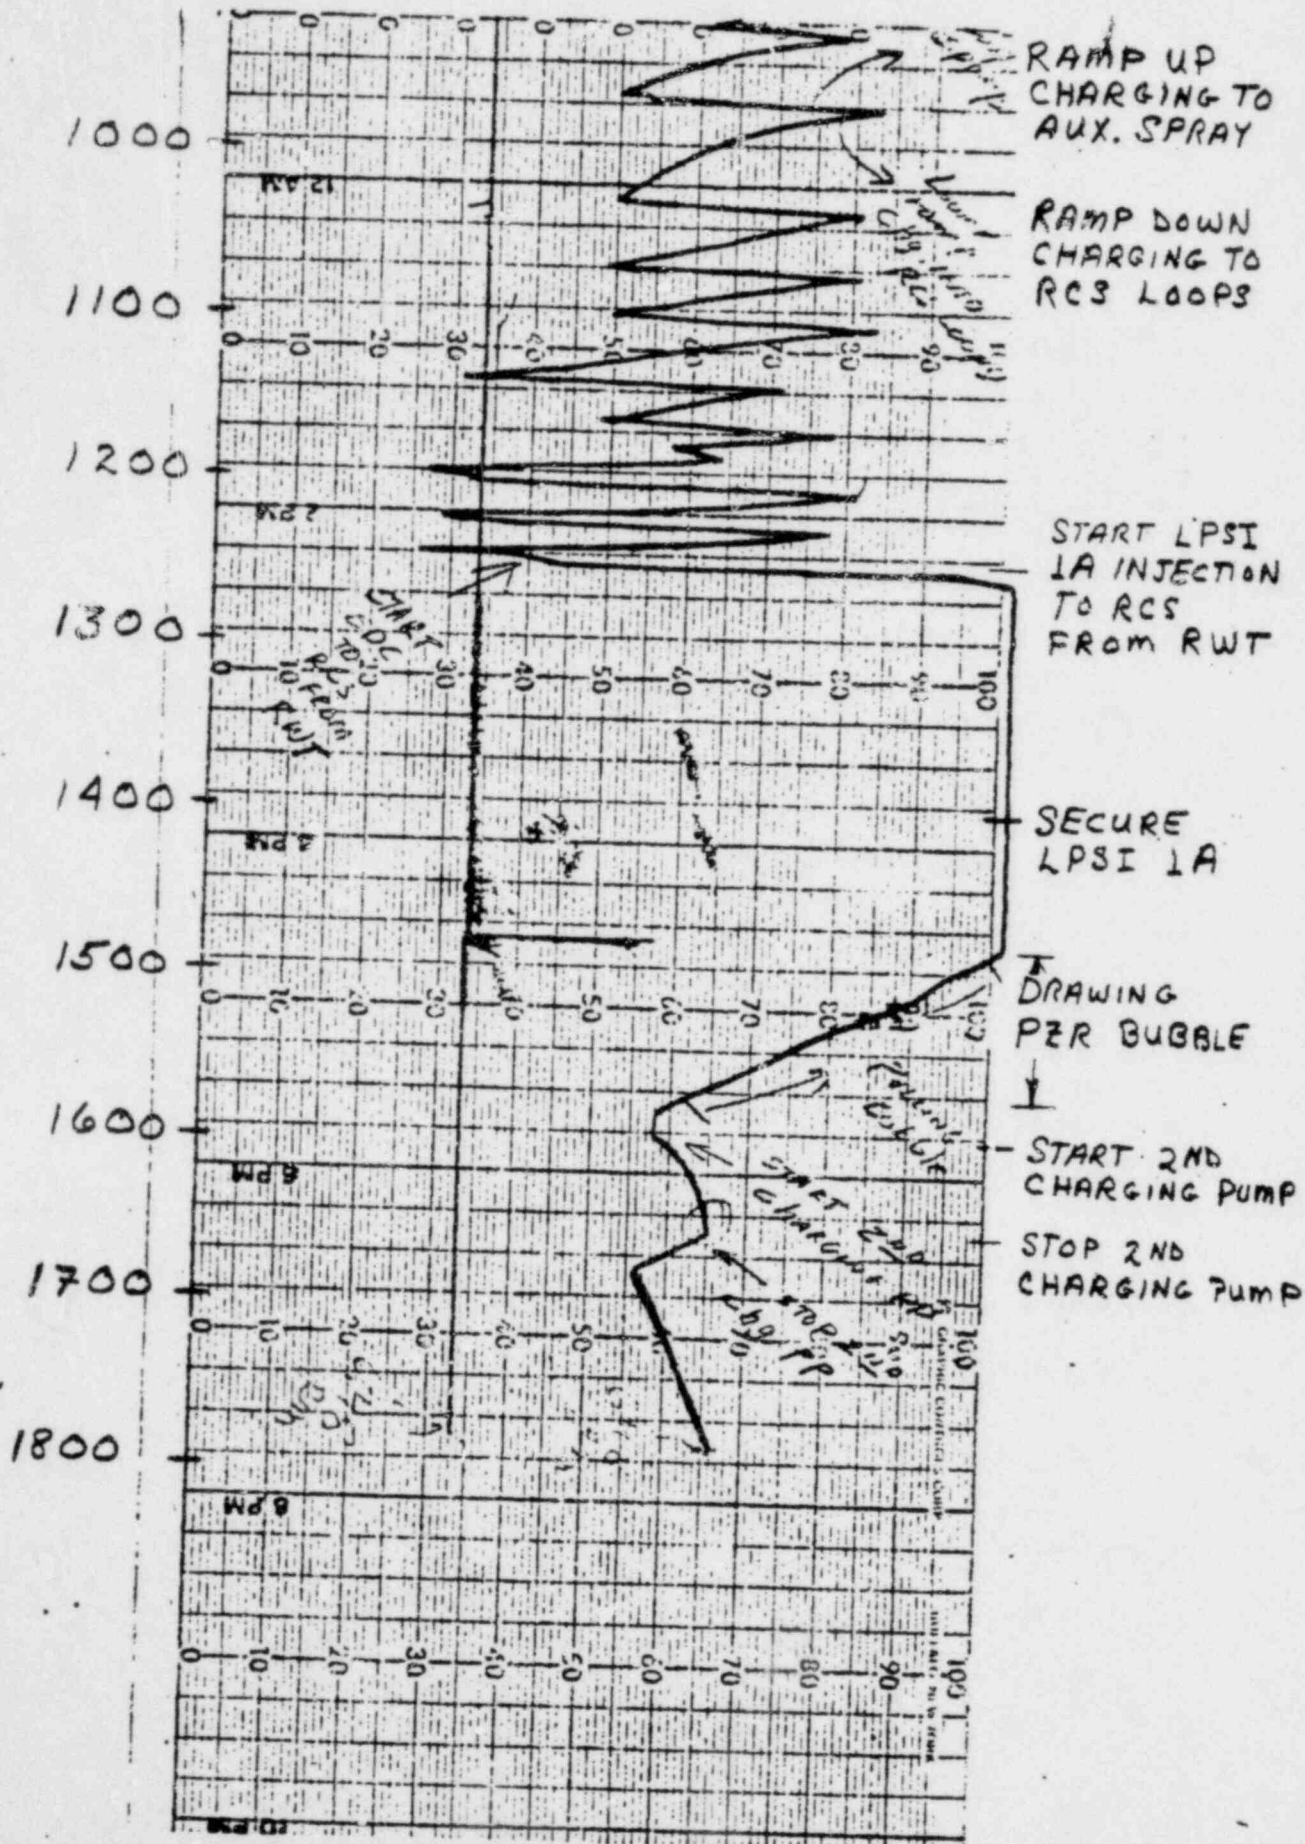
SHEET
2 OF 2

The cold calibrated pressurizer level instrument indication rose to 64 percent and remained constant while hot calibrated channels rose to 100% level. Temperature correction data for the cold calibrated level instrument didn't extend to 360 F, which was the approximate pressurizer temperature when the pressurizer indicated full. Constant level on the cold calibrated channel indicated the pressurizer was solid, but continued charging flow at 88 gpm was not causing pressure to rise above 200 psig, as it should have had the RCS been solid. Letdown had been secured while filling the pressurizer. The indications of a steam void in the reactor vessel head were no longer evident after RCS pressure increased although the exact time when the void disappeared has not been established.

miniflow was isolated. Continued charging with two pumps at 88 gpm total flowrate caused a slight rise in both pressurizer pressure (to 260 psig) and cold calibrated pressurizer level. Letdown in excess of charging flowrate was established at 1430, and by 1500 a steam bubble was drawn in the pressurizer with level in the indicating range.
