UNITED STATES  
NUCLEAR REGULATORY COMMISSION  
REGION V  
1990 N. CALIFORNIA BOULEVARD  
SUITE 202, WALNUT CREEK PLAZA  
WALNUT CREEK, CALIFORNIA 94596

IE Circular No. 80-15

LOSS OF REACTOR COOLANT PUMP COOLING AND NATURAL CIRCULATION COOLDOWN

Enclosure:  
Annotated record of  
pressurizer level

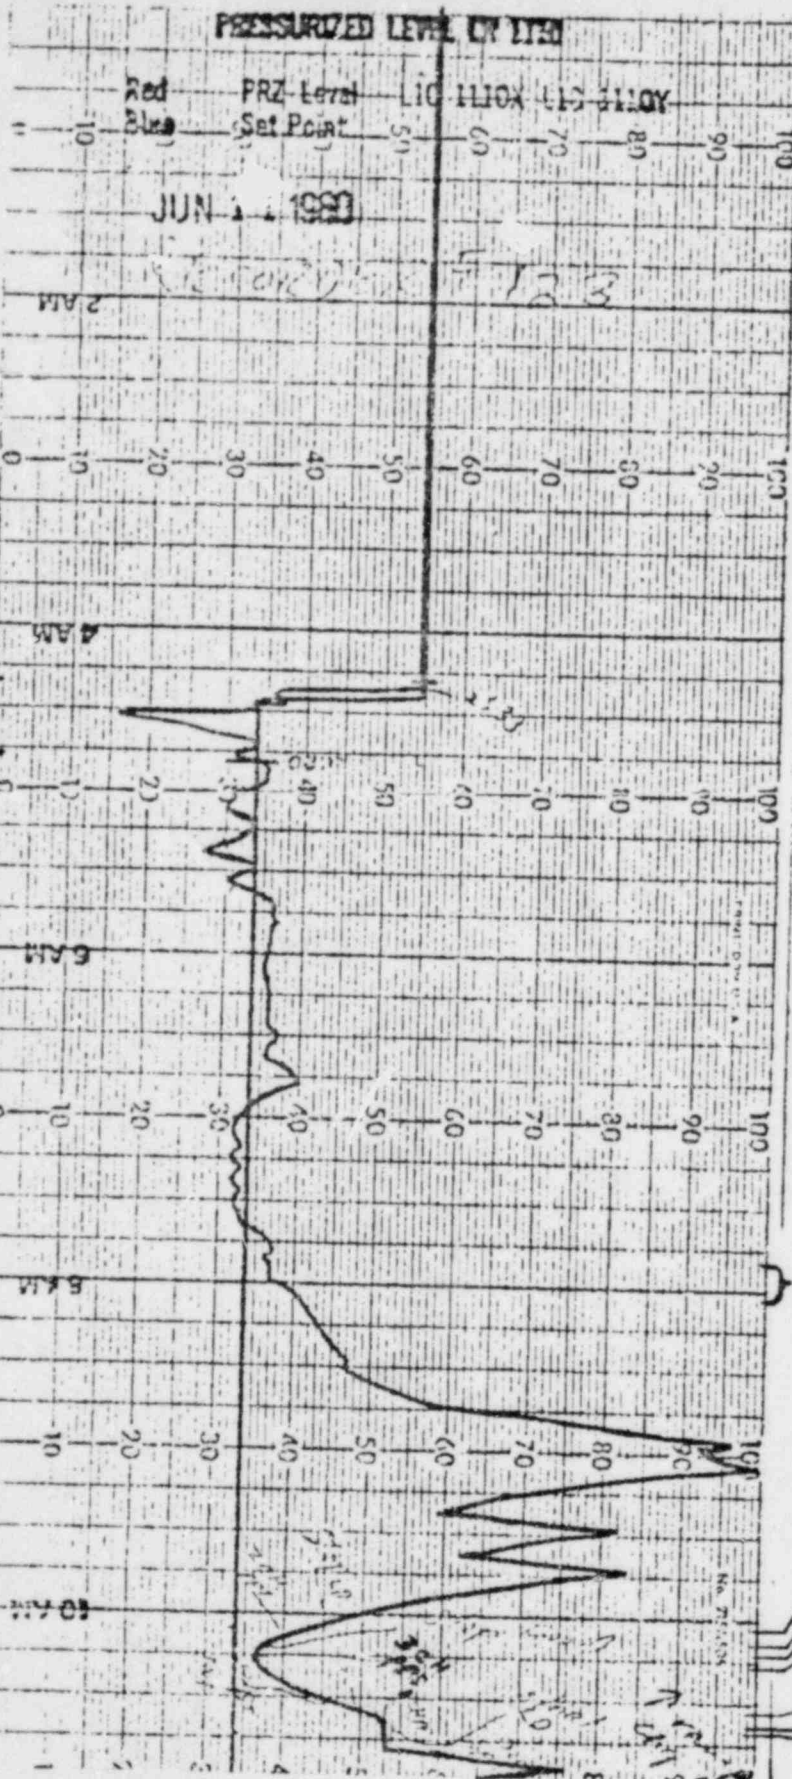
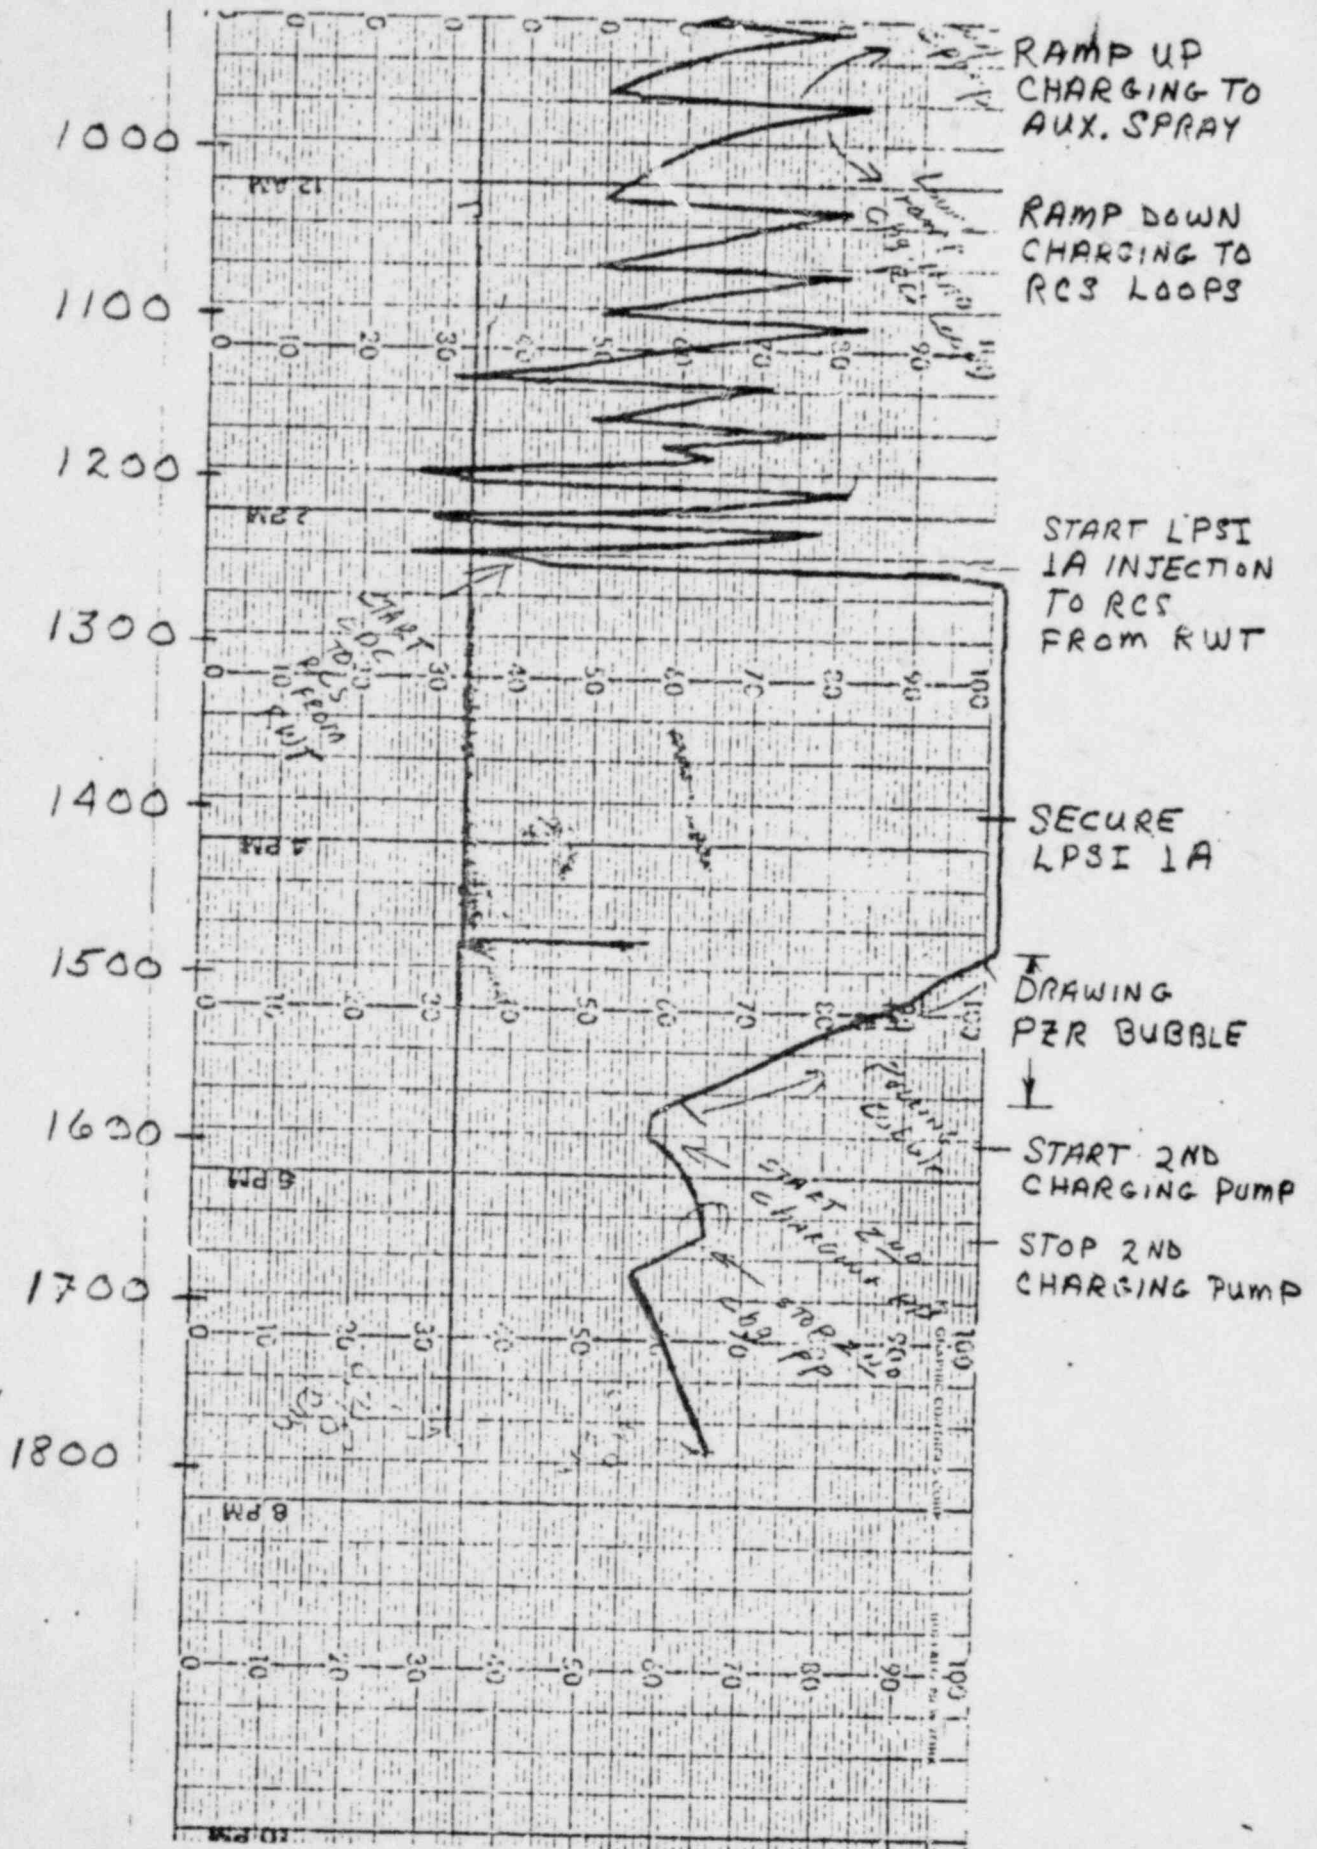
HOT CALIBRATED  
PRESSURIZER LEVEL

The natural circulation cooldown continued uneventfully until after time 0600. The highest cooldown rate achieved was approximately 65 to 70 F per hour. Between 0600 and 0630 RCS pressure was reduced from 1140 to 690 psi by charging water through the pressurizer auxiliary spray line. Pressurizer level increased rapidly around 0700 while charging via the auxiliary spray line. Pressurizer level variations continued for approximately five hours while the cooldown and depressurization continued. When charging was shifted to the RCS loops, pressurizer level decreased at rates lower than the rates of increase in level when charging through the auxiliary spray line. During a two minute interval while charging into the pressurizer auxiliary spray line at 88 gpm, pressurizer level rose at a rate approximately ten times greater than the charging flowrate.

The cause of pressurizer level variations appears to be formation of a steam void in the reactor head area due to a temperature lag with respect to bulk coolant temperature that developed because of insufficient cooling flow in that area during natural circulation cooldown. Gas concentration in a 0730 RCS sample was determined by the licensee to be 32 cc/kg hydrogen and 16 cc/kg nitrogen. These concentrations were not high enough to cause a significant volume of gas to come out of solution. The indicated subcooling margin ( $T_{sat} - T_{hot}$ ) ranged between 220 and 150 F when the reactor head steam void developed between 0600 and 0700. The minimum required subcooling of 50 F was not approached during the cooldown until around time 1219 at a pressurizer pressure of approximately 110 psig. An annotated record of pressurizer level is enclosed only to illustrate the high amplitudes and rates of pressurizer level variations. Insufficient information is contained in the enclosure to enable detailed evaluation of the RCS behavior.

The cold calibrated pressurizer level instrument indication rose to 64 percent and remained constant while hot calibrated channels rose to 100% level. Temperature correction data for the cold calibrated level instrument didn't extend to 360 F, which was the approximate pressurizer temperature when the pressurizer indicated full. Constant level on the cold calibrated channel indicated the pressurizer was solid, but continued charging flow at 88 gpm was not causing pressure to rise above 200 psig, as it should have had the RCS been solid. Letdown had been secured while filling the pressurizer. The indications of a steam void in the reactor vessel head were no longer evident after RCS pressure increased although the exact time when the void disappeared has not been established.

DEPRESSURIZE  
1140 psig to 690 psig

STOP LETDOWN  
2 CHARGING PUMPS  
STOP FEED  
3 CHARGING PUMPS

START FEED  
1 CHARGING PUMP  
START LETDOWN
