June 20, 1980

IE Circular No. 80-15

LOSS OF REACTOR COOLANT PUMP COOLING AND NATURAL CIRCULATION COOLDOWN

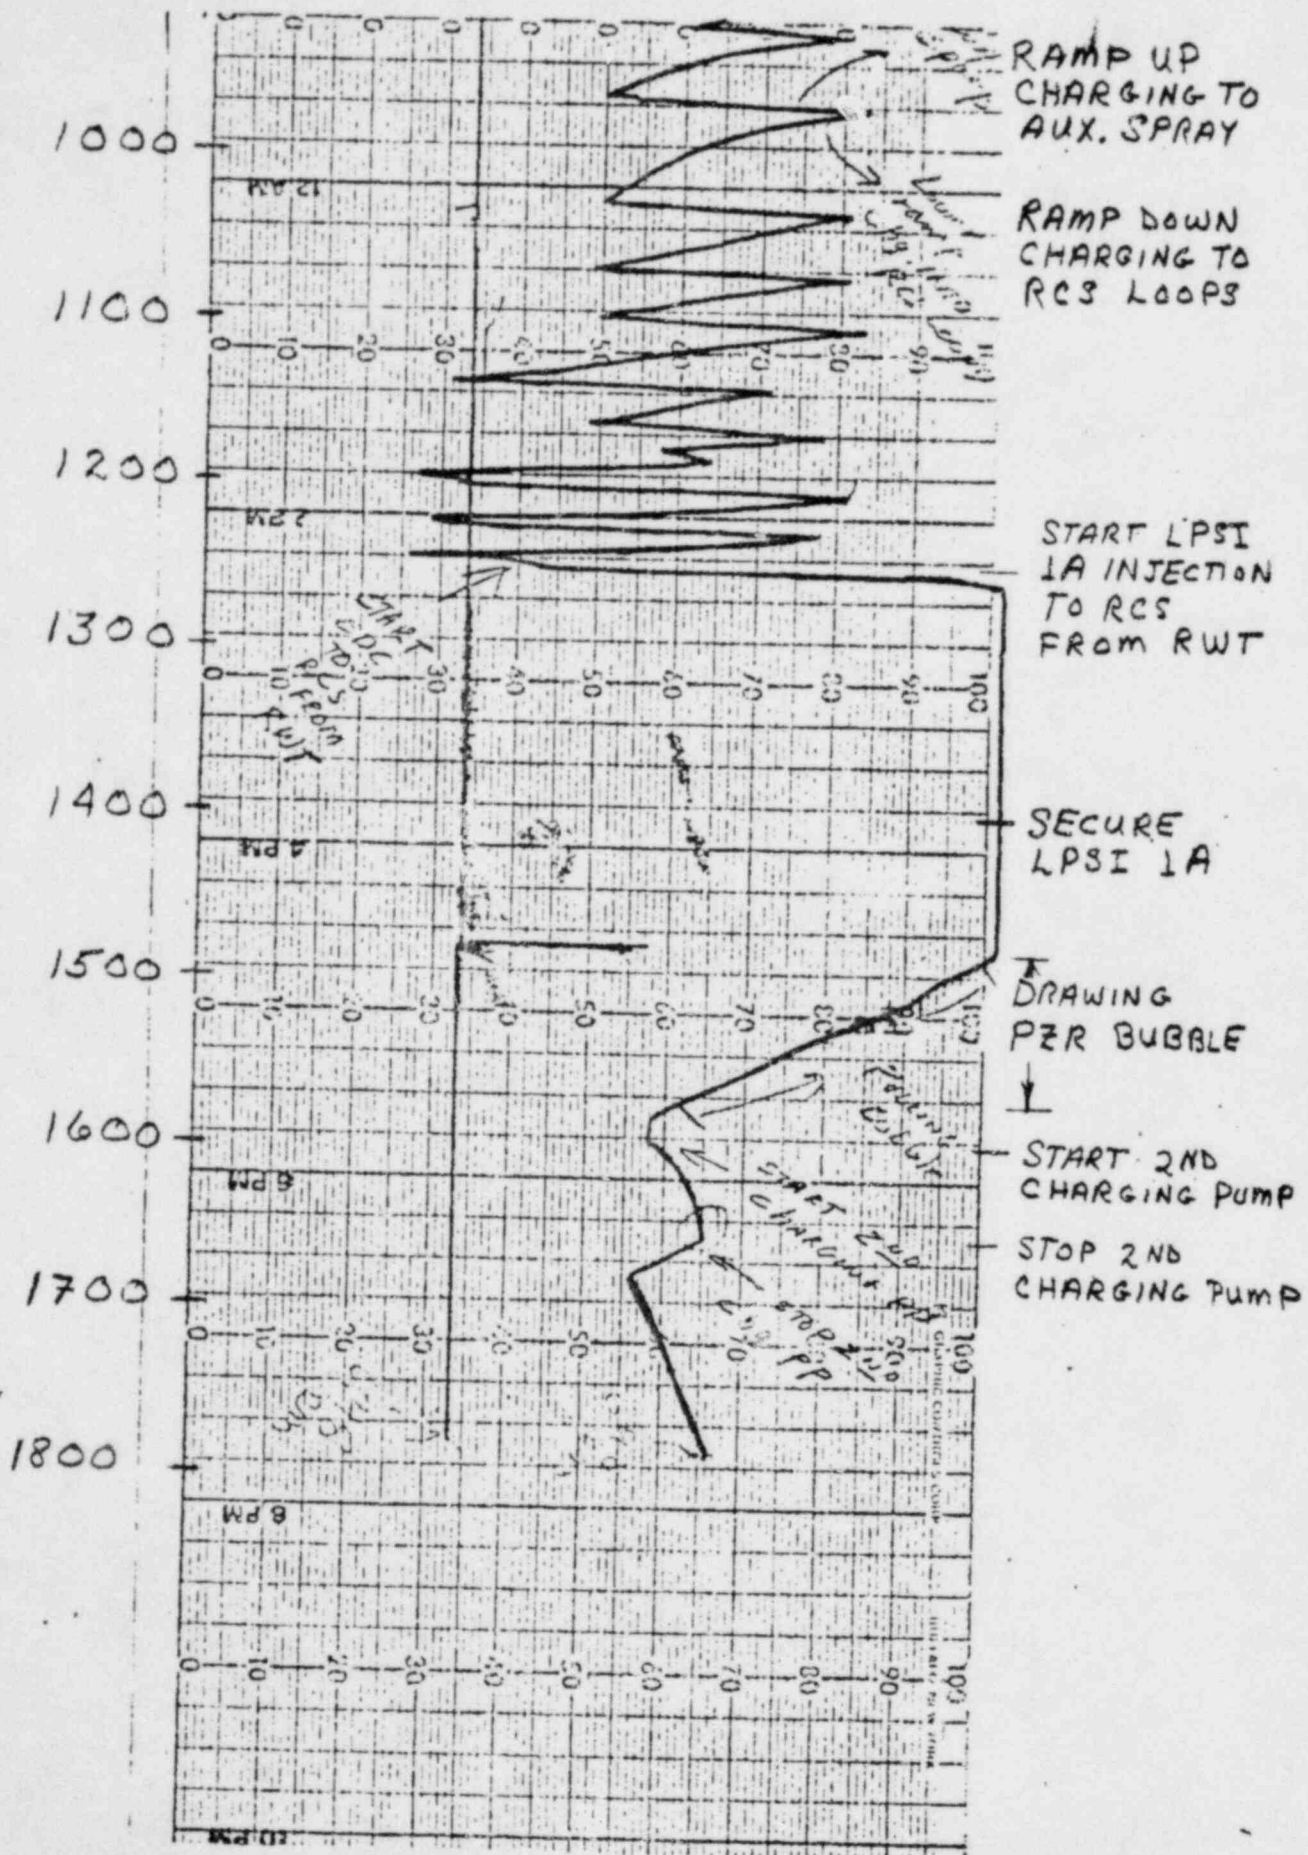
11 JUNE 1980
ST. LUCIE
HOT CALIBRATED
PRESSURIZER LEVEL

The natural circulation cooldown continued uneventfully until after time 0600. The highest cooldown rate achieved was approximately 65 to 70 F per hour. Between 0600 and 0630 RCS pressure was reduced from 1140 to 690 psi by charging water through the pressurizer auxiliary spray line. Pressurizer level increased rapidly around 0700 while charging via the auxiliary spray line. Pressurizer level variations continued for approximately five hours while the cooldown and depressurization continued. When charging was shifted to the RCS loops, pressurizer level decreased at rate lower than the rates of increase in level when charging through the auxiliary spray line. During a two minute interval while charging into the pressurizer auxiliary spray line at 88 gpm, pressurizer level rose at a rate approximately ten times greater than the charging flowrate.

The cause of pressurizer level variations appears to be formation of a steam void in the reactor head area due to a temperature lag with respect to bulk coolant temperature that developed because of insufficient cooling flow in that area during natural circulation cooldown. Gas concentration in a 0730 RCS sample was determined by the licensee to be 32 cc/kg hydrogen and 16 cc/kg nitrogen. These concentrations were not high enough to cause a significant volume of gas to come out of solution. The indicated subcooling margin ($T_{sat} - T_{hot}$) ranged between 220 and 150 F when the reactor head steam void developed between 0600 and 0700. The minimum required subcooling of 50 F was not approached during the cooldown until around time 1219 at a pressurizer pressure of approximately 110 psig. An annotated record of pressurizer level is enclosed only to illustrate the high amplitudes and rates of pressurizer level variations. Insufficient information is contained in the enclosure to enable detailed evaluation of the RCS behavior.

DEPRESSURIZE
1140 psig to 690 psig

- STOP LETDOWN
- 2 CHARGING PUMPS
- STOP FEED
- 3 CHARGING PUMPS
- START FEED
- 1 CHARGING PUMP
- START LETDOWN
