UNITED STATES
NUCLEAR REGULATORY COMMISSION
OFFICE OF INSPECTION AND ENFORCEMENT
WASHINGTON, D. C. 20555

IE Circular No. 80-15

LOSS OF REACTOR COOLANT PUMP COOLING AND NATURAL CIRCULATION COOLDOWN

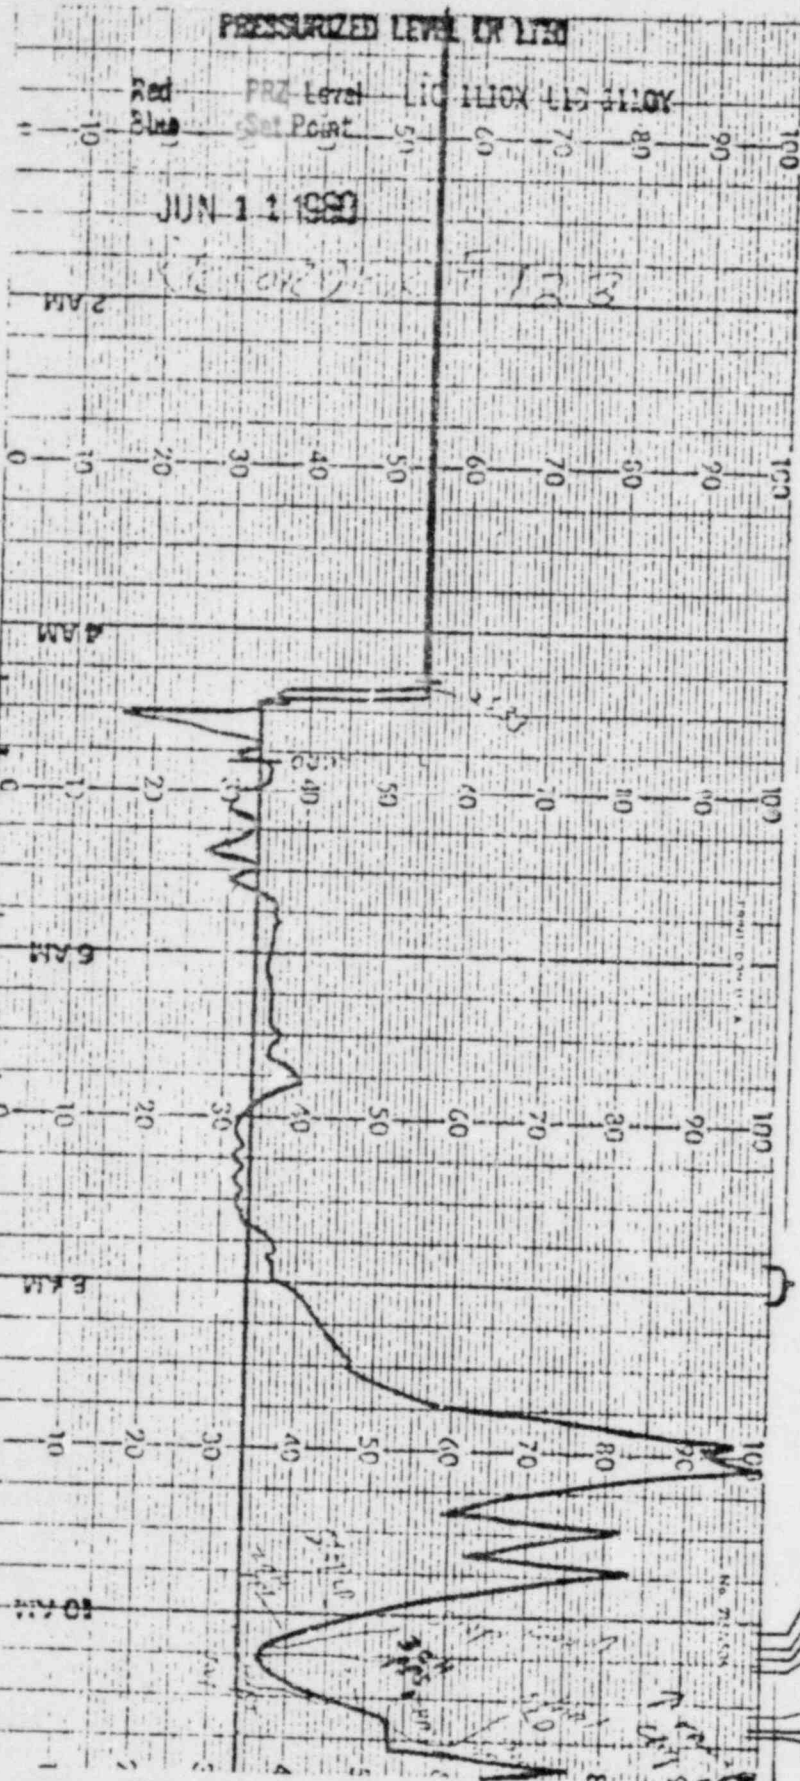
11 JUNE 1980
ST. LUCIE
HOT CALIBRATED
PRESSURIZER LEVEL

The natural circulation cooldown continued uneventfully until after time 0600. The highest cooldown rate achieved was approximately 65 to 70 F per hour. Between 0600 and 0630 RCS pressure was reduced from 1140 to 690 psi by charging water through the pressurizer auxiliary spray line. Pressurizer level increased rapidly around 0700 while charging via the auxiliary spray line. Pressurizer level variations continued for approximately five hours while the cooldown and depressurization continued. When charging was shifted to the RCS loops, pressurizer level decreased at rates lower than the rates of increase in level when charging through the auxiliary spray line. During a two minute interval while charging into the pressurizer auxiliary spray line at 88 gpm, pressurizer level rose at a rate approximately ten times greater than the charging flowrate.

The cause of pressurizer level variations appears to be formation of a steam void in the reactor head area due to a temperature lag with respect to bulk coolant temperature that developed because of insufficient cooling flow in that area during natural circulation cooldown. Gas concentration in a 0730 RCS sample was determined by the licensee to be 32 cc/kg hydrogen and 16 cc/kg nitrogen. These concentrations were not high enough to cause a significant volume of gas to come out of solution. The indicated subcooling margin ($T_{sat} - T_{hot}$) ranged between 220 and 150 F when the reactor head steam void developed between 0600 and 0700. The minimum required subcooling of 50 F was not approached during the cooldown until around time 1219 at a pressurizer pressure of approximately 110 psig. An annotated record of pressurizer level is enclosed only to illustrate the high amplitudes and rates of pressurizer level variations. Insufficient information is contained in the enclosure to enable detailed evaluation of the RCS behavior.

DEPRESSURIZE
1140 psig to 690 psig

- STOP LETDOWN
- 2 CHARGING PUMPS
- STOP FEED
- 3 CHARGING PUMPS
- START FEED
- 1 CHARGING PUMP
- START LETDOWN
