Docket Nos. 50-317
50-318

IE Circular No. 80-15
Date: June 20, 1980
Page 1 of 4

LOSS OF REACTOR COOLANT PUMP COOLING AND NATURAL CIRCULATION COOLDOWN

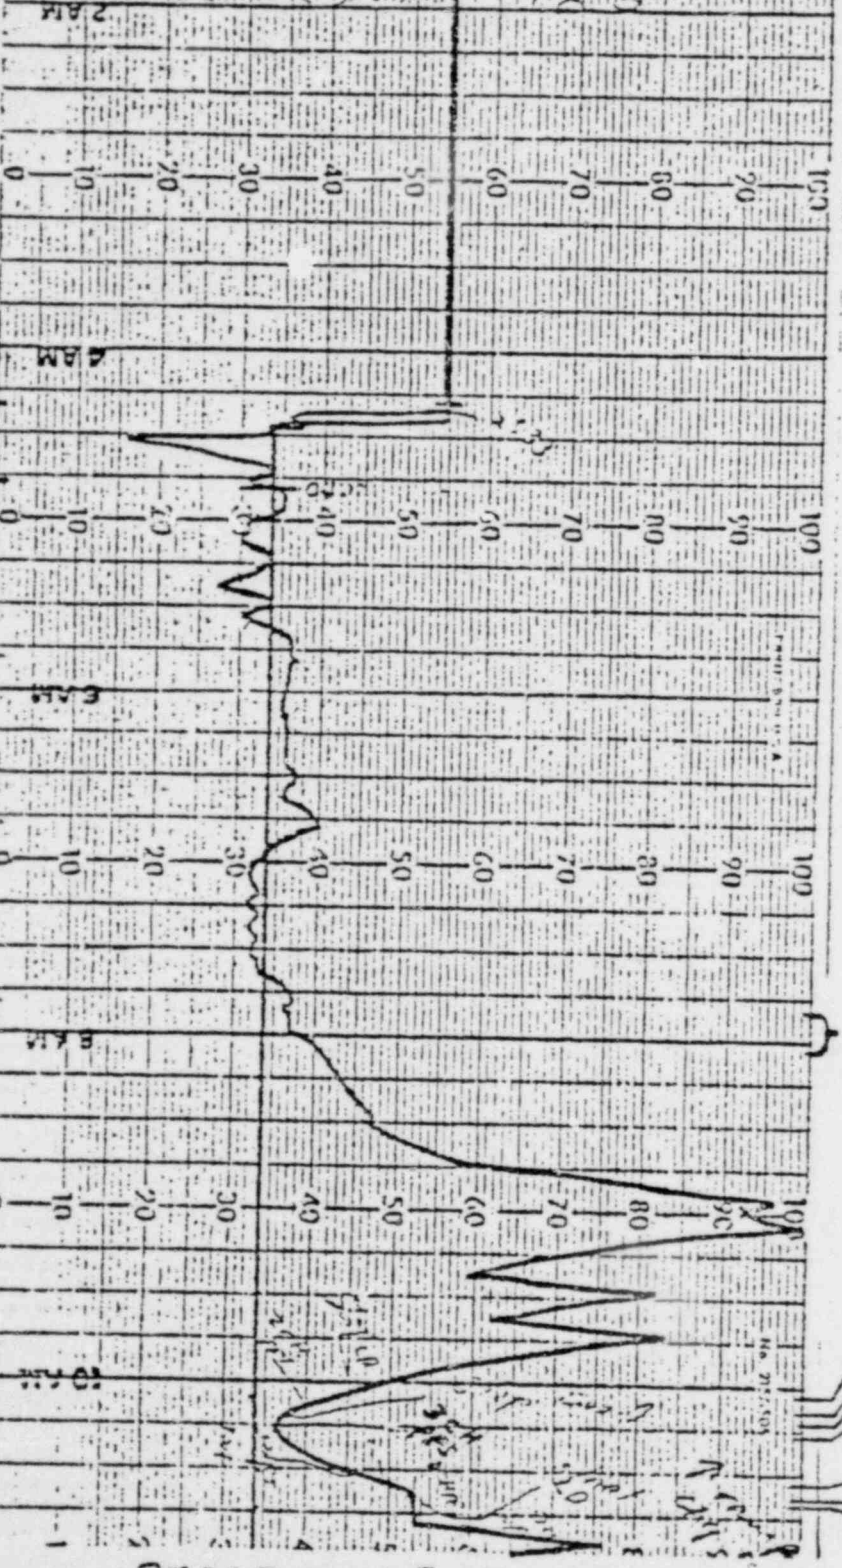
SHEET 1 OF 2

The cold calibrated pressurizer level instrument indication rose to 64 percent and remained constant while hot calibrated channels rose to 100% level. Temperature correction data for the cold calibrated level instrument didn't extend to 360 F, which was the approximate pressurizer temperature when the pressurizer indicated full. Constant level on the cold calibrated channel indicated the pressurizer was solid, but continued charging flow at 88 gpm was not causing pressure to rise above 200 psig, as it should have had the RCS been solid. Letdown had been secured while filling the pressurizer. The indications of a steam void in the reactor vessel head were no longer evident after RCS pressure increased although the exact time when the void disappeared has not been established.

HOT CALIBRATED
PRESSURIZER LEVEL
ST. LUCIE
11 JUNE 1980
TIME

DEPRESSURIZE
1140 psig to 690 psig

- STOP LETDOWN
- 2 CHARGING PUMPS
- STOP FEED
- 3 CHARGING PUMPS
- START FEED
- 1 CHARGING PUMP
- START LETDOWN
