Docket No. 50-293

UNITED STATES  
NUCLEAR REGULATORY COMMISSION  
OFFICE OF INSPECTION AND ENFORCEMENT  
WASHINGTON, D. C. 20555

IE Circular No. 80-15  
Date: June 20, 1980  
Page 1 of 4

LOSS OF REACTOR COOLANT PUMP COOLING AND NATURAL CIRCULATION COOLDOWN

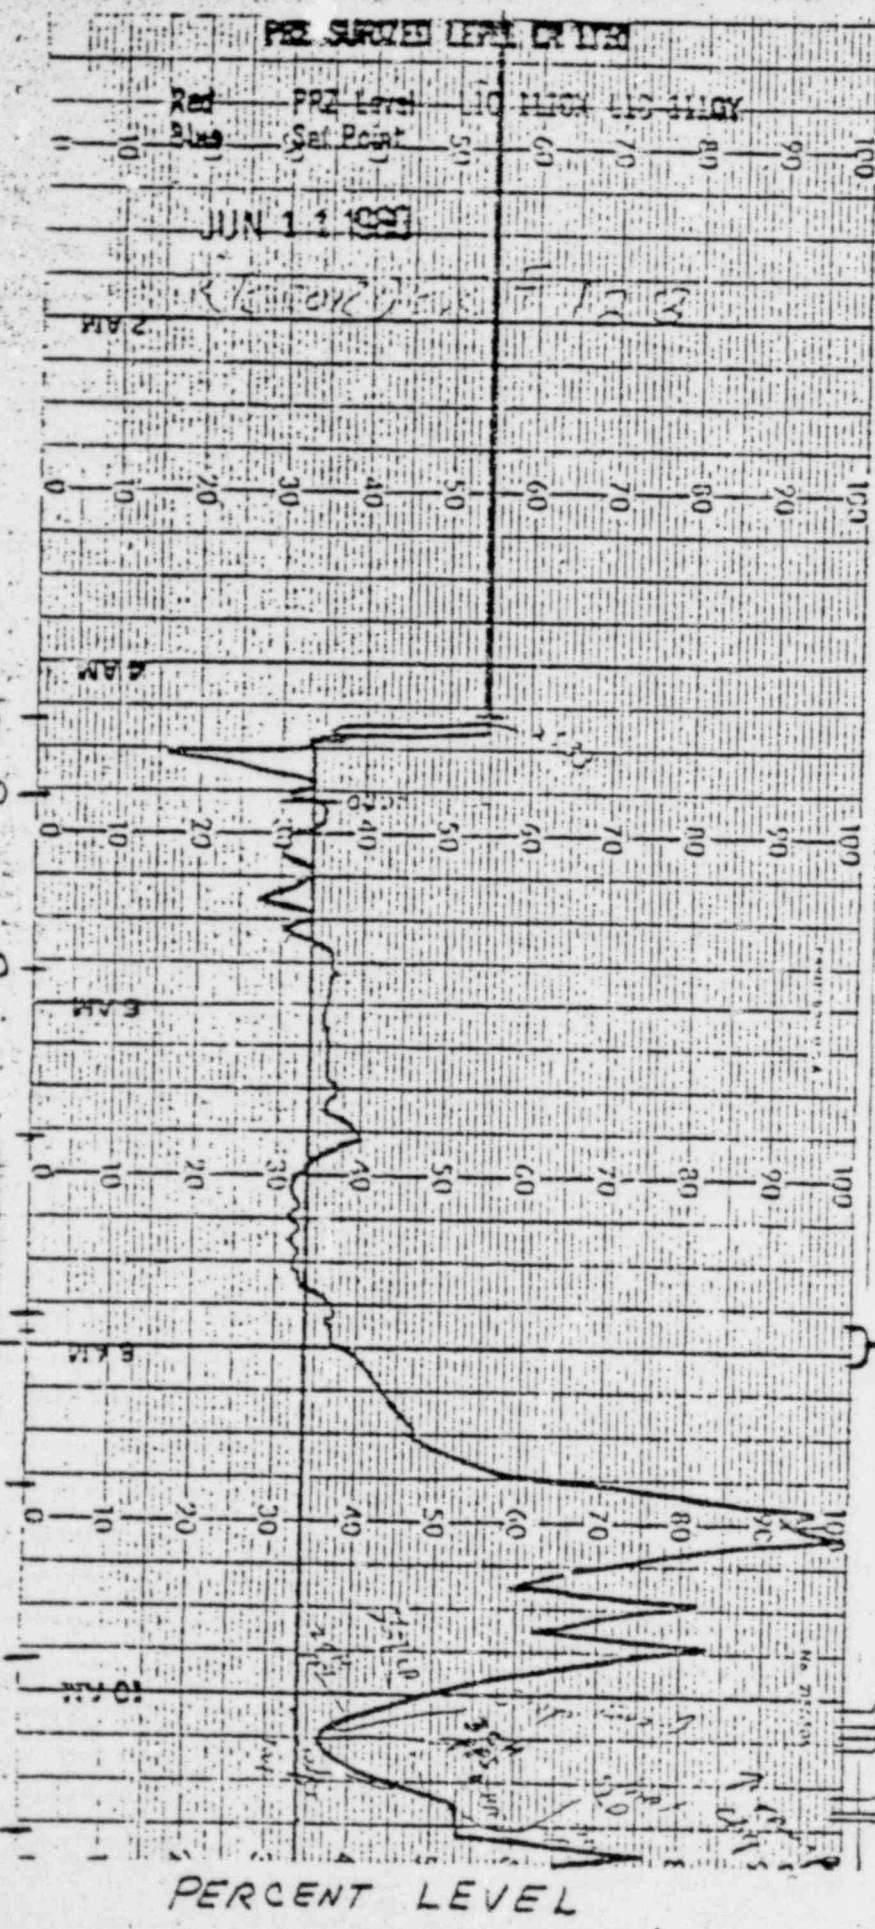
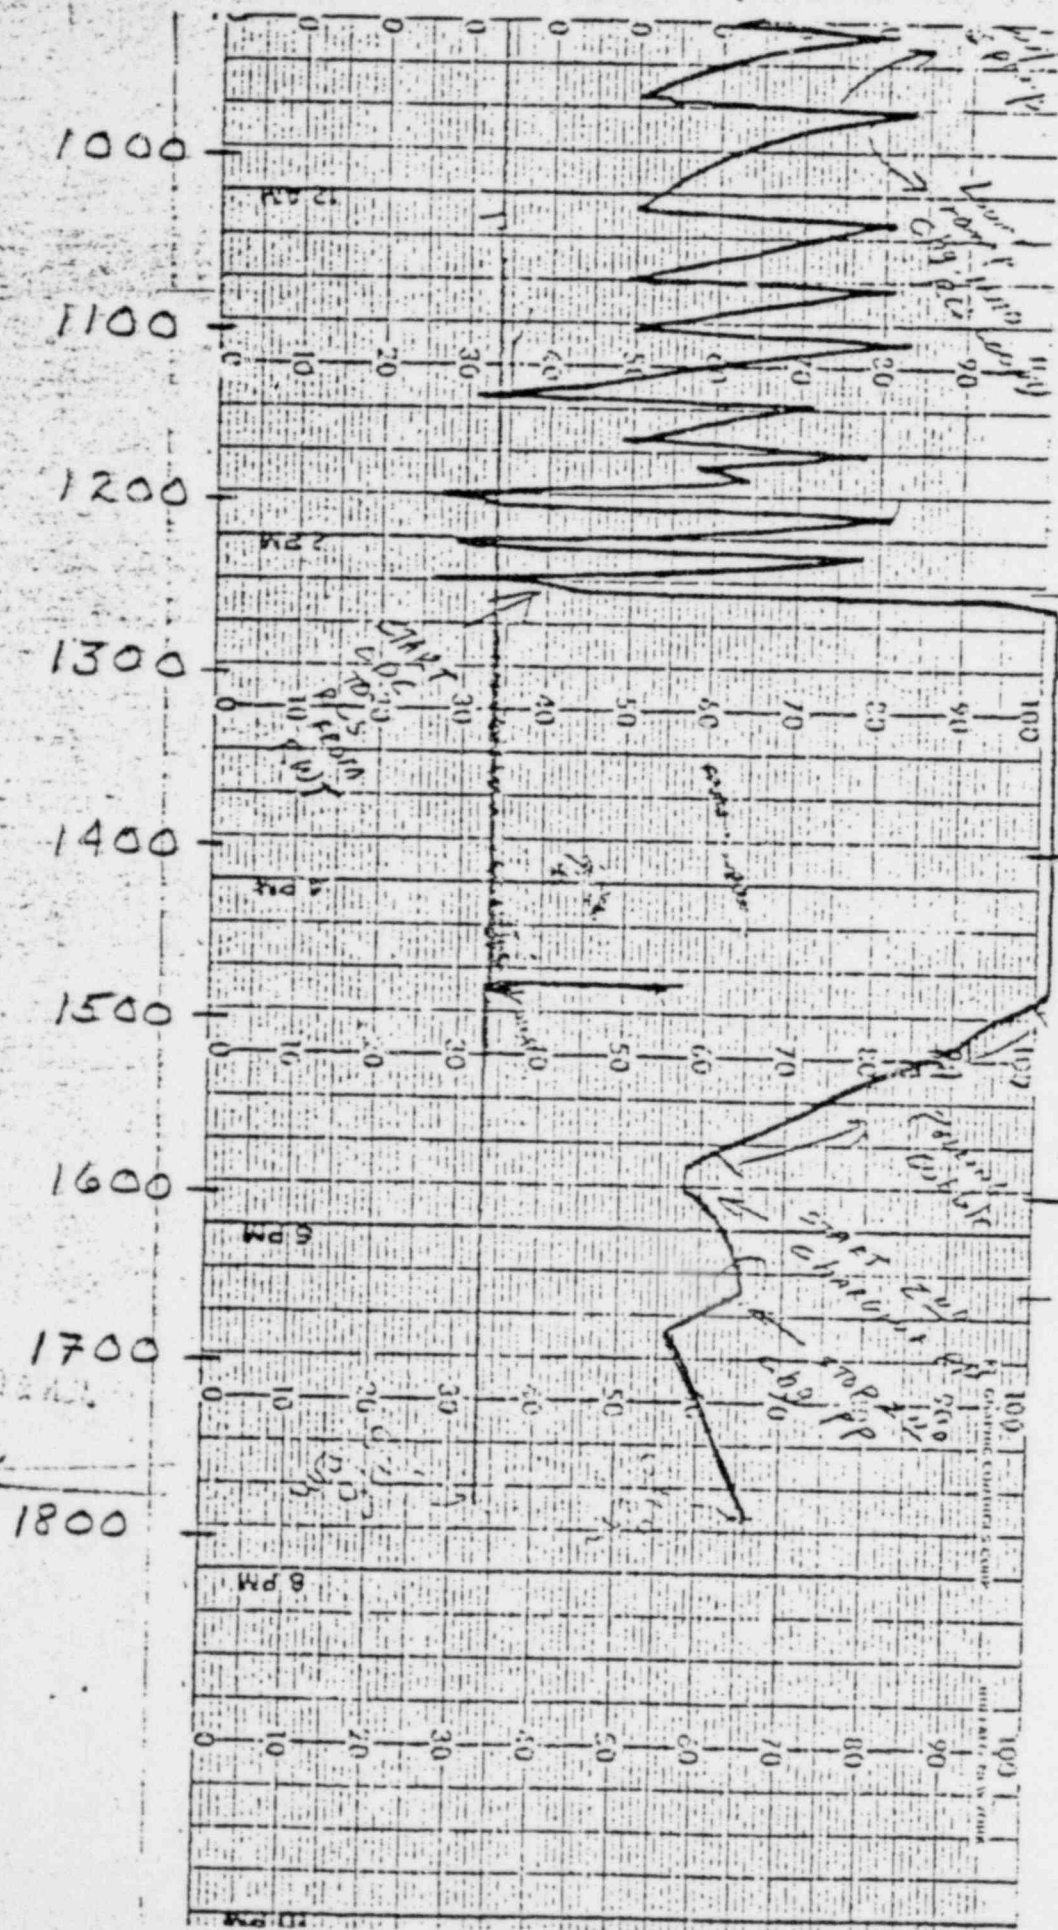
11 JUNE 1980  
ST. LUCIE  
HOT CALIBRATED  
PRESSURIZER LEVEL

The cause of pressurizer level variations appears to be formation of a steam void in the reactor head area due to a temperature lag with respect to bulk coolant temperature that developed because of insufficient cooling flow in that area during natural circulation cooldown. Gas concentration in a 0730 RCS sample was determined by the licensee to be 32 cc/kg hydrogen and 16 cc/kg nitrogen. These concentrations were not high enough to cause a significant volume of gas to come out of solution. The indicated subcooling margin ( $T_{sat} - T_{hot}$ ) ranged between 220 and 150 F when the reactor head steam void developed between 0600 and 0700. The minimum required subcooling of 50 F was not approached during the cooldown until around time 1219 at a pressurizer pressure of approximately 110 psig. An annotated record of pressurizer level is enclosed only to illustrate the high amplitudes and rates of pressurizer level variations. Insufficient information is contained in the enclosure to enable detailed evaluation of the RCS behavior.

The cold calibrated pressurizer level instrument indication rose to 64 percent and remained constant while hot calibrated channels rose to 100% level. Temperature correction data for the cold calibrated level instrument didn't extend to 360 F, which was the approximate pressurizer temperature when the pressurizer indicated full. Constant level on the cold calibrated channel indicated the pressurizer was solid, but continued charging flow at 88 gpm was not causing pressure to rise above 200 psig, as it should have had the RCS been solid. Letdown had been secured while filling the pressurizer. The indications of a steam void in the reactor vessel head were no longer evident after RCS pressure increased although the exact time when the void disappeared has not been established.

RAMP UP  
CHARGING TO  
AUX. SPRAY

RAMP DOWN  
CHARGING TO  
RCS LOOPS

START LPST  
1A INJECTION  
TO RCS  
FROM RWT

SECURE  
LPST 1A

DRAWING  
PER BUGLE

START 2ND  
CHARGING PUMP

STOP 2ND  
CHARGING PUMP
