UNITED STATES  
NUCLEAR REGULATORY COMMISSION  
OFFICE OF INSPECTION AND ENFORCEMENT  
WASHINGTON, D. C. 20555

IE Circular No. 80-15  
Date: June 20, 1980  
Page 1 of 4

LOSS OF REACTOR COOLANT PUMP COOLING AND NATURAL CIRCULATION COOLDOWN

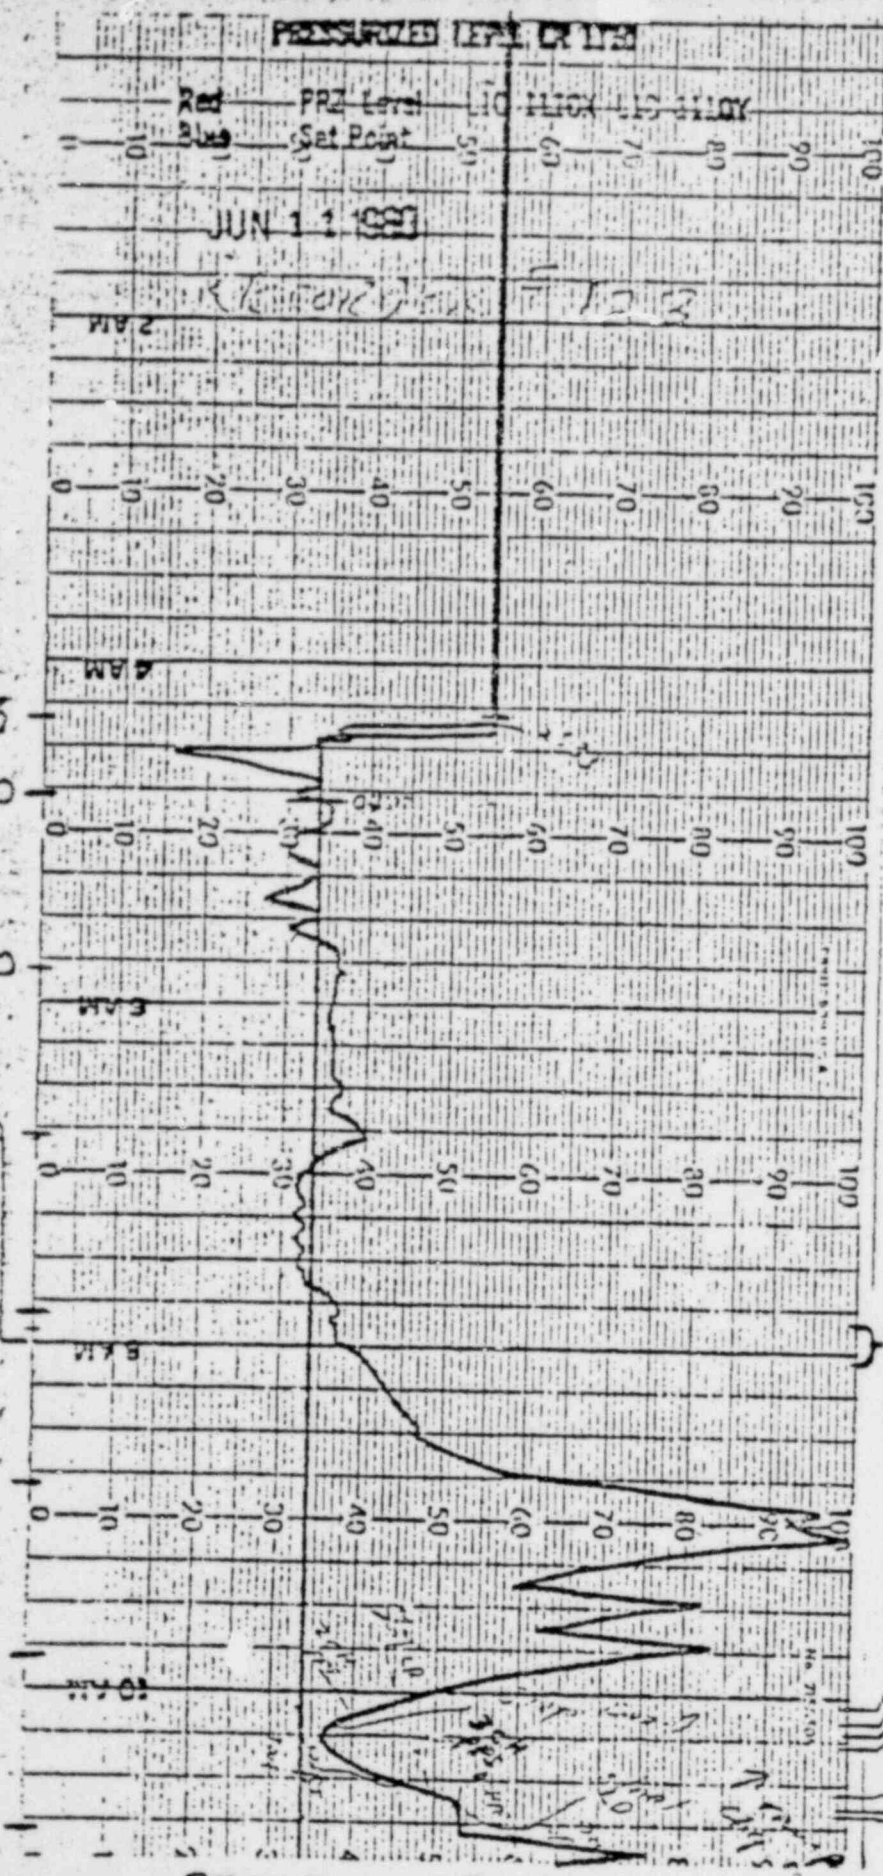
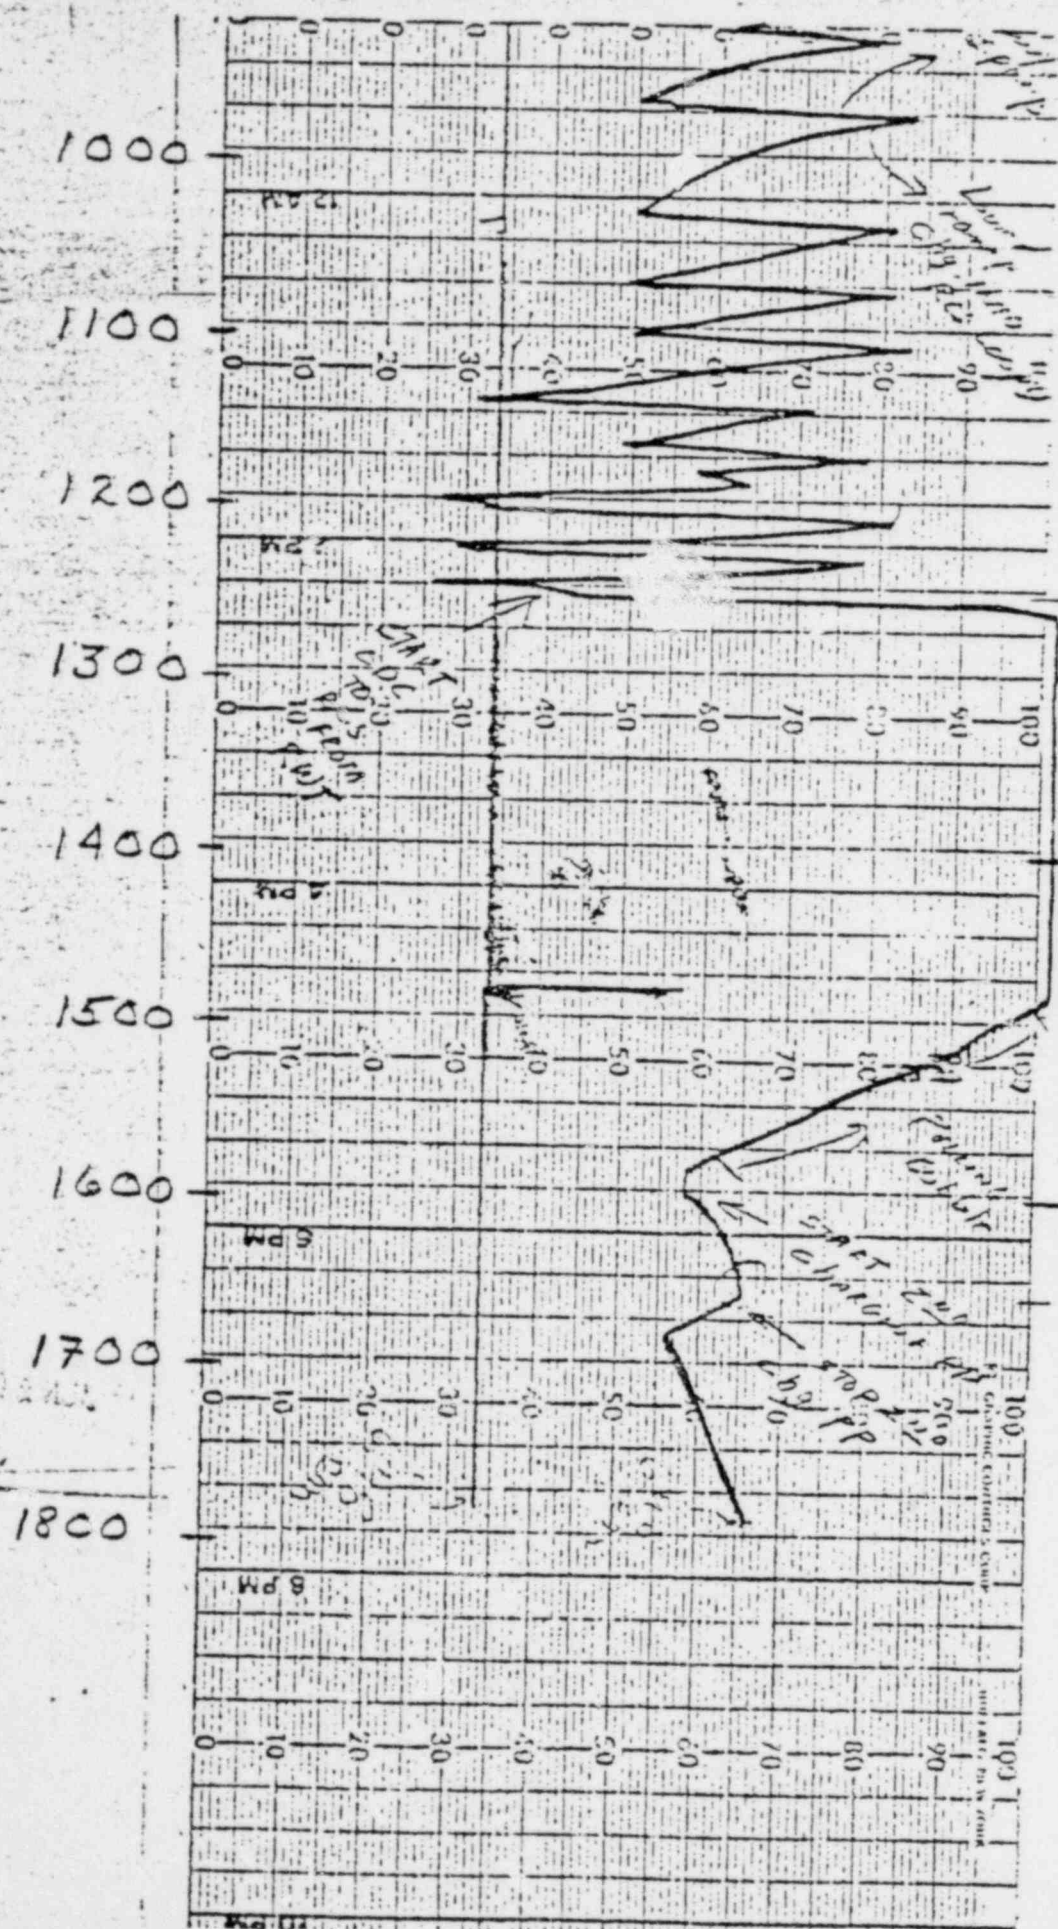
11 JUNE 1980  
ST. LUCIE  
HOT CALIBRATED  
PRESSURIZER LEVEL

The natural circulation cooldown continued uneventfully until after time 0600. The highest cooldown rate achieved was approximately 65 to 70 F per hour. Between 0600 and 0630 RCS pressure was reduced from 1140 to 690 psi by charging water through the pressurizer auxiliary spray line. Pressurizer level increased rapidly around 0700 while charging via the auxiliary spray line. Pressurizer level continued variations for approximately five hours while the cooldown and depressurization continued. When charging was shifted to the RCS loops, pressurizer level decreased at rates lower than the rates of increase in level when charging through the auxiliary spray line. During a two minute interval while charging into the pressurizer auxiliary spray line at 88 gpm, pressurizer level rose at a rate approximately ten times greater than the charging flowrate.

The cause of pressurizer level variations appears to be formation of a steam void in the reactor head area due to a temperature lag with respect to bulk coolant temperature that developed because of insufficient cooling flow in that area during natural circulation cooldown. Gas concentration in a 0730 RCS sample was determined by the licensee to be 32 cc/kg hydrogen and 16 cc/kg nitrogen. These concentrations were not high enough to cause a significant volume of gas to come out of solution. The indicated subcooling margin ( $T_{sat} - T_{hot}$ ) ranged between 220 and 150 F when the reactor head steam void developed between 0600 and 0700. The minimum required subcooling of 50 F was not approached during the cooldown until around time 1219 at a pressurizer pressure of approximately 110 psig. An annotated record of pressurizer level is enclosed only to illustrate the high amplitudes and rates of pressurizer level variations. Insufficient information is contained in the enclosure to enable detailed evaluation of the RCS behavior.

The cold calibrated pressurizer level instrument indication rose to 64 percent and remained constant while hot calibrated channels rose to 100% level. Temperature correction data for the cold calibrated level instrument didn't extend to 360 F, which was the approximate pressurizer temperature when the pressurizer indicated full. Constant level on the cold calibrated channel indicated the pressurizer was solid, but continued charging flow at 88 gpm was not causing pressure to rise above 200 psig, as it should have had the RCS been solid. Letdown had been secured while filling the pressurizer. The indications of a steam void in the reactor vessel head were no longer evident after RCS pressure increased although the exact time when the void disappeared has not been established.

miniflow was isolated. Continued charging with two pumps at 88 gpm total flowrate caused a slight rise in both pressurizer pressure (to 260 psig) and cold calibrated pressurizer level. Letdown in excess of charging flowrate was established at 1430, and by 1500 a steam bubble was drawn in the pressurizer with level in the indicating range.
