UNITED STATES
NUCLEAR REGULATORY COMMISSION
OFFICE OF INSPECTION AND ENFORCEMENT
WASHINGTON, D. C. 20555

IE Circular No. 80-15
Date: June 20, 1980
Page 1 of 4

LOSS OF REACTOR COOLANT PUMP COOLING AND NATURAL CIRCULATION COOLDOWN

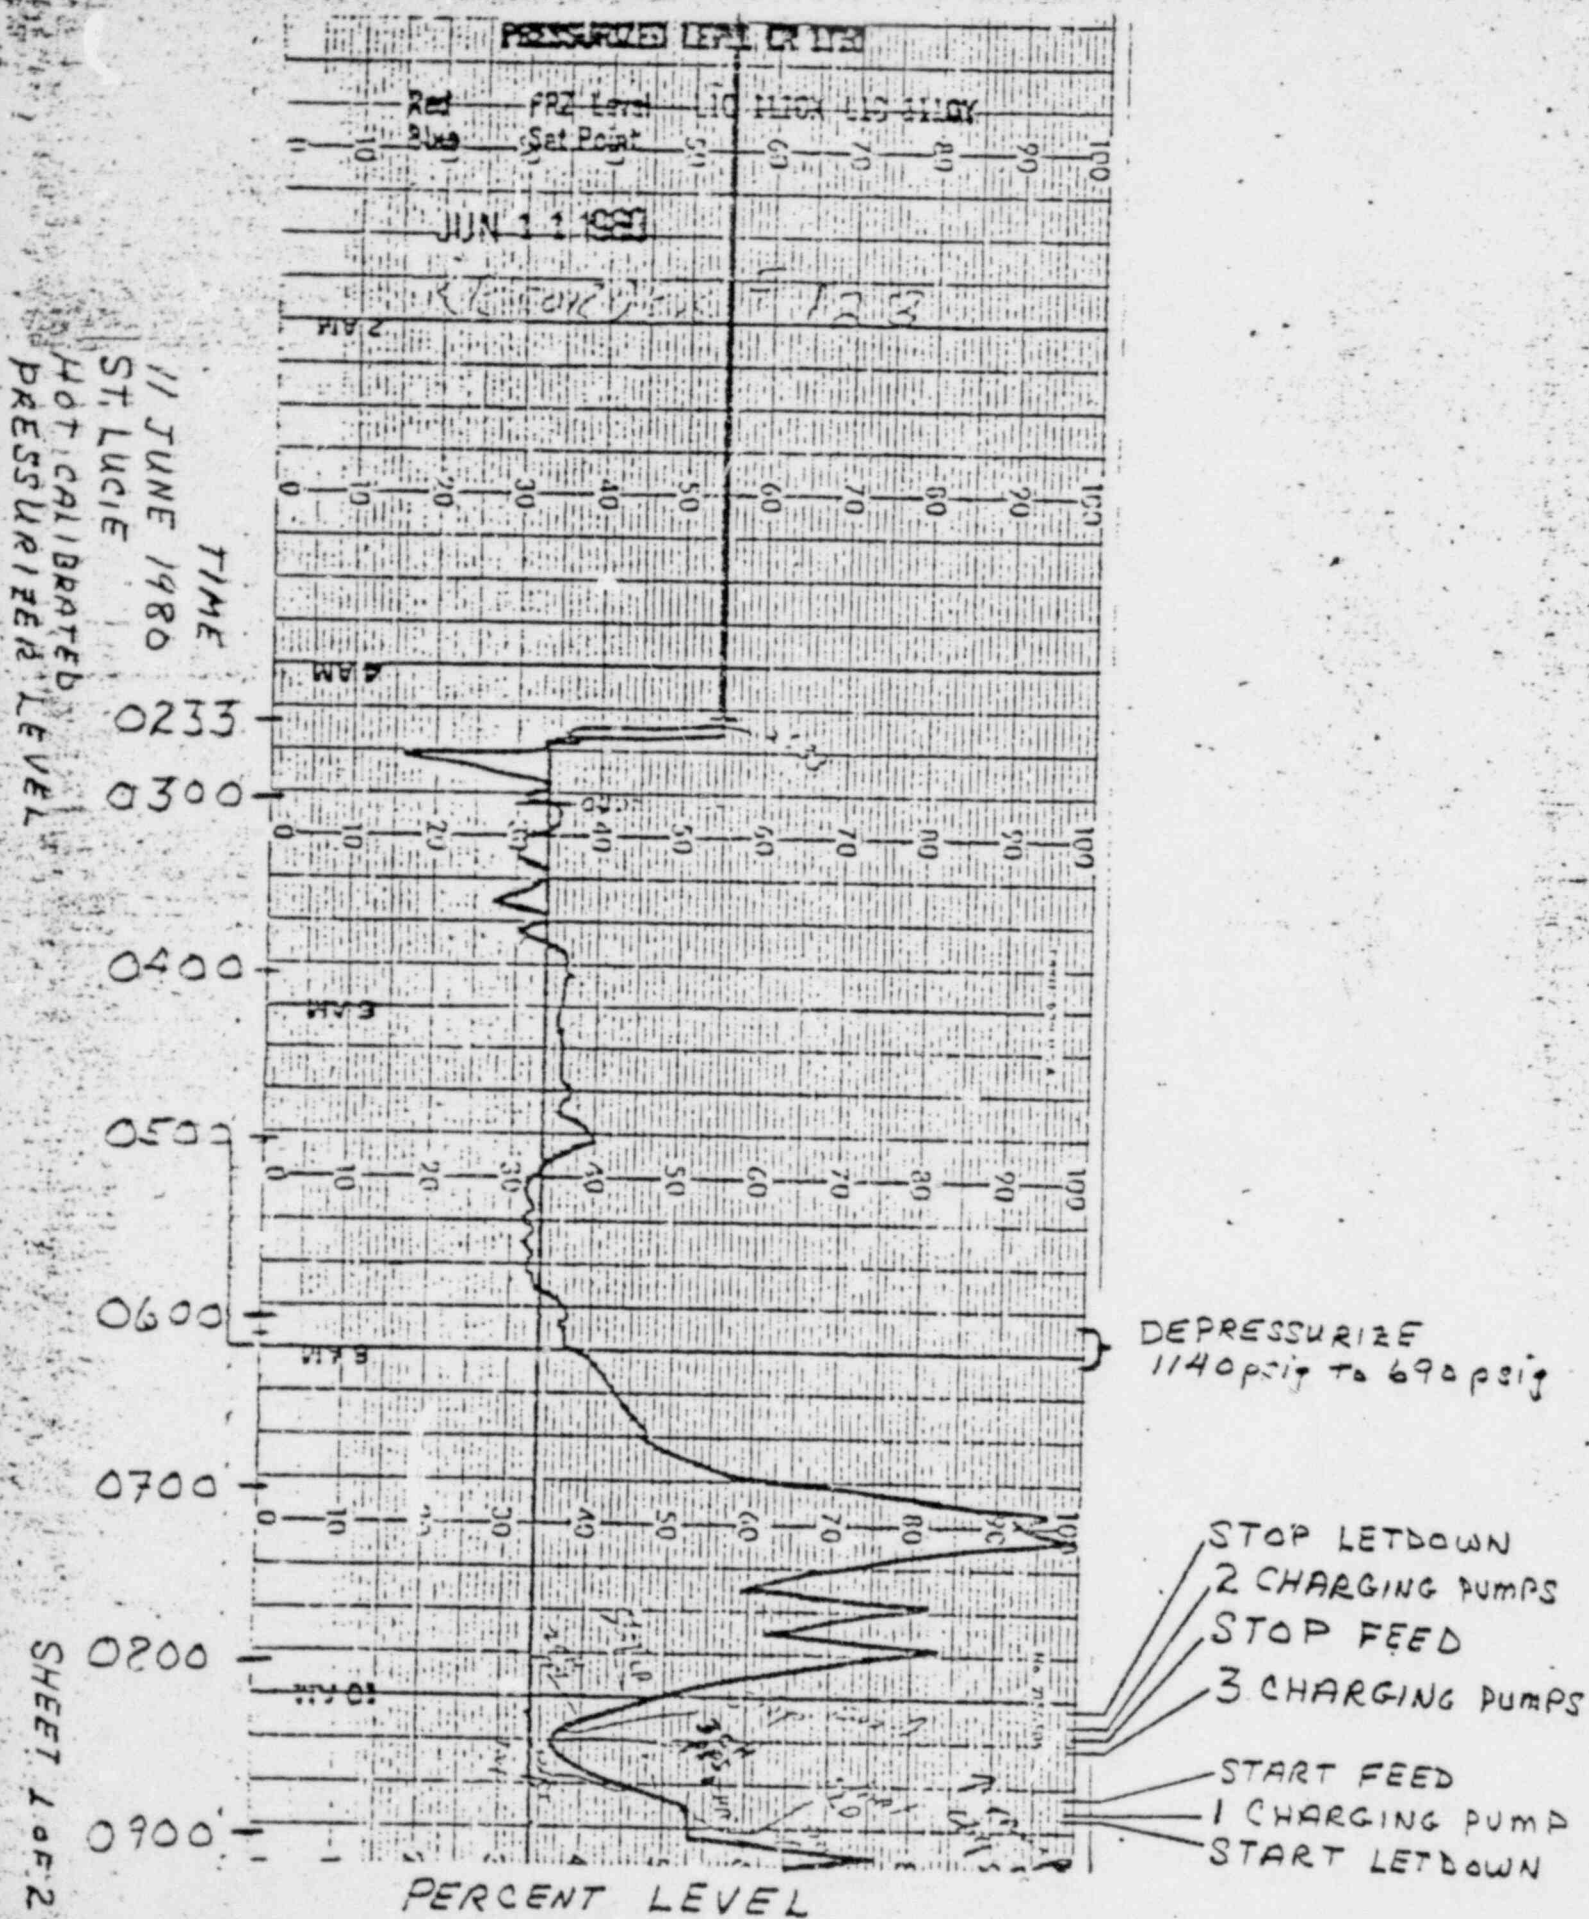
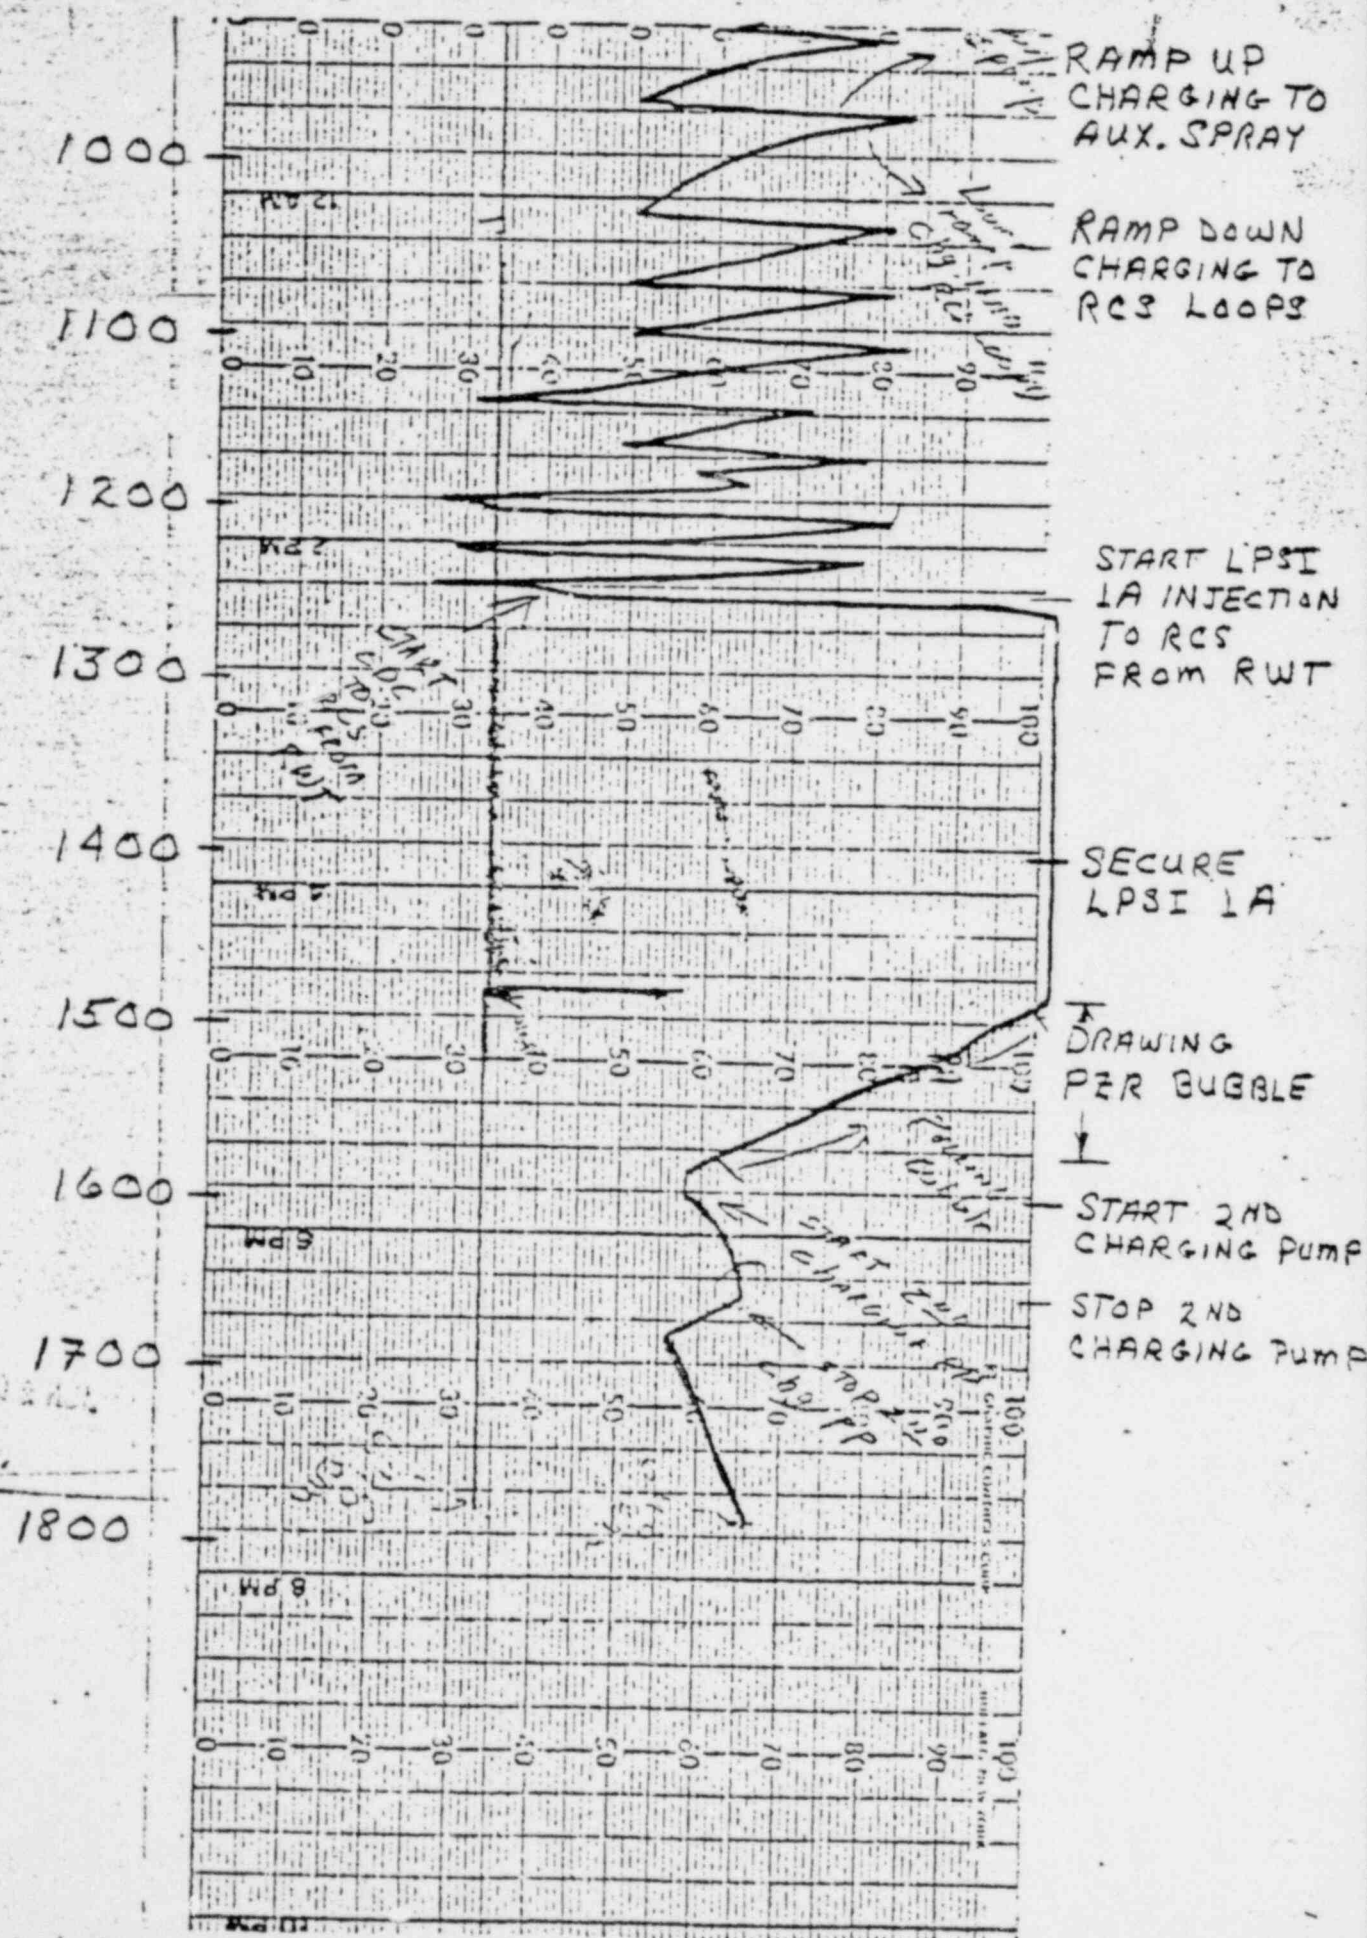
Enclosure:
Annotated record of
pressurizer level

The natural circulation cooldown continued uneventfully until after time 0600. The highest cooldown rate achieved was approximately 65 to 70 F per hour. Between 0600 and 0630 RCS pressure was reduced from 1140 to 690 psi by charging water through the pressurizer auxiliary spray line. Pressurizer level increased rapidly around 0700 while charging via the auxiliary spray line. Pressurizer level continued variations for approximately five hours while the cooldown and depressurization continued. When charging was shifted to the RCS loops, pressurizer level decreased at rates lower than the rates of increase in level when charging through the auxiliary spray line. During a two minute interval while charging into the pressurizer auxiliary spray line at 88 gpm, pressurizer level rose at a rate approximately ten times greater than the charging flowrate.

The cause of pressurizer level variations appears to be formation of a steam void in the reactor head area due to a temperature lag with respect to bulk coolant temperature that developed because of insufficient cooling flow in that area during natural circulation cooldown. Gas concentration in a 0730 RCS sample was determined by the licensee to be 32 cc/kg hydrogen and 16 cc/kg nitrogen. These concentrations were not high enough to cause a significant volume of gas to come out of solution. The indicated subcooling margin ($T_{sat} - T_{hot}$) ranged between 220 and 150 F when the reactor head steam void developed between 0600 and 0700. The minimum required subcooling of 50 F was not approached during the cooldown until around time 1219 at a pressurizer pressure of approximately 110 psig. An annotated record of pressurizer level is enclosed only to illustrate the high amplitudes and rates of pressurizer level variations. Insufficient information is contained in the enclosure to enable detailed evaluation of the RCS behavior.

The cold calibrated pressurizer level instrument indication rose to 64 percent and remained constant while hot calibrated channels rose to 100% level. Temperature correction data for the cold calibrated level instrument didn't extend to 360 F, which was the approximate pressurizer temperature when the pressurizer indicated full. Constant level on the cold calibrated channel indicated the pressurizer was solid, but continued charging flow at 88 gpm was not causing pressure to rise above 200 psig, as it should have had the RCS been solid. Letdown had been secured while filling the pressurizer. The indications of a steam void in the reactor vessel head were no longer evident after RCS pressure increased although the exact time when the void disappeared has not been established.
