UNITED STATES  
NUCLEAR REGULATORY COMMISSION  
OFFICE OF INSPECTION AND ENFORCEMENT  
WASHINGTON, D. C. 20555

IE Circular No. 80-15  
Date: June 20, 1980  
Page 1 of 4

LOSS OF REACTOR COOLANT PUMP COOLING AND NATURAL CIRCULATION COOLDOWN

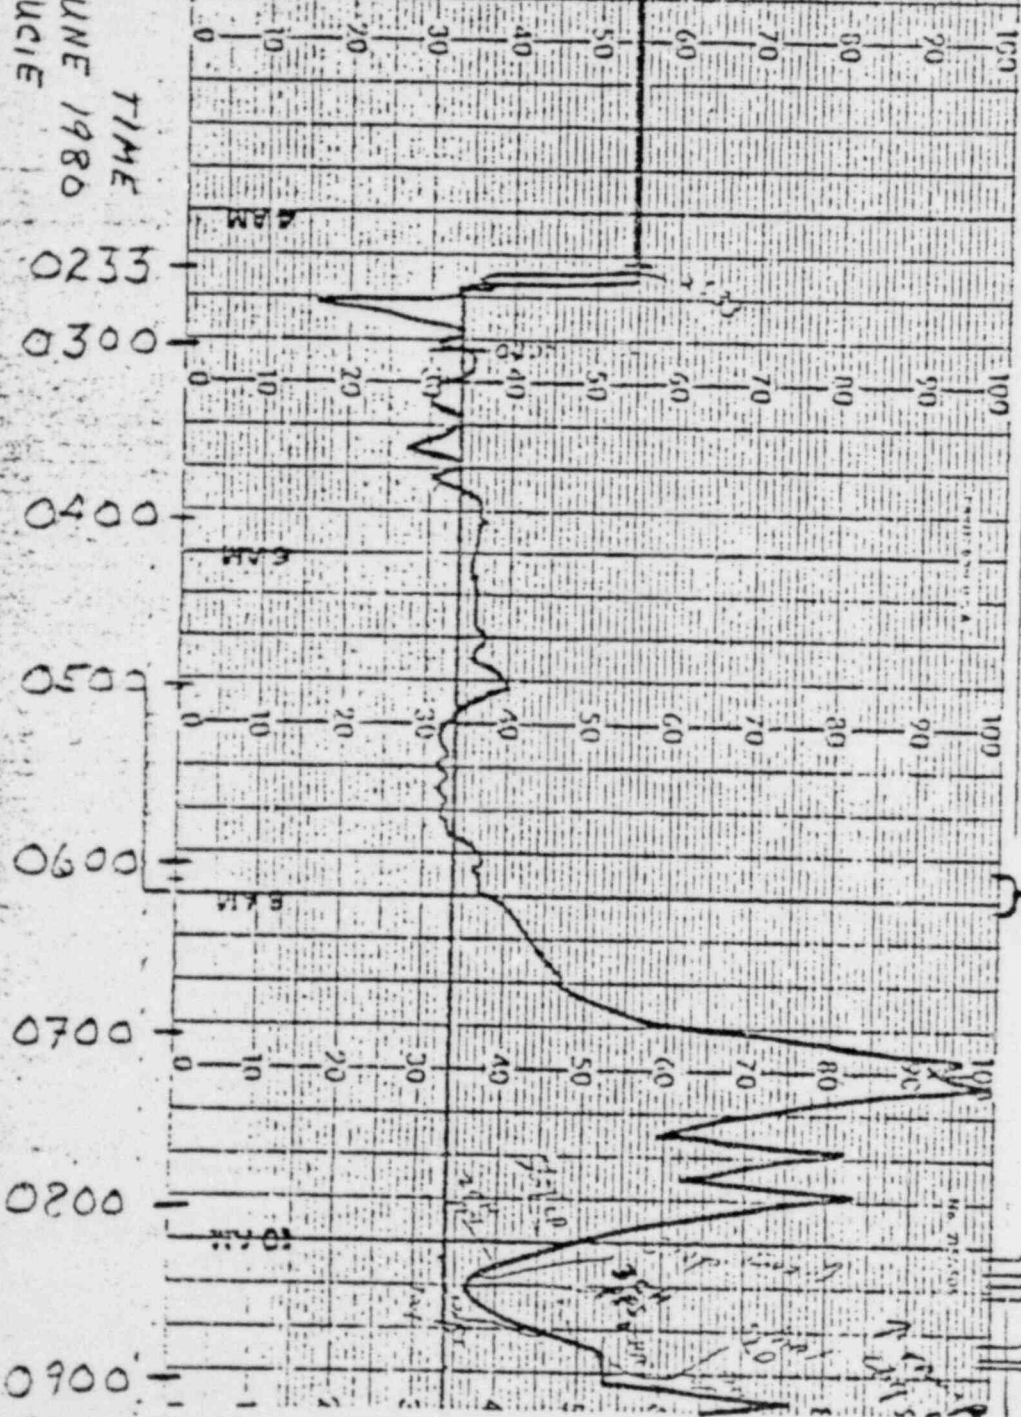
SHEET 1 OF 2

The cold calibrated pressurizer level instrument indication rose to 64 percent and remained constant while hot calibrated channels rose to 100% level. Temperature correction data for the cold calibrated level instrument didn't extend to 360 F, which was the approximate pressurizer temperature when the pressurizer indicated full. Constant level on the cold calibrated channel indicated the pressurizer was solid, but continued charging flow at 88 gpm was not causing pressure to rise above 200 psig, as it should have had the RCS been solid. Letdown had been secured while filling the pressurizer. The indications of a steam void in the reactor vessel head were no longer evident after RCS pressure increased although the exact time when the void disappeared has not been established.

11 JUNE 1980  
ST LUCIE  
HOT CALIBRATED  
PRESSURIZER LEVEL

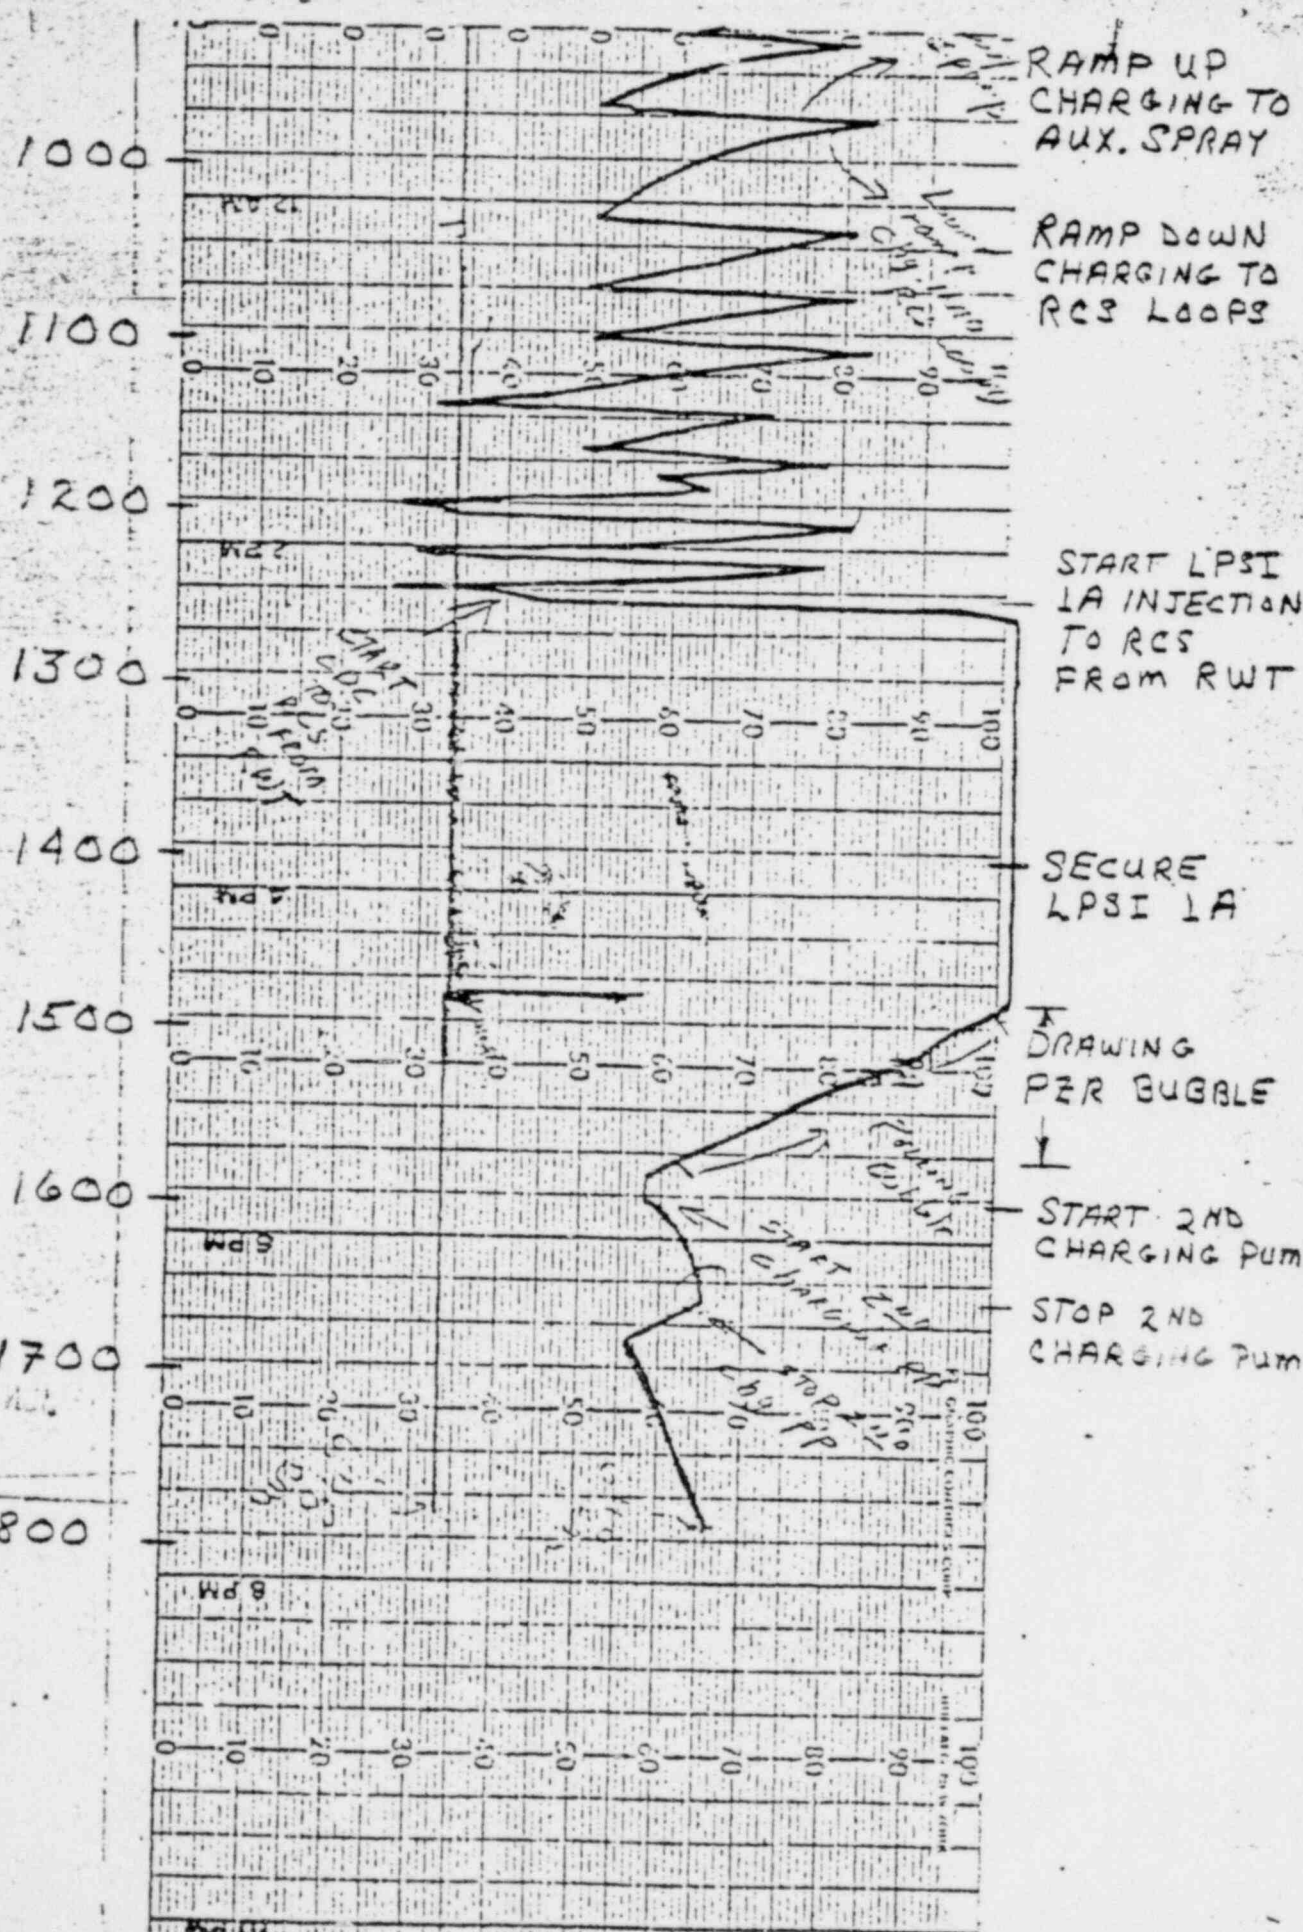
SHEET  
2 OF 2

The natural circulation cooldown continued uneventfully until after time 0600. The highest cooldown rate achieved was approximately 65 to 70 F per hour. Between 0600 and 0630 RCS pressure was reduced from 1140 to 690 psi by charging water through the pressurizer auxiliary spray line. Pressurizer level increased rapidly around 0700 while charging via the auxiliary spray line. Pressurizer level continued variations for approximately five hours while the cooldown and depressurization continued. When charging was shifted to the RCS loops, pressurizer level decreased at rates lower than the rates of increase in level when charging through the auxiliary spray line. During a two minute interval while charging into the pressurizer auxiliary spray line at 88 gpm, pressurizer level rose at a rate approximately ten times greater than the charging flowrate.

DEPRESSURIZE  
1140 psig to 690 psig

- STOP LETDOWN
- 2 CHARGING PUMPS
- STOP FEED
- 3 CHARGING PUMPS
- START FEED
- 1 CHARGING PUMP
- START LETDOWN
