UNITED STATES
NUCLEAR REGULATORY COMMISSION
REGION I
631 PARK AVENUE
KING OF PRUSSIA, PENNSYLVANIA 19406

June 20, 1980

IE Circular No. 80-15
Date: June 20, 1980
Page 1 of 4

LOSS OF REACTOR COOLANT PUMP COOLING AND NATURAL CIRCULATION COOLDOWN

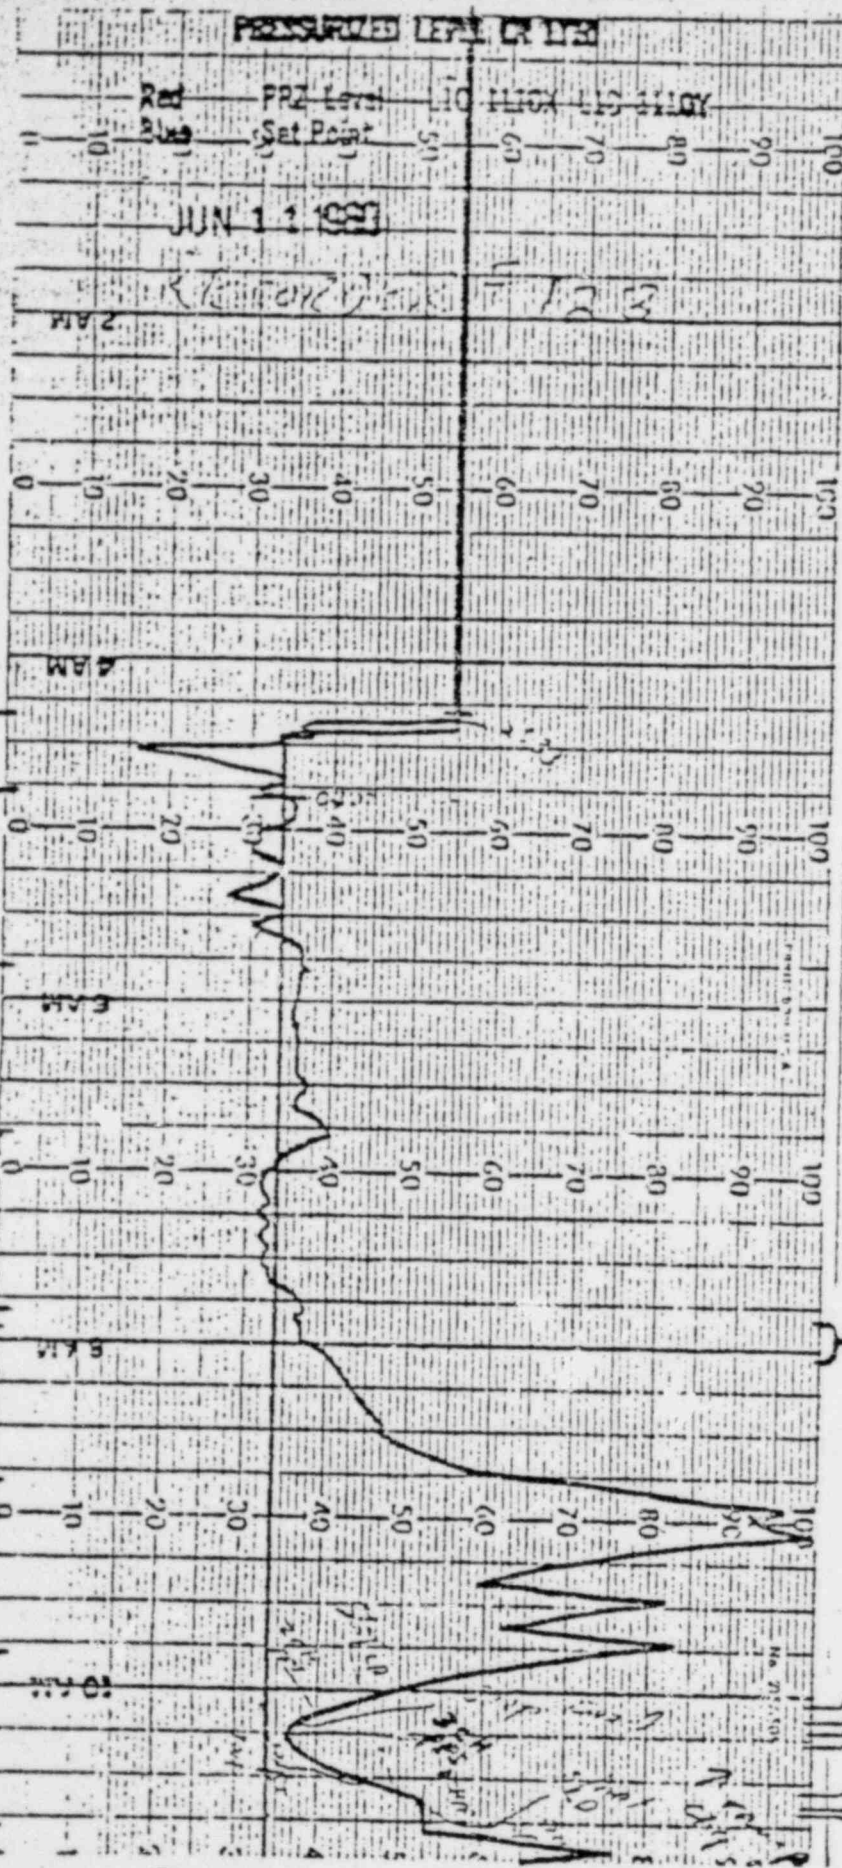
Enclosure:
Annotated record of
pressurizer level

The natural circulation cooldown continued uneventfully until after time 0600. The highest cooldown rate achieved was approximately 65 to 70 F per hour. Between 0600 and 0630 RCS pressure was reduced from 1140 to 690 psi by charging water through the pressurizer auxiliary spray line. Pressurizer level increased rapidly around 0700 while charging via the auxiliary spray line. Pressurizer level continued variations for approximately five hours while the cooldown and depressurization continued. When charging was shifted to the RCS loops, pressurizer level decreased at rates lower than the rates of increase in level when charging through the auxiliary spray line. During a two minute interval while charging into the pressurizer auxiliary spray line at 88 gpm, pressurizer level rose at a rate approximately ten times greater than the charging flowrate.

The cause of pressurizer level variations appears to be formation of a steam void in the reactor head area due to a temperature lag with respect to bulk coolant temperature that developed because of insufficient cooling flow in that area during natural circulation cooldown. Gas concentration in a 0730 RCS sample was determined by the licensee to be 32 cc/kg hydrogen and 16 cc/kg nitrogen. These concentrations were not high enough to cause a significant volume of gas to come out of solution. The indicated subcooling margin ($T_{sat} - T_{hot}$) ranged between 220 and 150 F when the reactor head steam void developed between 0600 and 0700. The minimum required subcooling of 50 F was not approached during the cooldown until around time 1219 at a pressurizer pressure of approximately 110 psig. An annotated record of pressurizer level is enclosed only to illustrate the high amplitudes and rates of pressurizer level variations. Insufficient information is contained in the enclosure to enable detailed evaluation of the RCS behavior.

11 JUNE 1980
ST. LUCIE
HOT CALIBRATED
PRESSURIZED LEVEL

DEPRESSURIZE
1140 psig to 690 psig

- STOP LETDOWN
- 2 CHARGING PUMPS
- STOP FEED
- 3 CHARGING PUMPS
- START FEED
- 1 CHARGING PUMP
- START LETDOWN
