UNITED STATES  
NUCLEAR REGULATORY COMMISSION  
OFFICE OF INSPECTION AND ENFORCEMENT  
WASHINGTON, D. C. 20555

IE Circular No. 80-15  
Date: June 20, 1980  
Page 1 of 4

LOSS OF REACTOR COOLANT PUMP COOLING AND NATURAL CIRCULATION COOLDOWN

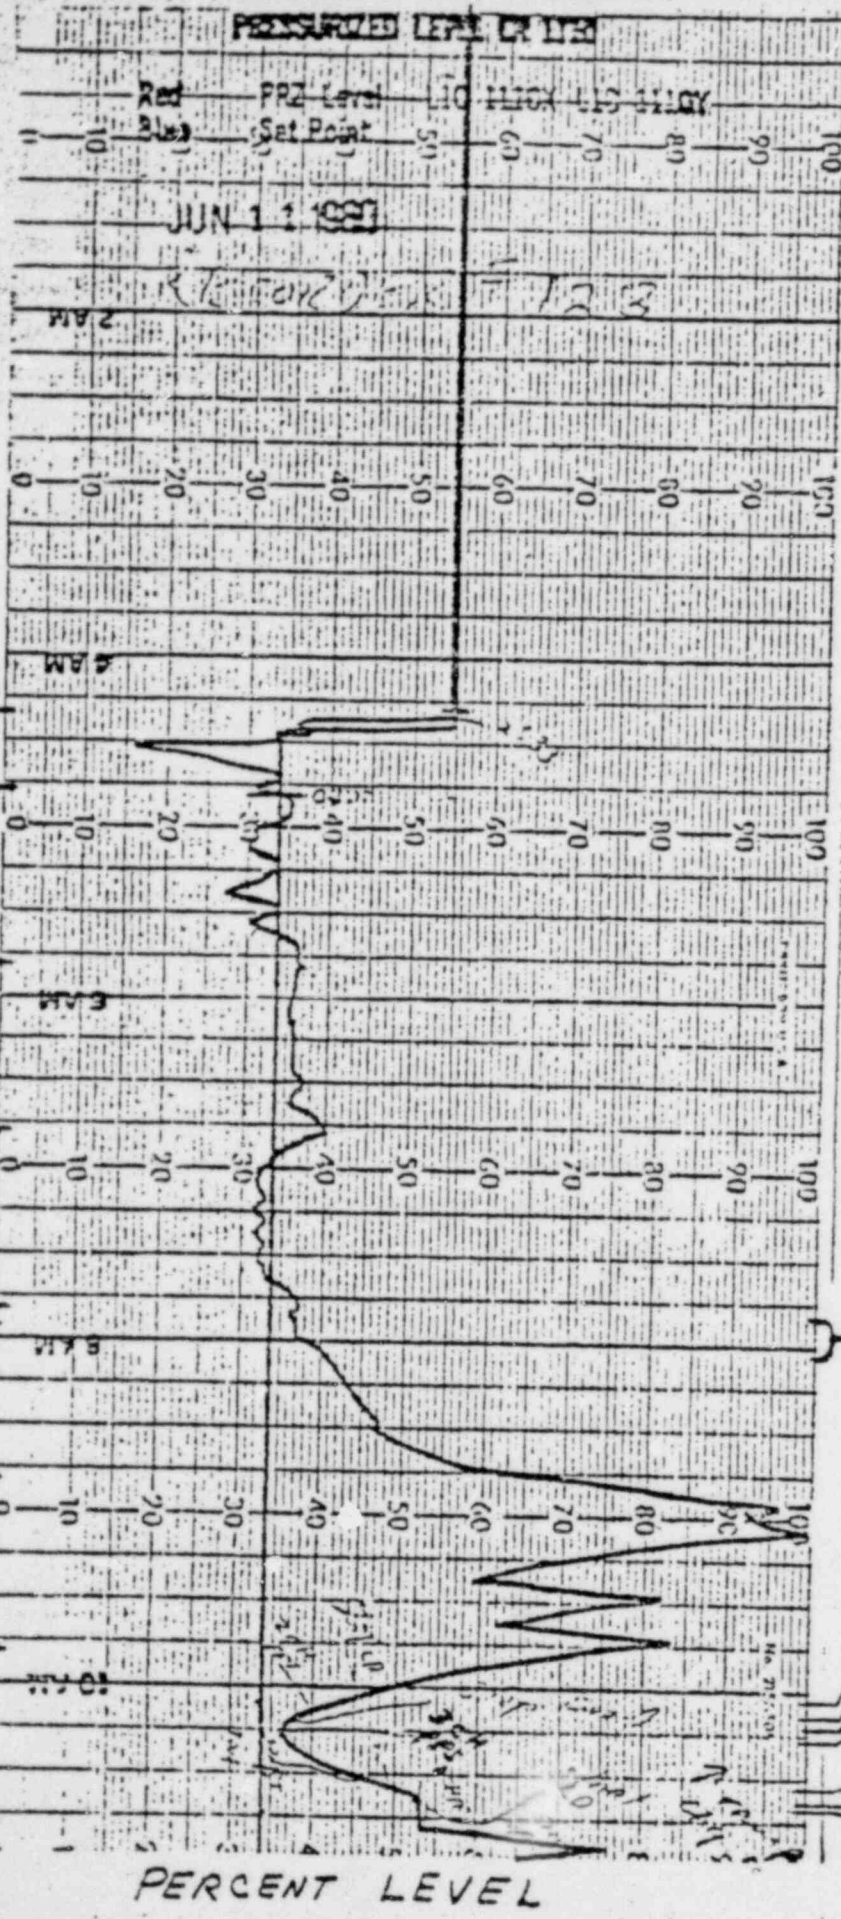
SHEET 1 of 2

The natural circulation cooldown continued uneventfully until after time 0600. The highest cooldown rate achieved was approximately 65 to 70 F per hour. Between 0600 and 0630 RCS pressure was reduced from 1140 to 690 psi by charging water through the pressurizer auxiliary spray line. Pressurizer level increased rapidly around 0700 while charging via the auxiliary spray line. Pressurizer level continued variations for approximately five hours while the cooldown and depressurization continued. When charging was shifted to the RCS loops, pressurizer level decreased at rates lower than the rates of increase in level when charging through the auxiliary spray line. During a two minute interval while charging into the pressurizer auxiliary spray line at 88 gpm, pressurizer level rose at a rate approximately ten times greater than the charging flowrate.

The cause of pressurizer level variations appears to be formation of a steam void in the reactor head area due to a temperature lag with respect to bulk coolant temperature that developed because of insufficient cooling flow in that area during natural circulation cooldown. Gas concentration in a 0730 RCS sample was determined by the licensee to be 32 cc/kg hydrogen and 16 cc/kg nitrogen. These concentrations were not high enough to cause a significant volume of gas to come out of solution. The indicated subcooling margin ( $T_{sat} - T_{hot}$ ) ranged between 220 and 150 F when the reactor head steam void developed between 0600 and 0700. The minimum required subcooling of 50 F was not approached during the cooldown until around time 1219 at a pressurizer pressure of approximately 110 psig. An annotated record of pressurizer level is enclosed only to illustrate the high amplitudes and rates of pressurizer level variations. Insufficient information is contained in the enclosure to enable detailed evaluation of the RCS behavior.

11 JUNE 1980  
ST. LUCIE  
HOT CALIBRATED  
PRESSURIZER LEVEL

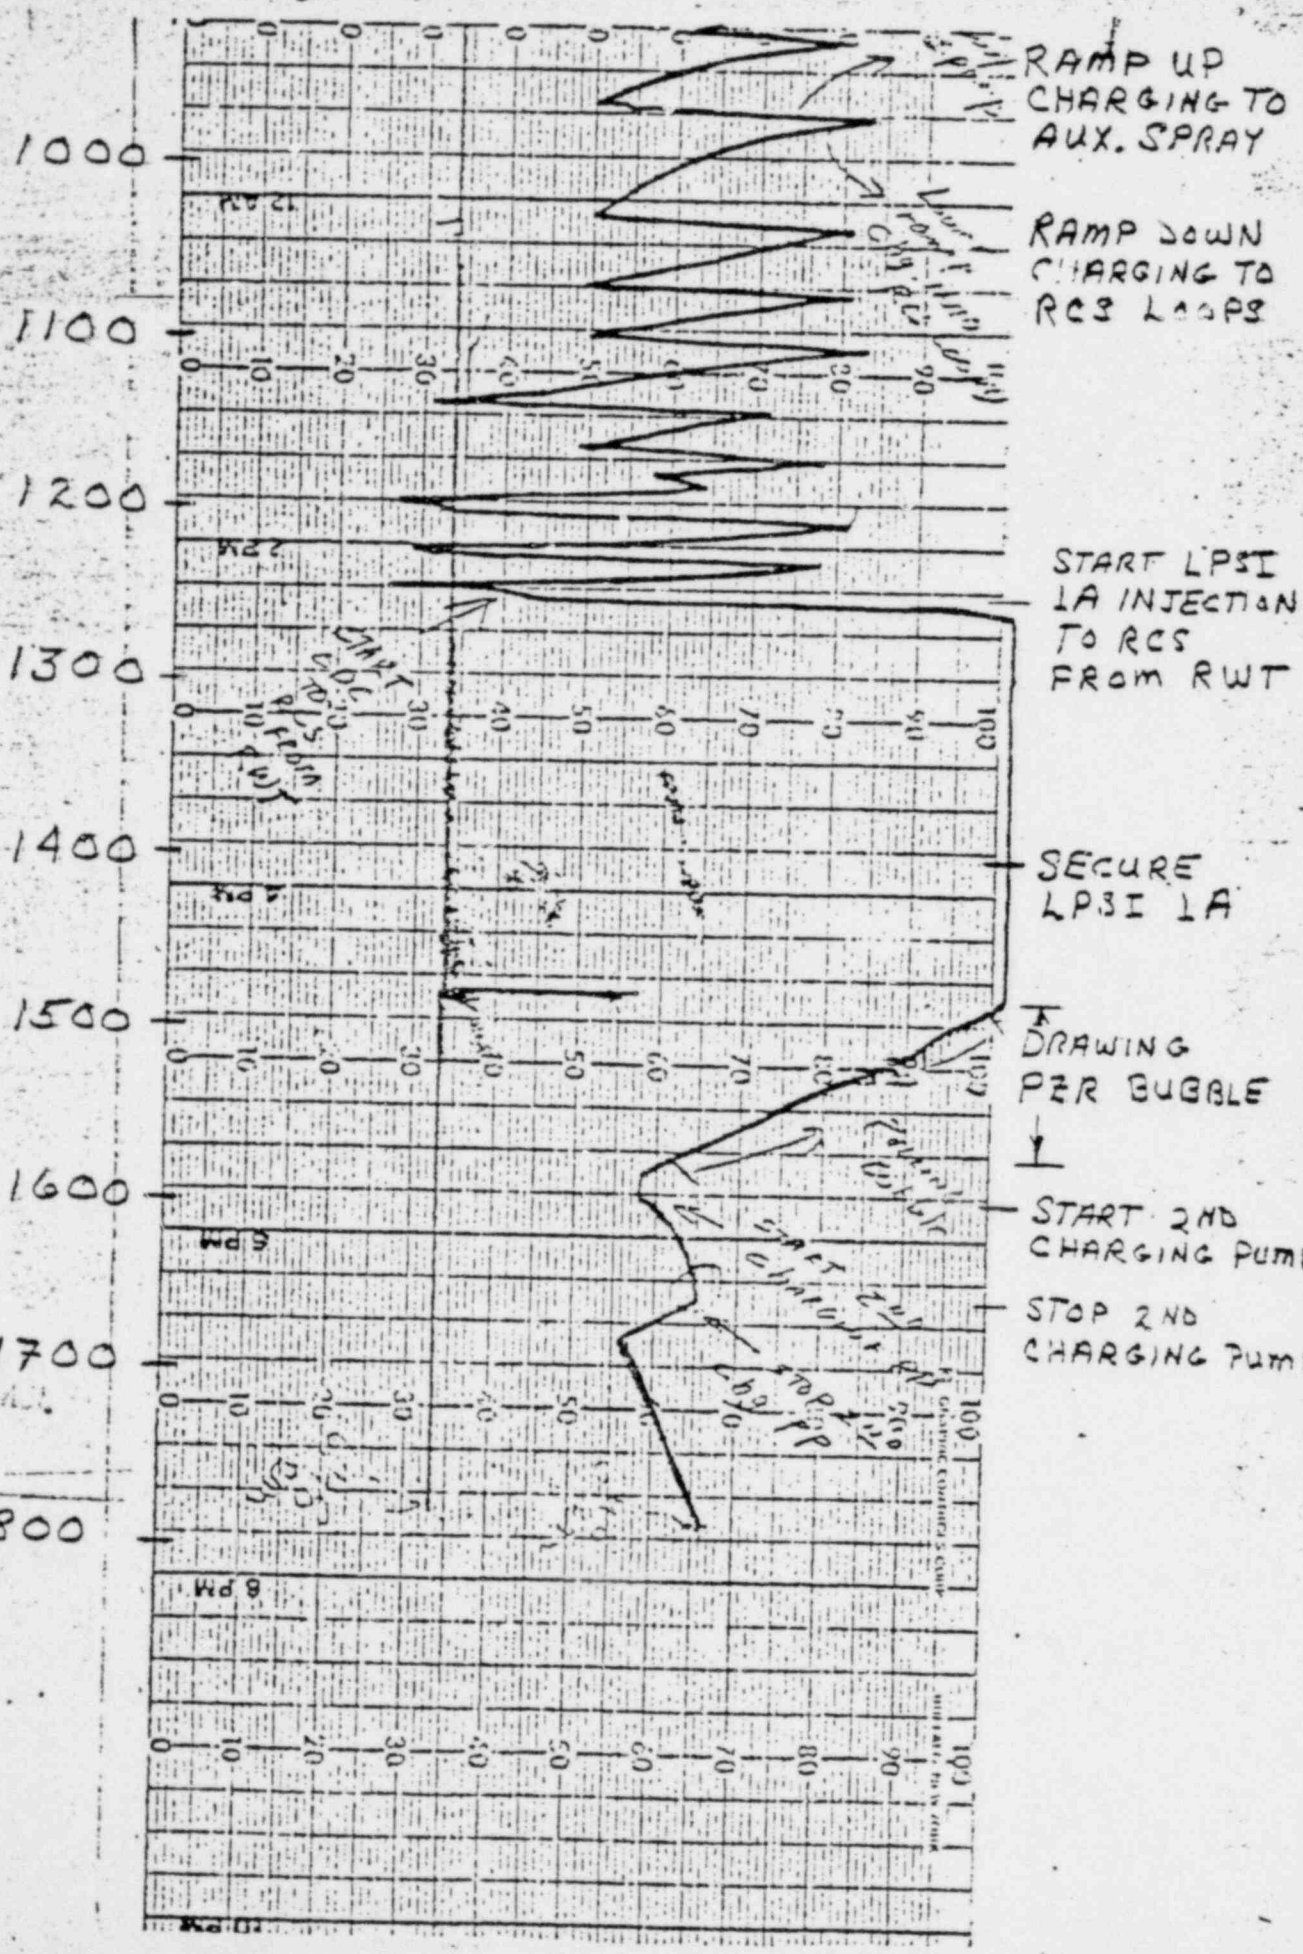
SHEET  
 2 OF 2

DEPRESSURIZE  
1140 psig to 690 psig

- STOP LETDOWN
- 2 CHARGING PUMPS
- STOP FEED
- 3 CHARGING PUMPS
- START FEED
- 1 CHARGING PUMP
- START LETDOWN
