UNITED STATES
NUCLEAR REGULATORY COMMISSION
OFFICE OF INSPECTION AND ENFORCEMENT
WASHINGTON, D. C. 20555

IE Circular No. 80-15
Date: June 20, 1980
Page 1 of 4

LOSS OF REACTOR COOLANT PUMP COOLING AND NATURAL CIRCULATION COOLDOWN

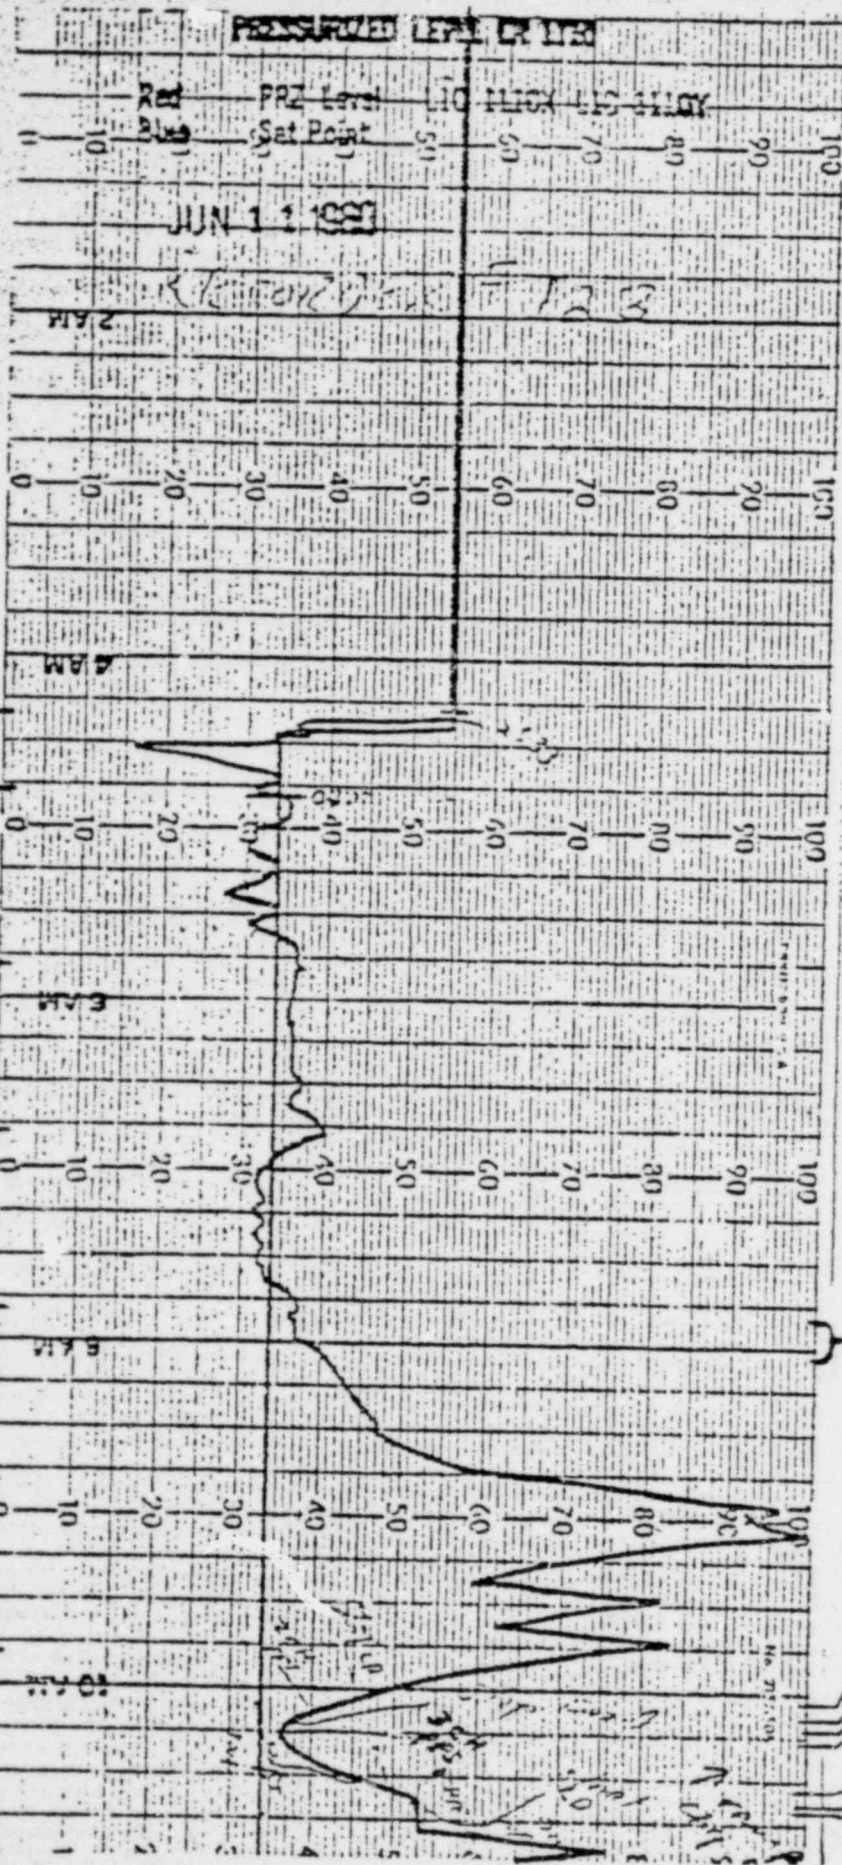
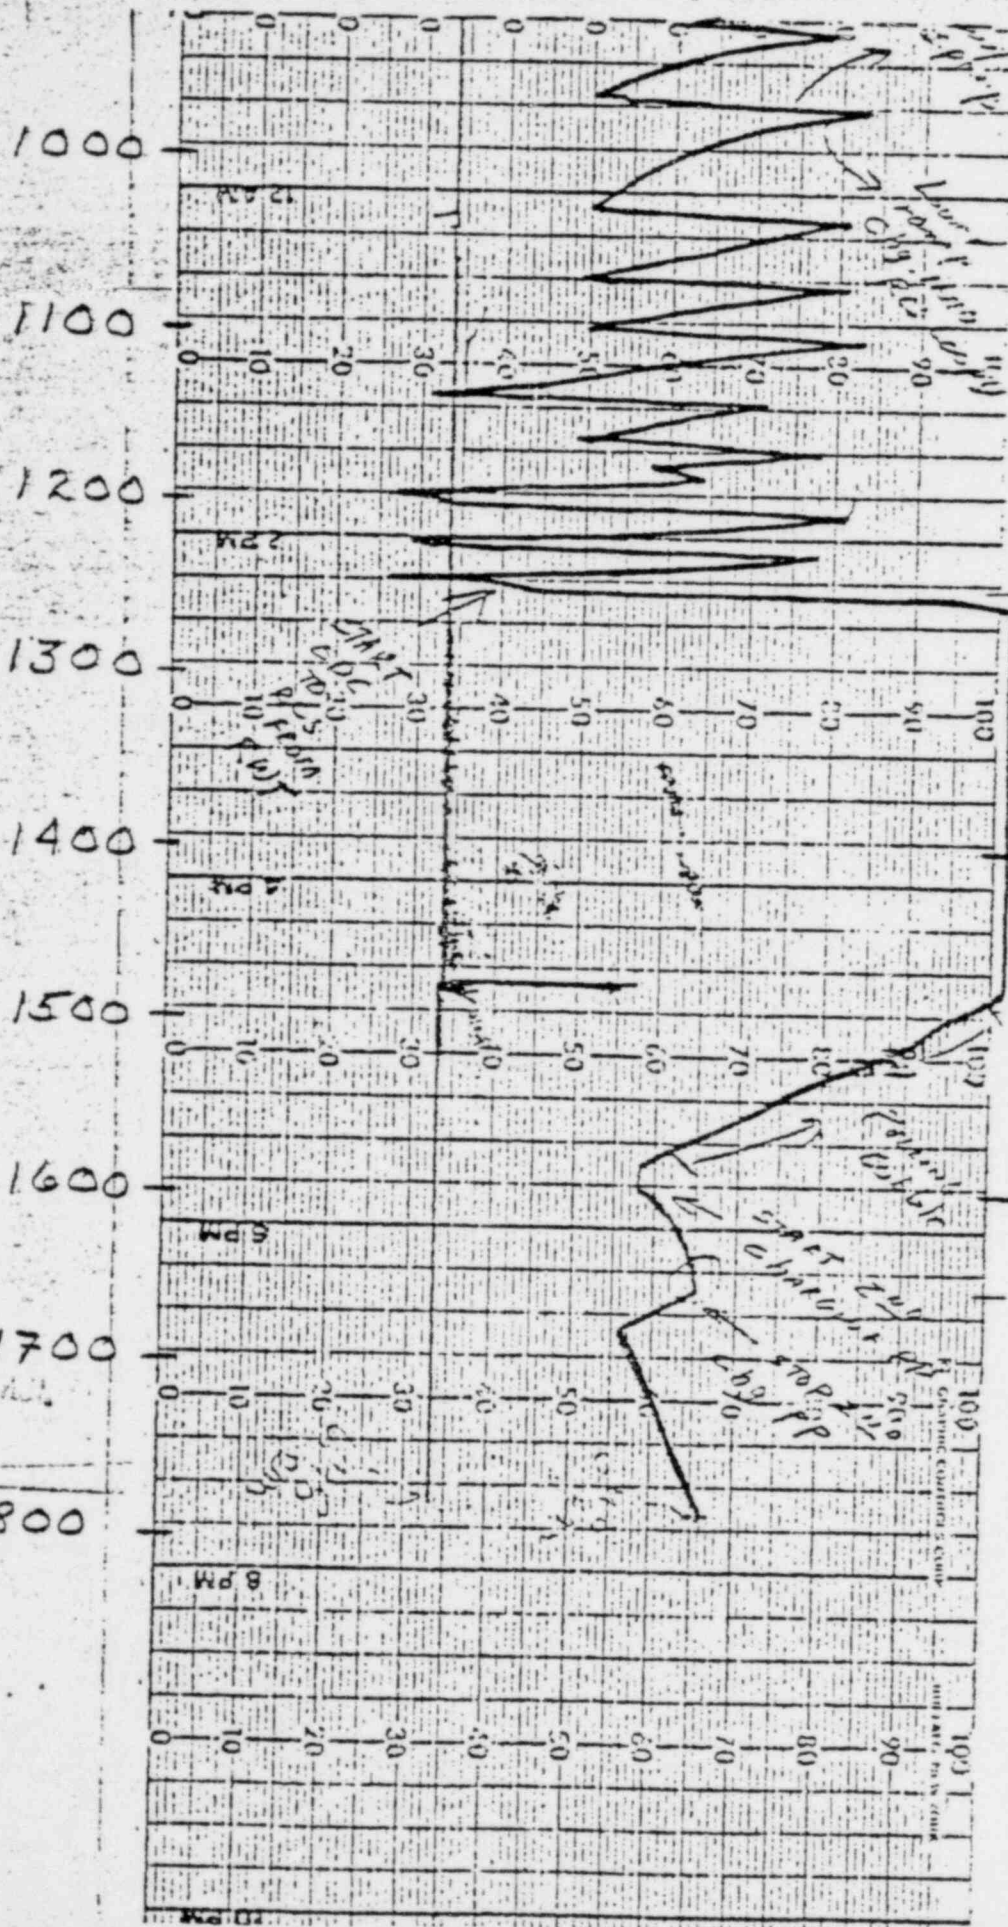
11 JUNE 1980
ST. LUCIE
HOT CALIBRATED
PRESSURIZER LEVEL

The natural circulation cooldown continued uneventfully until after time 0600. The highest cooldown rate achieved was approximately 65 to 70 F per hour. Between 0600 and 0630 RCS pressure was reduced from 1140 to 690 psi by charging water through the pressurizer auxiliary spray line. Pressurizer level increased rapidly around 0700 while charging via the auxiliary spray line. Pressurizer level continued variations for approximately five hours while the cooldown and depressurization continued. When charging was shifted to the RCS loops, pressurizer level decreased at rates lower than the rates of increase in level when charging through the auxiliary spray line. During a two minute interval while charging into the pressurizer auxiliary spray line at 88 gpm, pressurizer level rose at a rate approximately ten times greater than the charging flowrate.

The cause of pressurizer level variations appears to be formation of a steam void in the reactor head area due to a temperature lag with respect to bulk coolant temperature that developed because of insufficient cooling flow in that area during natural circulation cooldown. Gas concentration in a 0730 RCS sample was determined by the licensee to be 32 cc/kg hydrogen and 16 cc/kg nitrogen. These concentrations were not high enough to cause a significant volume of gas to come out of solution. The indicated subcooling margin ($T_{sat} - T_{hot}$) ranged between 220 and 150 F when the reactor head steam void developed between 0600 and 0700. The minimum required subcooling of 50 F was not approached during the cooldown until around time 1219 at a pressurizer pressure of approximately 110 psig. An annotated record of pressurizer level is enclosed only to illustrate the high amplitudes and rates of pressurizer level variations. Insufficient information is contained in the enclosure to enable detailed evaluation of the RCS behavior.

The cold calibrated pressurizer level instrument indication rose to 64 percent and remained constant while hot calibrated channels rose to 100% level. Temperature correction data for the cold calibrated level instrument didn't extend to 360 F, which was the approximate pressurizer temperature when the pressurizer indicated full. Constant level on the cold calibrated channel indicated the pressurizer was solid, but continued charging flow at 88 gpm was not causing pressure to rise above 200 psig, as it should have had the RCS been solid. Letdown had been secured while filling the pressurizer. The indications of a steam void in the reactor vessel head were no longer evident after RCS pressure increased although the exact time when the void disappeared has not been established.

miniflow was isolated. Continued charging with two pumps at 88 gpm total flowrate caused a slight rise in both pressurizer pressure (to 260 psig) and cold calibrated pressurizer level. Letdown in excess of charging flowrate was established at 1430, and by 1500 a steam bubble was drawn in the pressurizer with level in the indicating range.
