UNITED STATES  
NUCLEAR REGULATORY COMMISSION  
REGION I  
631 PARK AVENUE  
KING OF PRUSSIA, PENNSYLVANIA 19406

IE Circular No. 80-15  
Date: June 20, 1980  
Page 1 of 4

LOSS OF REACTOR COOLANT PUMP COOLING AND NATURAL CIRCULATION COOLDOWN

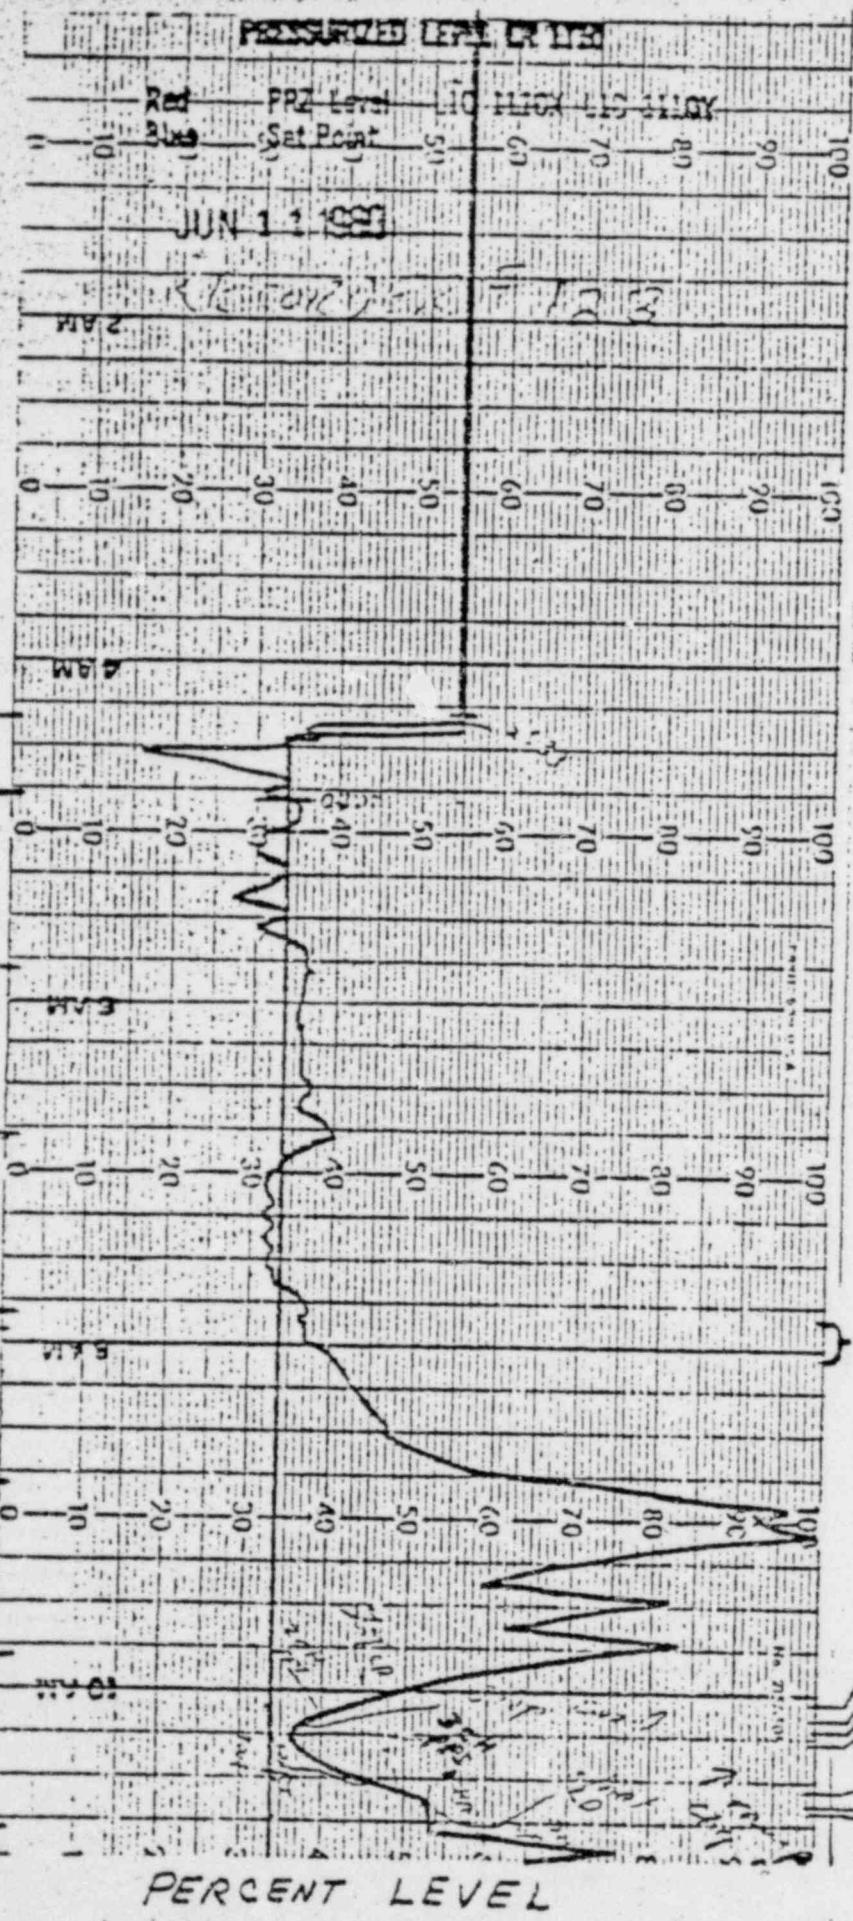
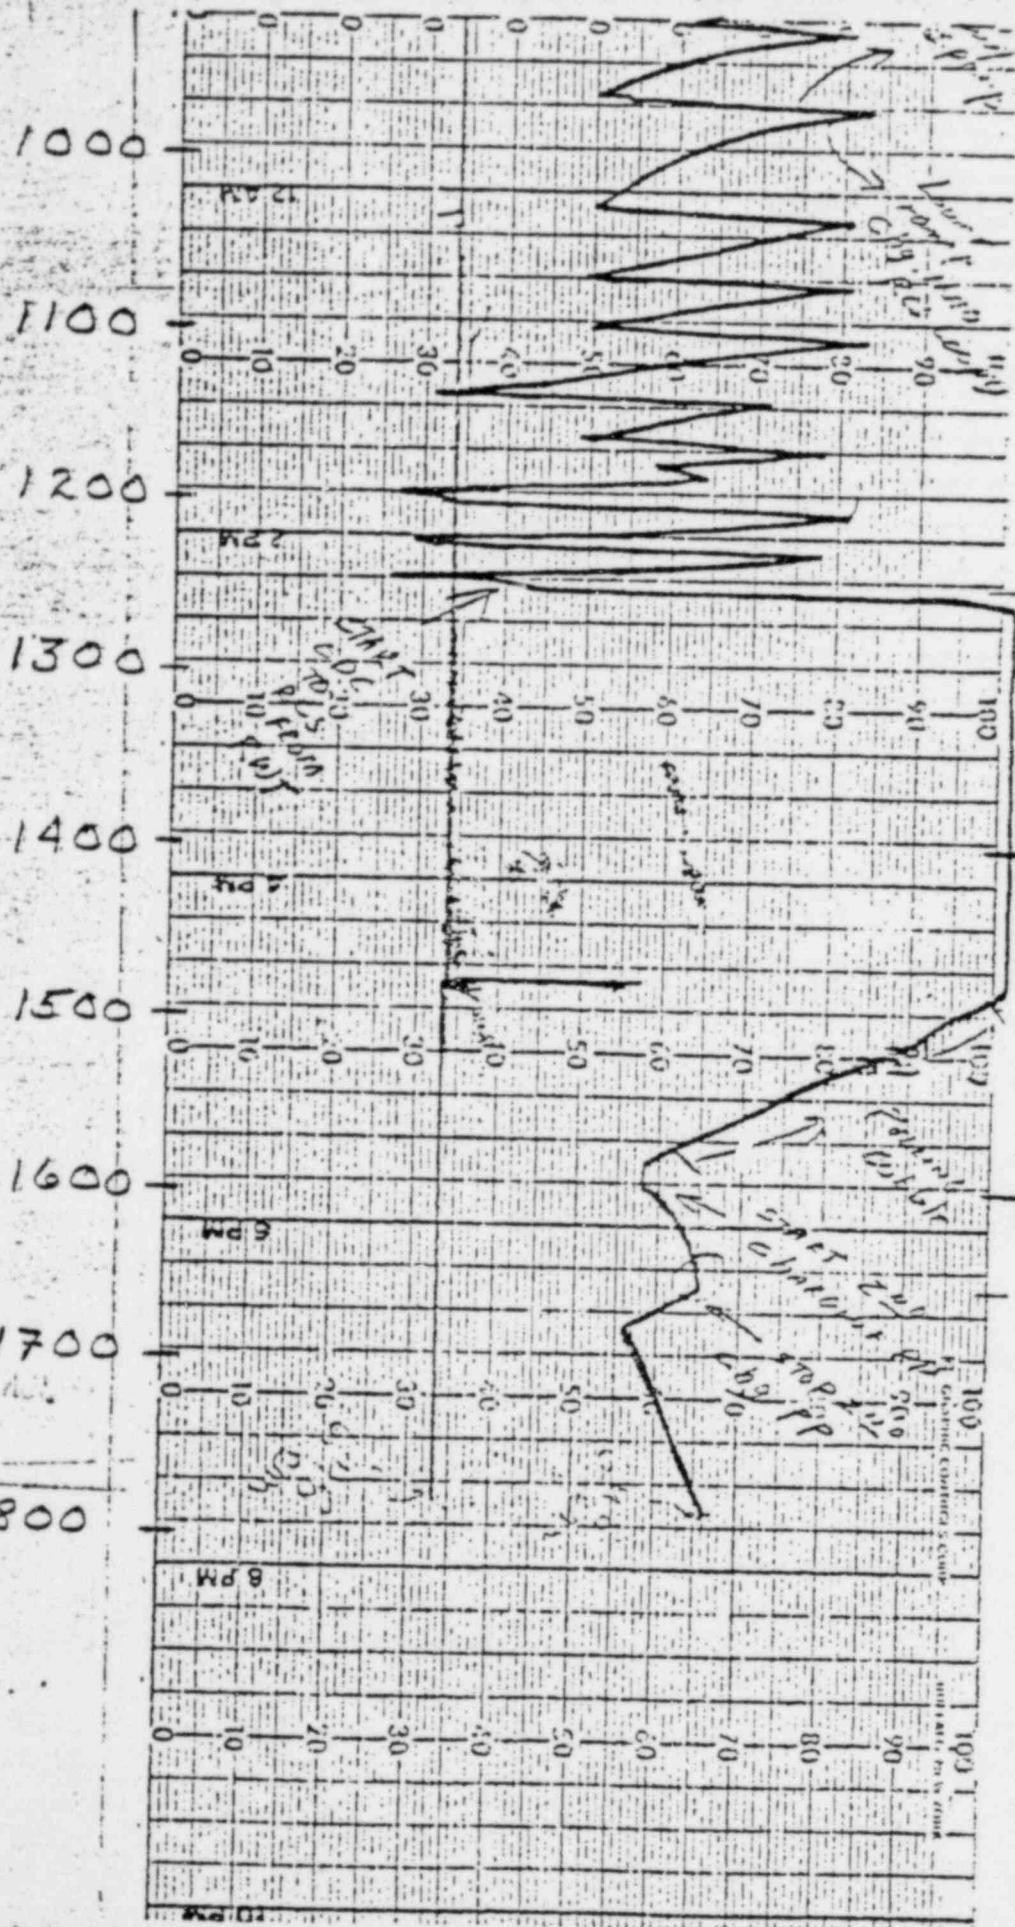
Annotated record of  
pressurizer level

The natural circulation cooldown continued uneventfully until after time 0600. The highest cooldown rate achieved was approximately 65 to 70 F per hour. Between 0600 and 0630 RCS pressure was reduced from 1140 to 690 psi by charging water through the pressurizer auxiliary spray line. Pressurizer level increased rapidly around 0700 while charging via the auxiliary spray line. Pressurizer level continued variations for approximately five hours while the cooldown and depressurization continued. When charging was shifted to the RCS loops, pressurizer level decreased at rates lower than the rates of increase in level when charging through the auxiliary spray line. During a two minute interval while charging into the pressurizer auxiliary spray line at 88 gpm, pressurizer level rose at a rate approximately ten times greater than the charging flowrate.

The cause of pressurizer level variations appears to be formation of a steam void in the reactor head area due to a temperature lag with respect to bulk coolant temperature that developed because of insufficient cooling flow in that area during natural circulation cooldown. Gas concentration in a 0730 RCS sample was determined by the licensee to be 32 cc/kg hydrogen and 16 cc/kg nitrogen. These concentrations were not high enough to cause a significant volume of gas to come out of solution. The indicated subcooling margin ( $T_{sat} - T_{hot}$ ) ranged between 220 and 150 F when the reactor head steam void developed between 0600 and 0700. The minimum required subcooling of 50 F was not approached during the cooldown until around time 1219 at a pressurizer pressure of approximately 110 psig. An annotated record of pressurizer level is enclosed only to illustrate the high amplitudes and rates of pressurizer level variations. Insufficient information is contained in the enclosure to enable detailed evaluation of the RCS behavior.

The cold calibrated pressurizer level instrument indication rose to 64 percent and remained constant while hot calibrated channels rose to 100% level. Temperature correction data for the cold calibrated level instrument didn't extend to 360 F, which was the approximate pressurizer temperature when the pressurizer indicated full. Constant level on the cold calibrated channel indicated the pressurizer was solid, but continued charging flow at 88 gpm was not causing pressure to rise above 200 psig, as it should have had the RCS been solid. Letdown had been secured while filling the pressurizer. The indications of a steam void in the reactor vessel head were no longer evident after RCS pressure increased although the exact time when the void disappeared has not been established.

DEPRESSURIZE  
1140 psig to 690 psig

STOP LETDOWN  
2 CHARGING PUMPS  
STOP FEED  
3 CHARGING PUMPS

START FEED  
1 CHARGING PUMP  
START LETDOWN

RAMP UP  
CHARGING TO  
AUX. SPRAY

RAMP DOWN  
CHARGING TO  
RCS LOOPS

START LPST  
1A INJECTION  
TO RCS  
FROM RWT

SECURE  
LPST 1A

DRAWING  
PER BUBBLE

START 2ND  
CHARGING PUMP

STOP 2ND  
CHARGING PUMP
