UNITED STATES
NUCLEAR REGULATORY COMMISSION
OFFICE OF INSPECTION AND ENFORCEMENT
WASHINGTON, D. C. 20555

June 20, 1980

IE Circular No. 80-15

LOSS OF REACTOR COOLANT PUMP COOLING AND NATURAL CIRCULATION COOLDOWN

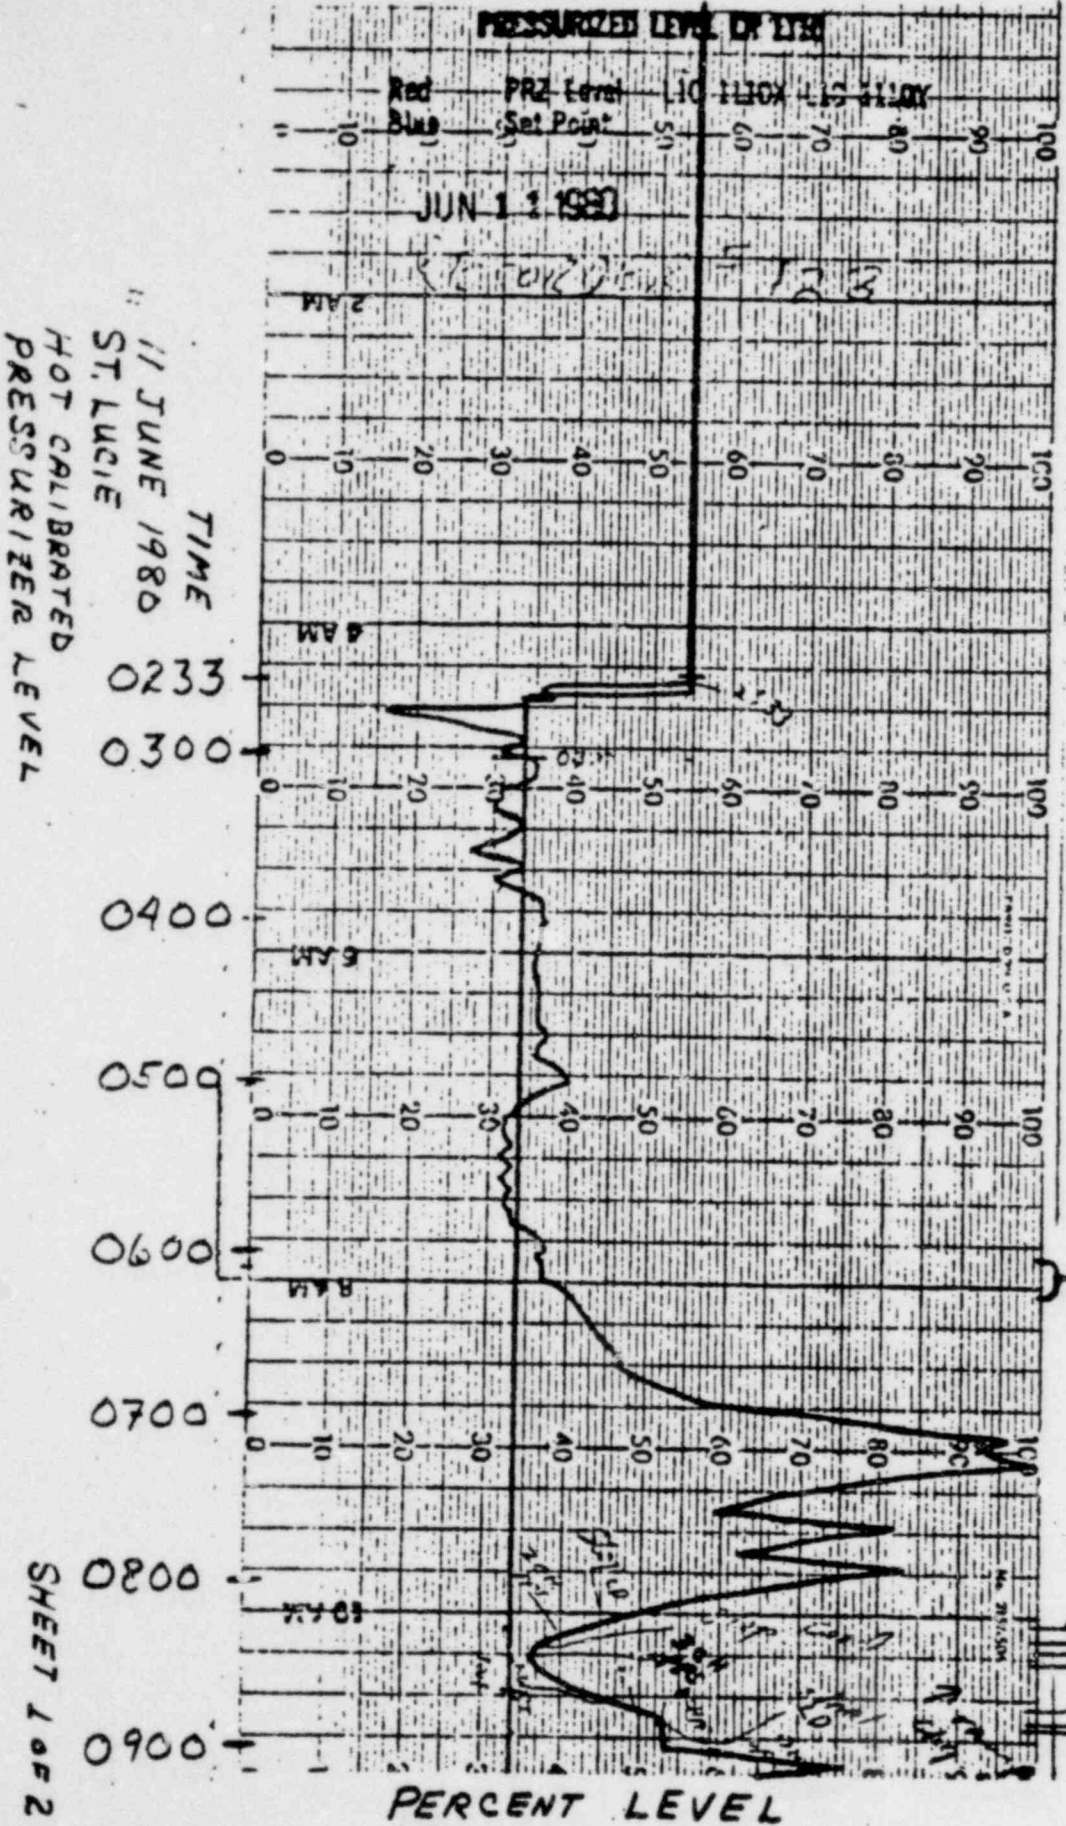
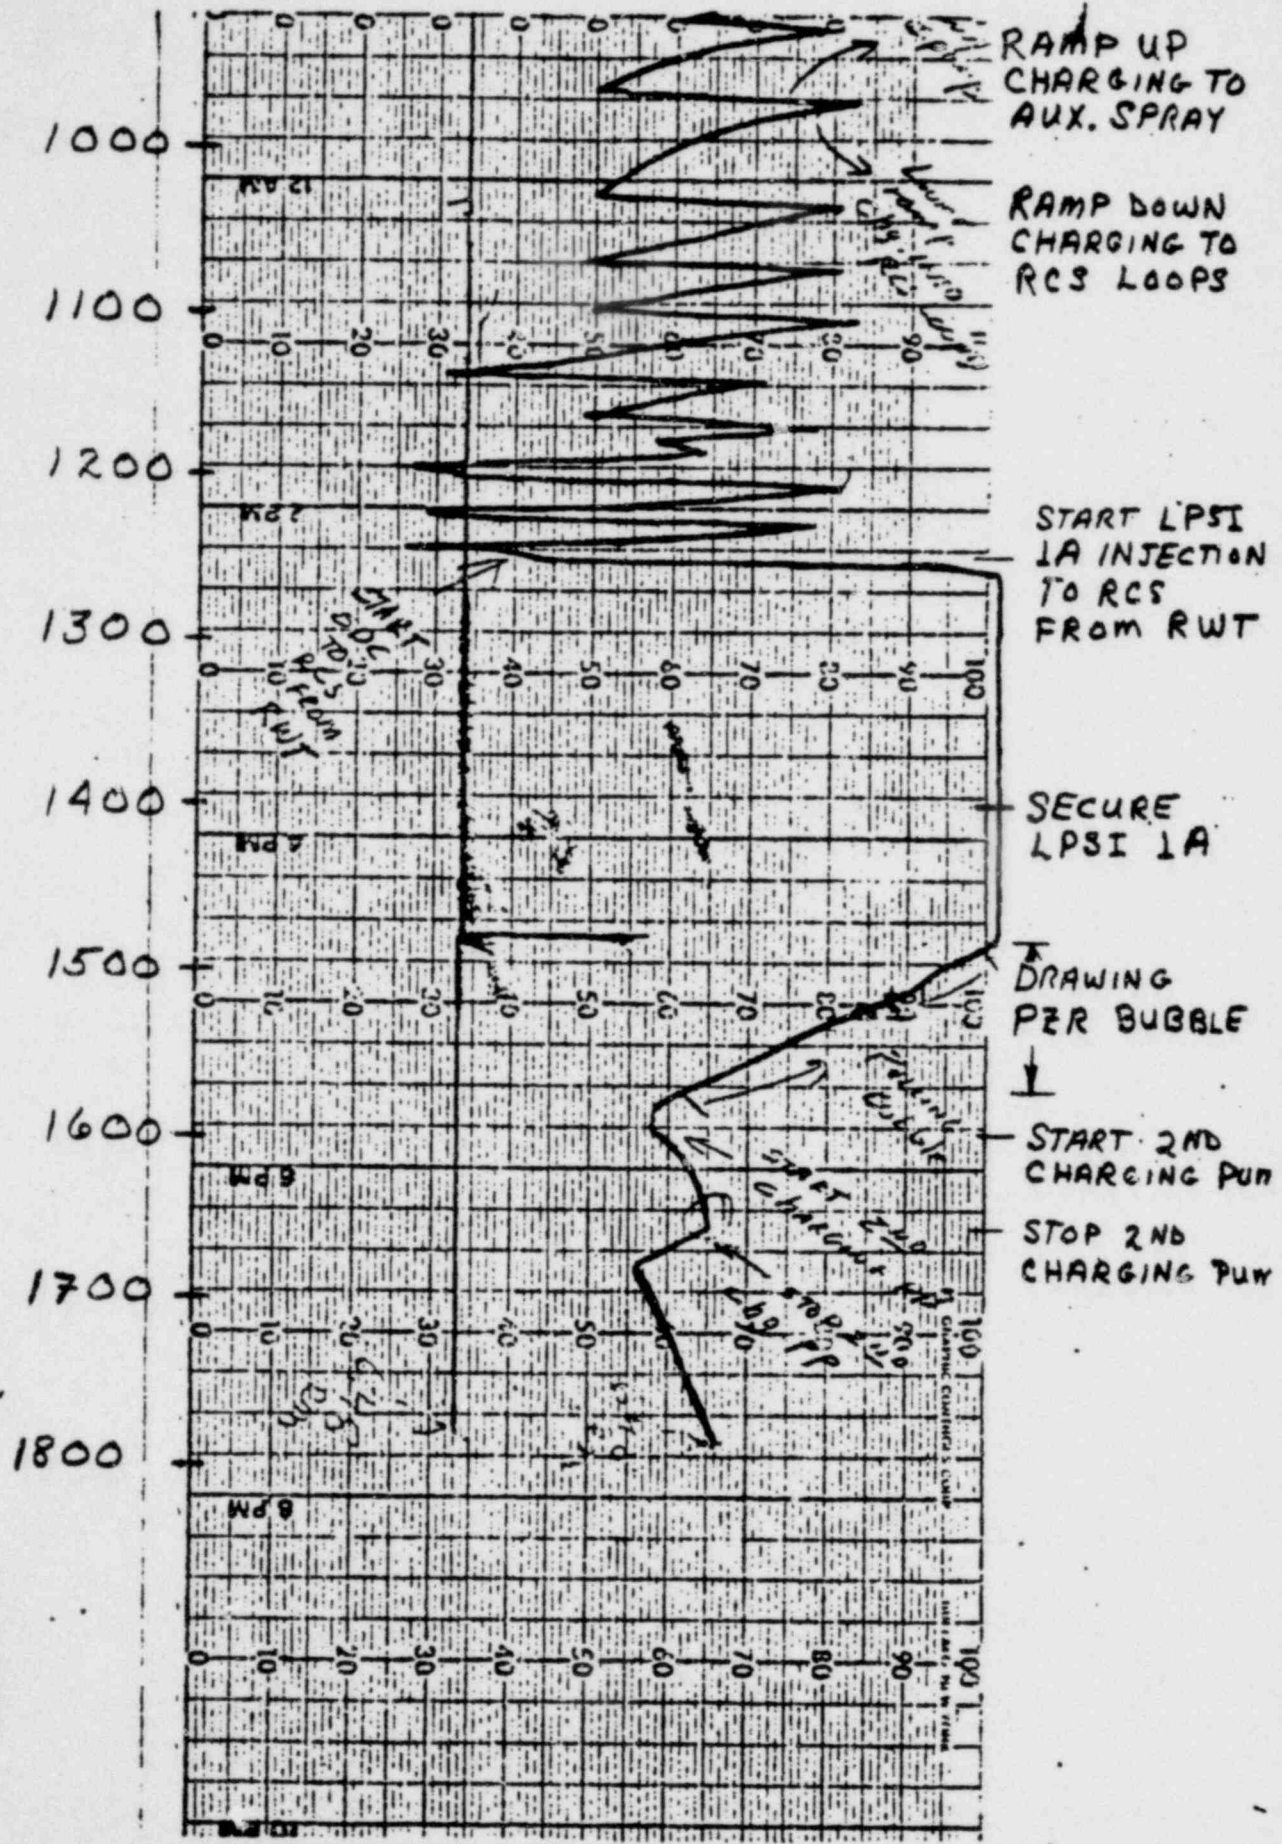
Enclosure:
Annotated record of
pressurizer level

The natural circulation cooldown continued uneventfully until after time 0600. The highest cooldown rate achieved was approximately 65 to 70 F per hour. Between 0600 and 0630 RCS pressure was reduced from 1140 to 690 psi by charging water through the pressurizer auxiliary spray line. Pressurizer level increased rapidly around 0700 while charging via the auxiliary spray line. Pressurizer level continued variations for approximately five hours while the cooldown and depressurization continued. When charging was shifted to the RCS loops, pressurizer level decreased at rates lower than the rates of increase in level when charging through the auxiliary spray line. During a two minute interval while charging into the pressurizer auxiliary spray line at 88 gpm, pressurizer level rose at a rate approximately ten times greater than the charging flowrate.

The cause of pressurizer level variations appears to be formation of a steam void in the reactor head area due to a temperature lag with respect to bulk coolant temperature that developed because of insufficient cooling flow in that area during natural circulation cooldown. Gas concentration in a 0730 RCS sample was determined by the licensee to be 32 cc/kg hydrogen and 16 cc/kg nitrogen. These concentrations were not high enough to cause a significant volume of gas to come out of solution. The indicated subcooling margin ($T_{sat} - T_{hot}$) ranged between 220 and 150 F when the reactor head steam void developed between 0600 and 0700. The minimum required subcooling of 50 F was not approached during the cooldown until around time 1219 at a pressurizer pressure of approximately 110 psig. An annotated record of pressurizer level is enclosed only to illustrate the high amplitudes and rates of pressurizer level variations. Insufficient information is contained in the enclosure to enable detailed evaluation of the RCS behavior.

The cold calibrated pressurizer level instrument indication rose to 64 percent and remained constant while hot calibrated channels rose to 100% level. Temperature correction data for the cold calibrated level instrument didn't extend to 360 F, which was the approximate pressurizer temperature when the pressurizer indicated full. Constant level on the cold calibrated channel indicated the pressurizer was solid, but continued charging flow at 88 gpm was not causing pressure to rise above 200 psig, as it should have had the RCS been solid. Letdown had been secured while filling the pressurizer. The indications of a steam void in the reactor vessel head were no longer evident after RCS pressure increased although the exact time when the void disappeared has not been established.
