UNITED STATES
NUCLEAR REGULATORY COMMISSION
OFFICE OF INSPECTION AND ENFORCEMENT
WASHINGTON, D. C. 20555

IE Circular No. 80-15

LOSS OF REACTOR COOLANT PUMP COOLING AND NATURAL CIRCULATION COOLDOWN

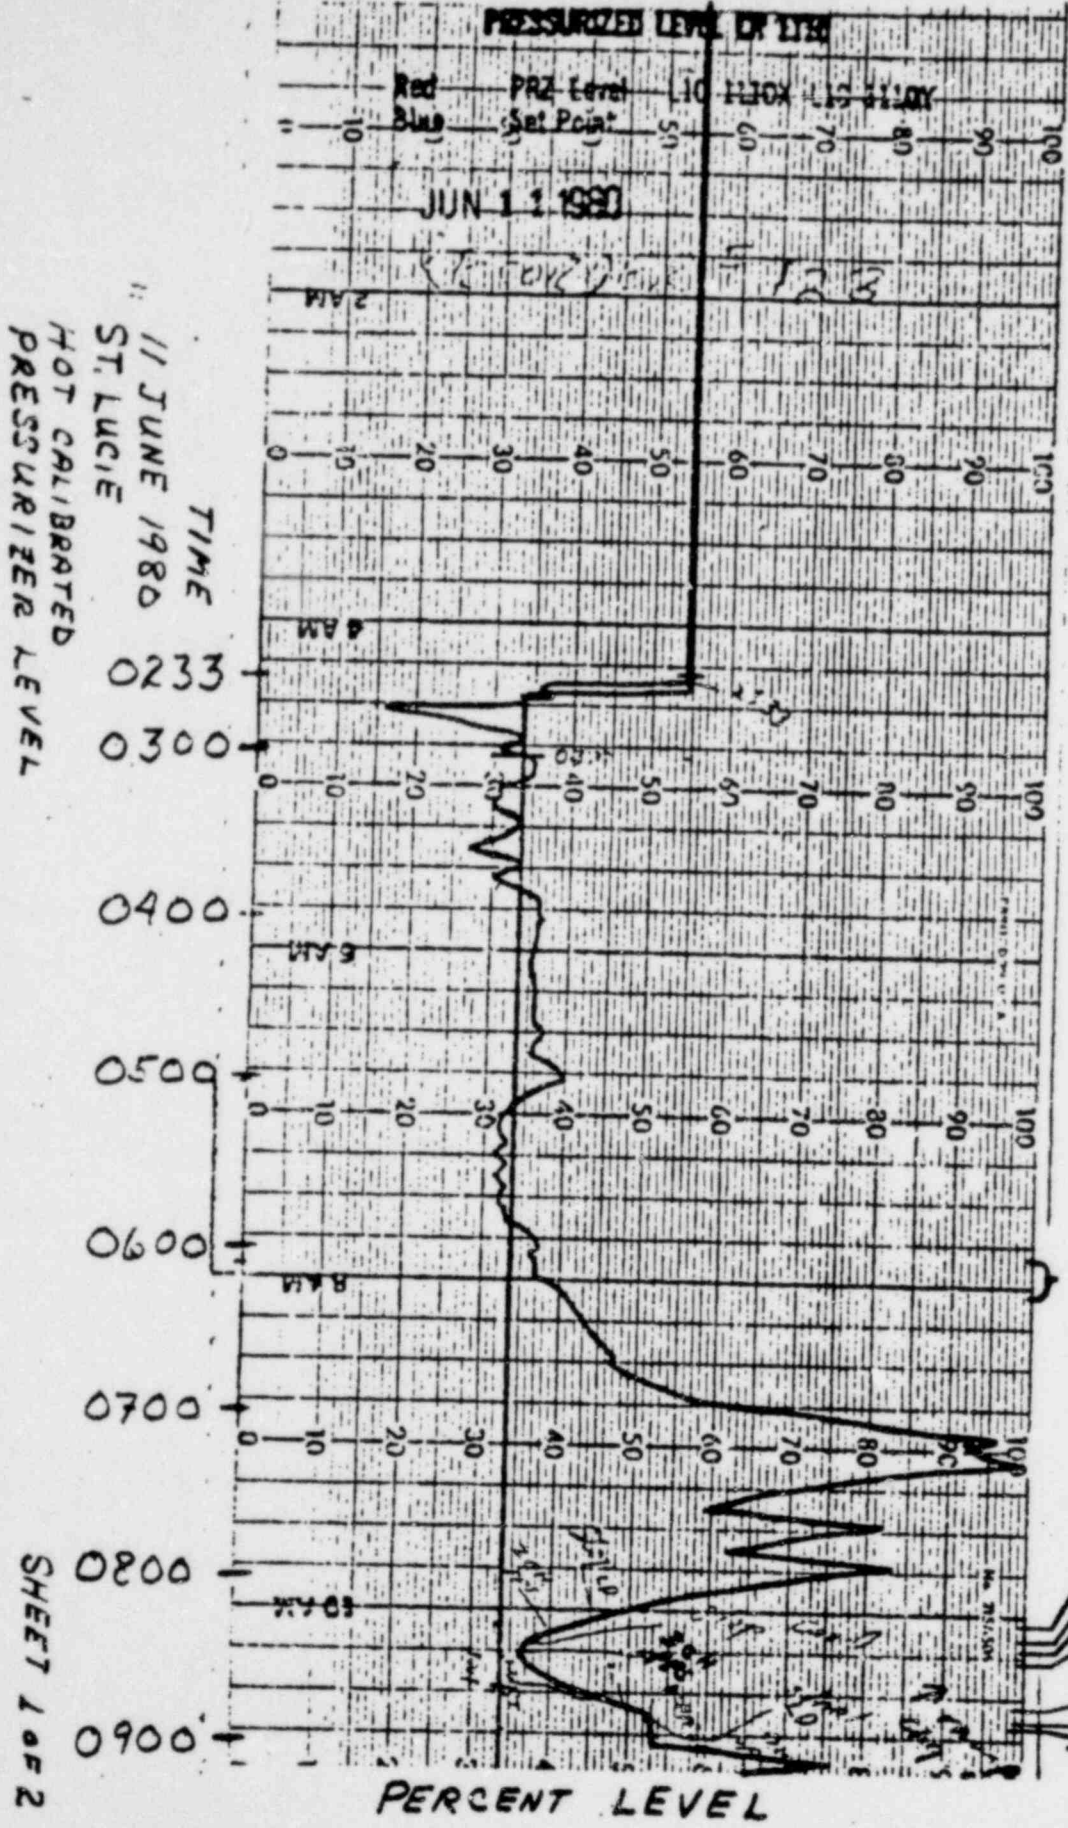
SHEET 1 OF 2

The natural circulation cooldown continued uneventfully until after time 0600. The highest cooldown rate achieved was approximately 65 to 70 F per hour. Between 0600 and 0630 RCS pressure was reduced from 1140 to 690 psi by charging water through the pressurizer auxiliary spray line. Pressurizer level increased rapidly around 0700 while charging via the auxiliary spray line. Pressurizer level continued variations for approximately five hours while the cooldown and depressurization continued. When charging was shifted to the RCS loops, pressurizer level decreased at rates lower than the rates of increase in level when charging through the auxiliary spray line. During a two minute interval while charging into the pressurizer auxiliary spray line at 88 gpm, pressurizer level rose at a rate approximately ten times greater than the charging flowrate.

The cause of pressurizer level variations appears to be formation of a steam void in the reactor head area due to a temperature lag with respect to bulk coolant temperature that developed because of insufficient cooling flow in that area during natural circulation cooldown. Gas concentration in a 0730 RCS sample was determined by the licensee to be 32 cc/kg hydrogen and 16 cc/kg nitrogen. These concentrations were not high enough to cause a significant volume of gas to come out of solution. The indicated subcooling margin ($T_{sat} - T_{hot}$) ranged between 220 and 150 F when the reactor head steam void developed between 0600 and 0700. The minimum required subcooling of 50 F was not approached during the cooldown until around time 1219 at a pressurizer pressure of approximately 110 psig. An annotated record of pressurizer level is enclosed only to illustrate the high amplitudes and rates of pressurizer level variations. Insufficient information is contained in the enclosure to enable detailed evaluation of the RCS behavior.

The cold calibrated pressurizer level instrument indication rose to 64 percent and remained constant while hot calibrated channels rose to 100% level. Temperature correction data for the cold calibrated level instrument didn't extend to 360 F, which was the approximate pressurizer temperature when the pressurizer indicated full. Constant level on the cold calibrated channel indicated the pressurizer was solid, but continued charging flow at 88 gpm was not causing pressure to rise above 200 psig, as it should have had the RCS been solid. Letdown had been secured while filling the pressurizer. The indications of a steam void in the reactor vessel head were no longer evident after RCS pressure increased although the exact time when the void disappeared has not been established.

Enclosure:
Annotated record of
 pressurizer level

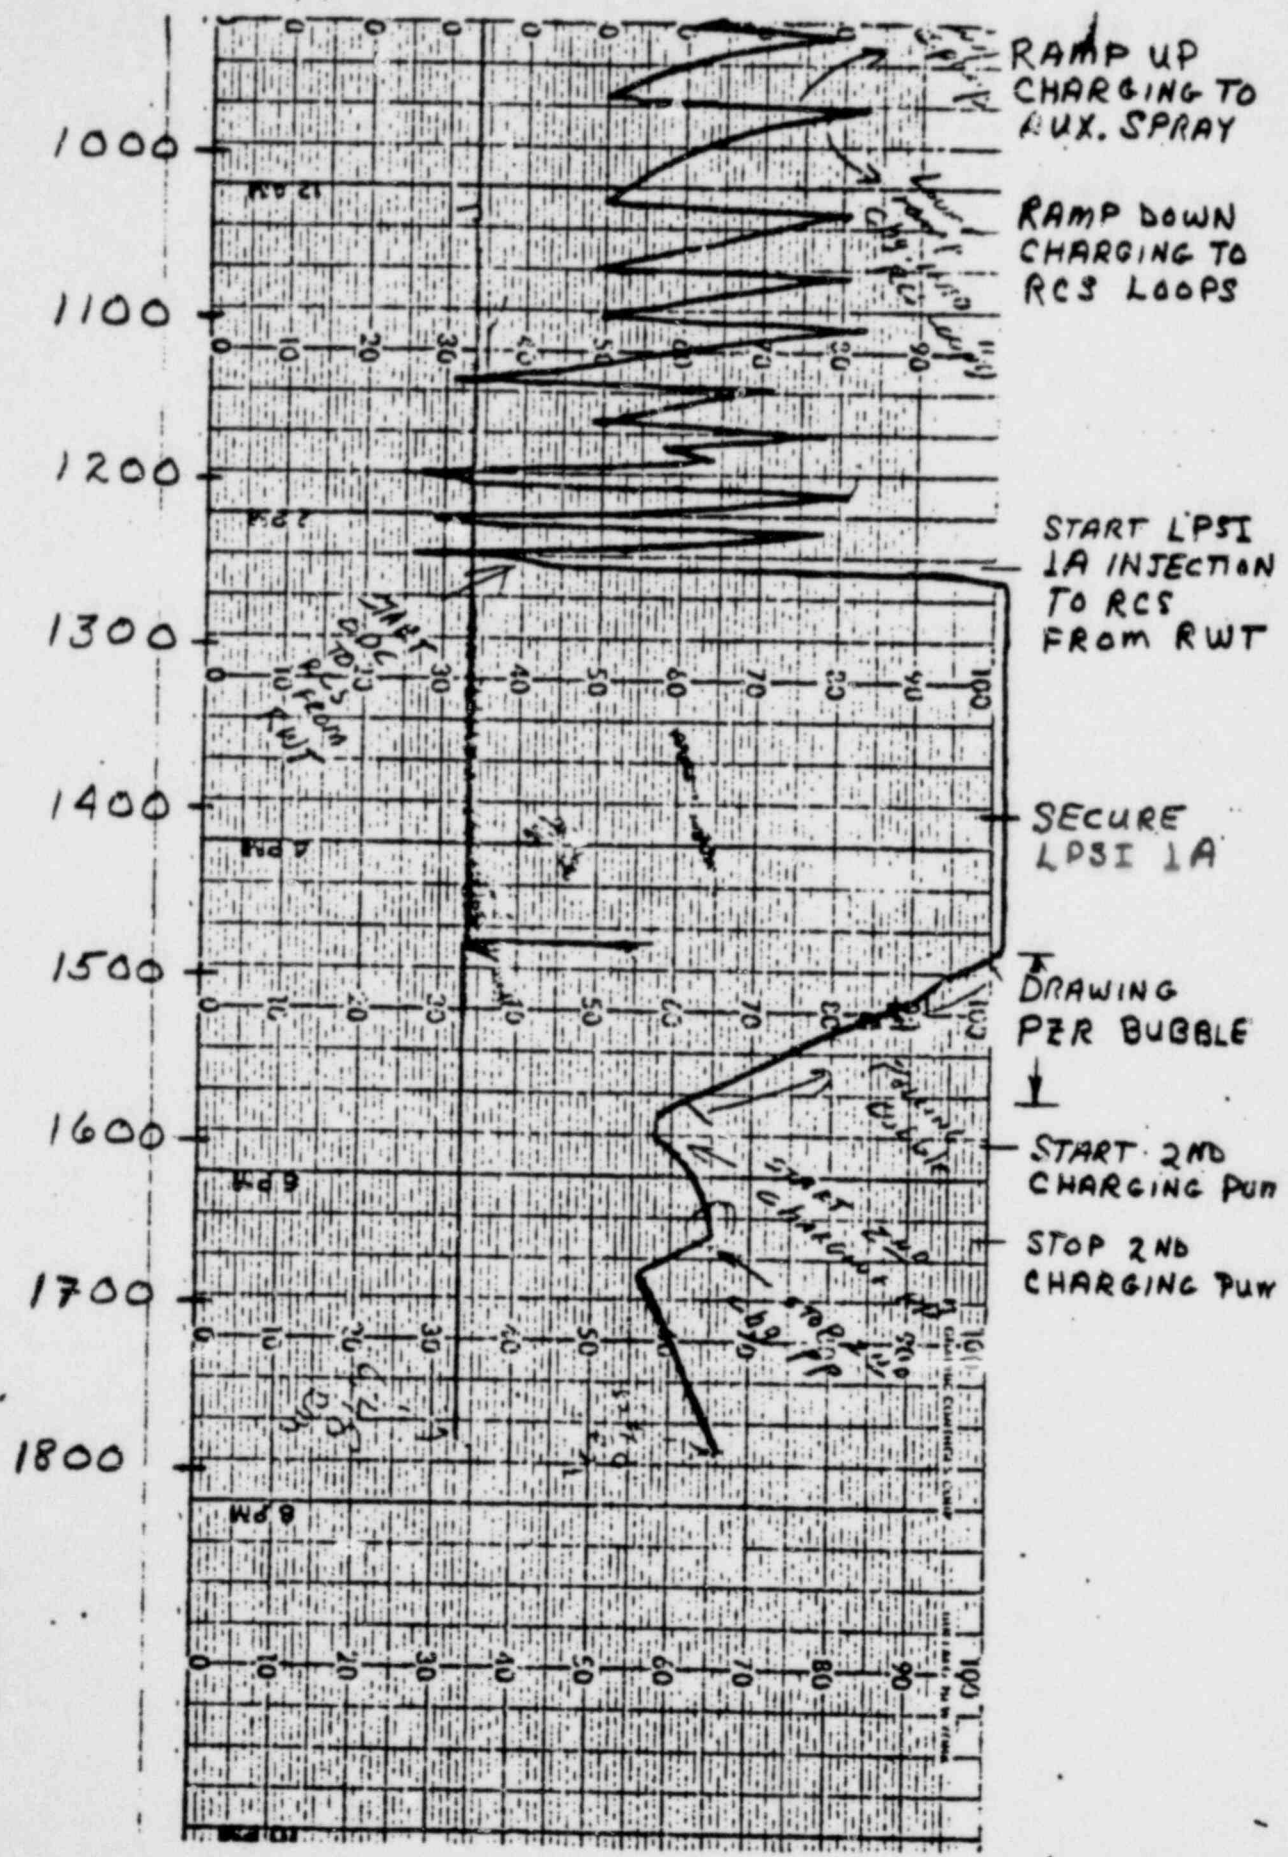
SHEET
2 OF 2

miniflow was isolated. Continued charging with two pumps at 88 gpm total flowrate caused a slight rise in both pressurizer pressure (to 260 psig) and cold calibrated pressurizer level. Letdown in excess of charging flowrate was established at 1430, and by 1500 a steam bubble was drawn in the pressurizer with level in the indicating range.
