UNITED STATES
NUCLEAR REGULATORY COMMISSION
REGION III
799 ROOSEVELT ROAD
GLEN ELLYN, ILLINOIS 60137

IE Circular No. 80-15

LOSS OF REACTOR COOLANT PUMP COOLING AND NATURAL CIRCULATION COOLDOWN

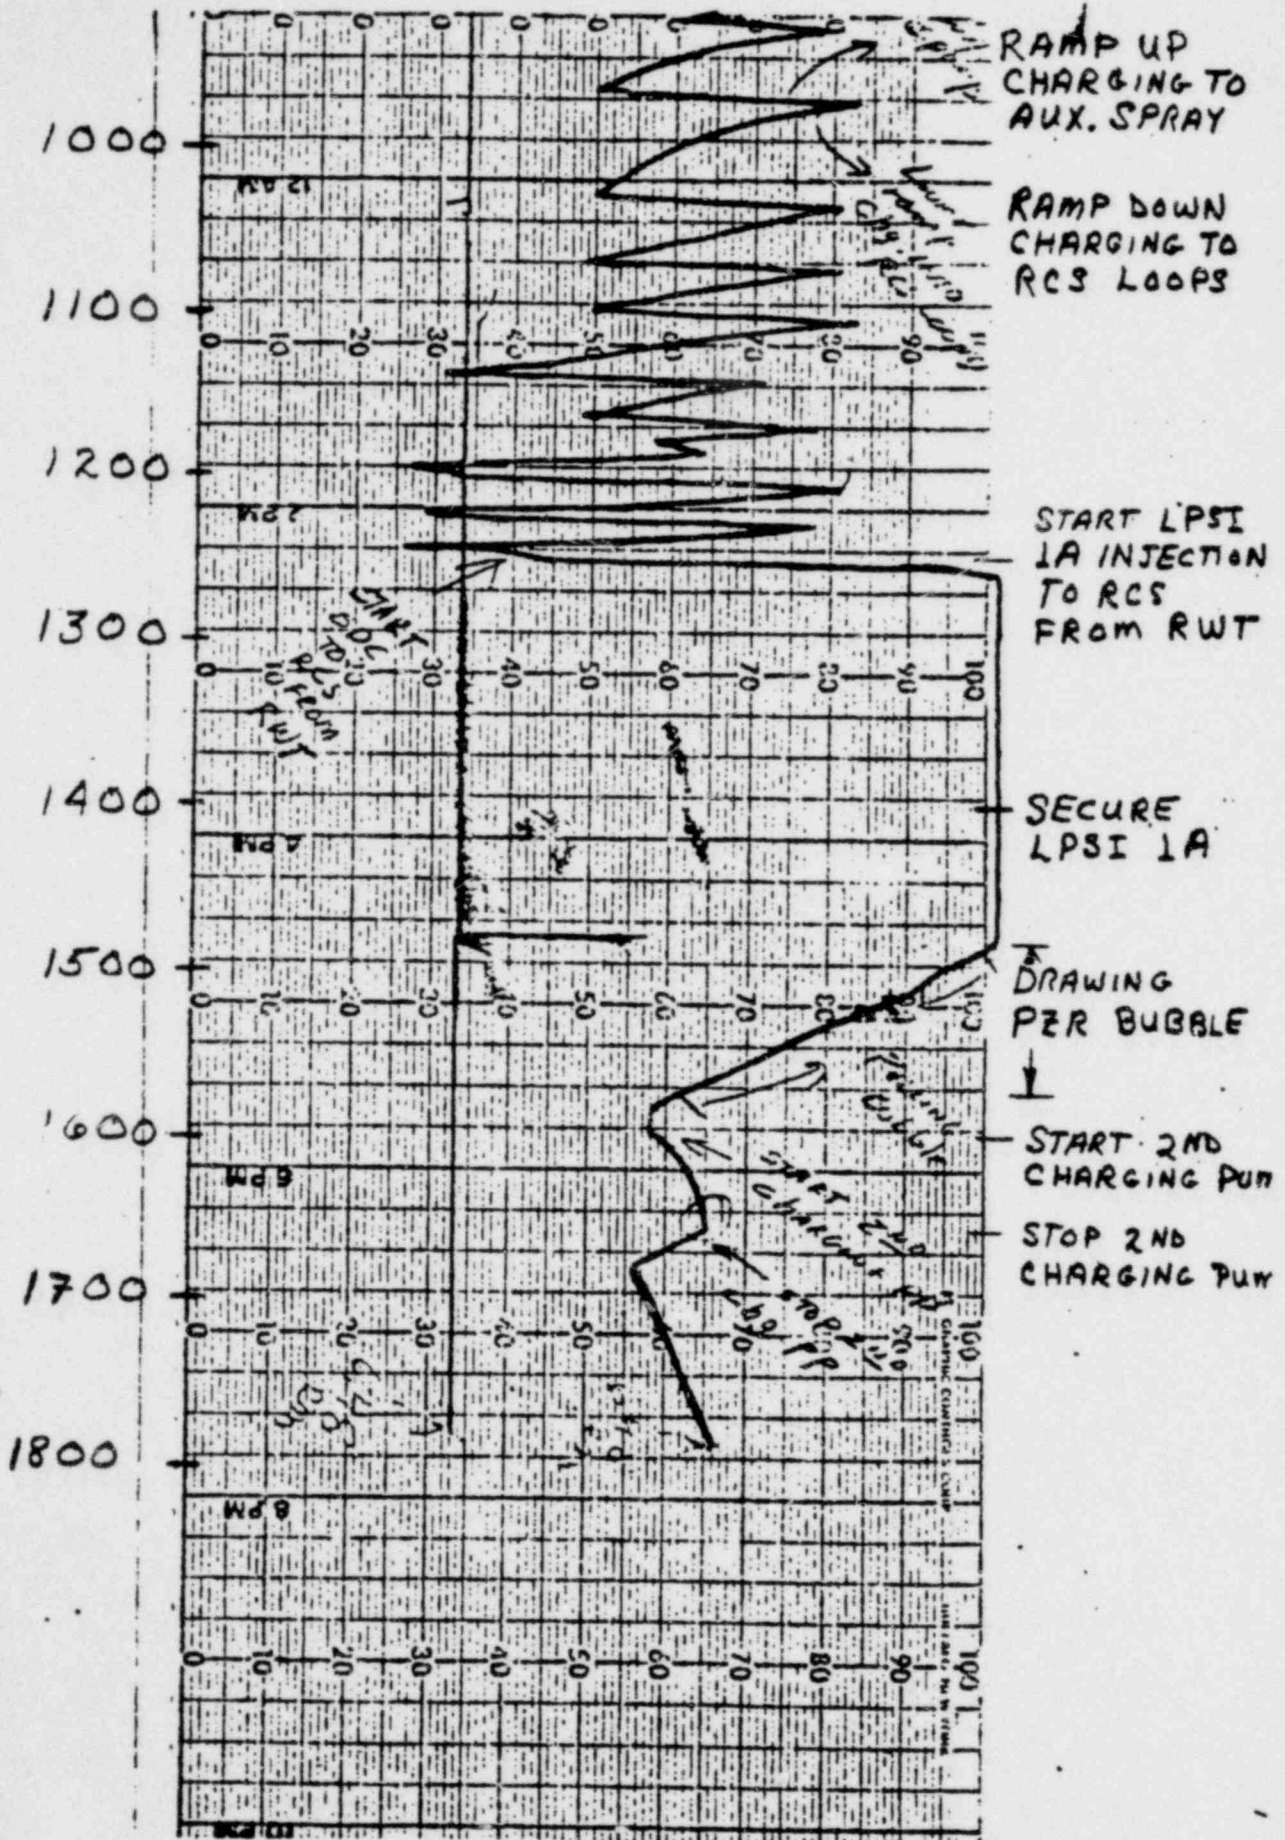
Enclosure:
Annotated record of
pressurizer level

The cold calibrated pressurizer level instrument indication rose to 64 percent and remained constant while hot calibrated channels rose to 100% level. Temperature correction data for the cold calibrated level instrument didn't extend to 360 F, which was the approximate pressurizer temperature when the pressurizer indicated full. Constant level on the cold calibrated channel indicated the pressurizer was solid, but continued charging flow at 88 gpm was not causing pressure to rise above 200 psig, as it should have had the RCS been solid. Letdown had been secured while filling the pressurizer. The indications of a steam void in the reactor vessel head were no longer evident after RCS pressure increased although the exact time when the void disappeared has not been established.
