UNITED STATES
NUCLEAR REGULATORY COMMISSION
OFFICE OF INSPECTION AND ENFORCEMENT
WASHINGTON, D. C. 20555

IE Circular No. 80-15

LOSS OF REACTOR COOLANT PUMP COOLING AND NATURAL CIRCULATION COOLDOWN

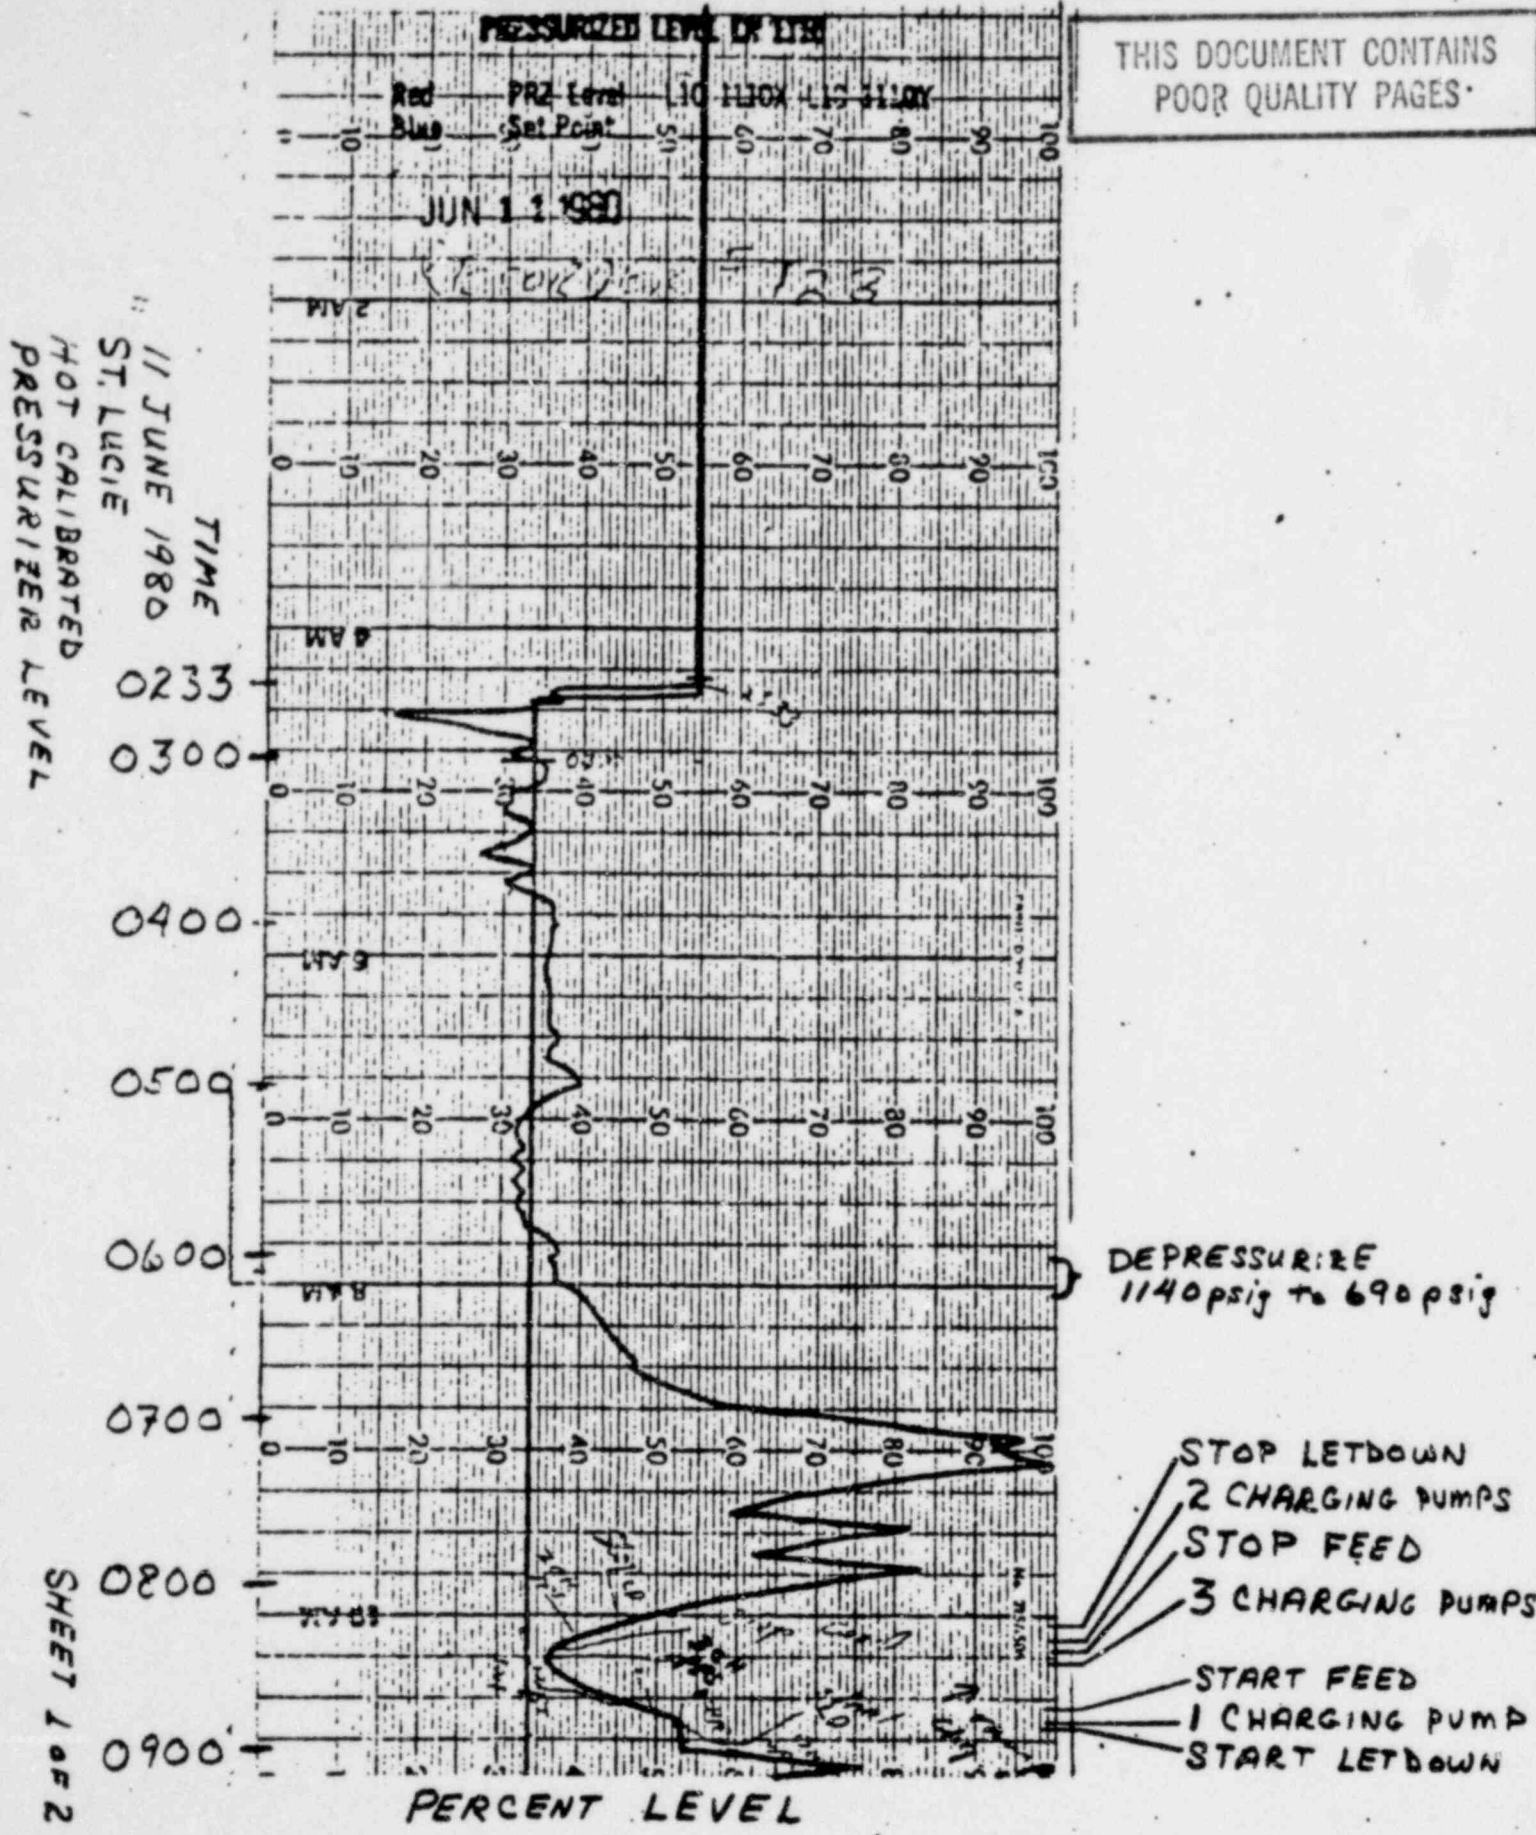
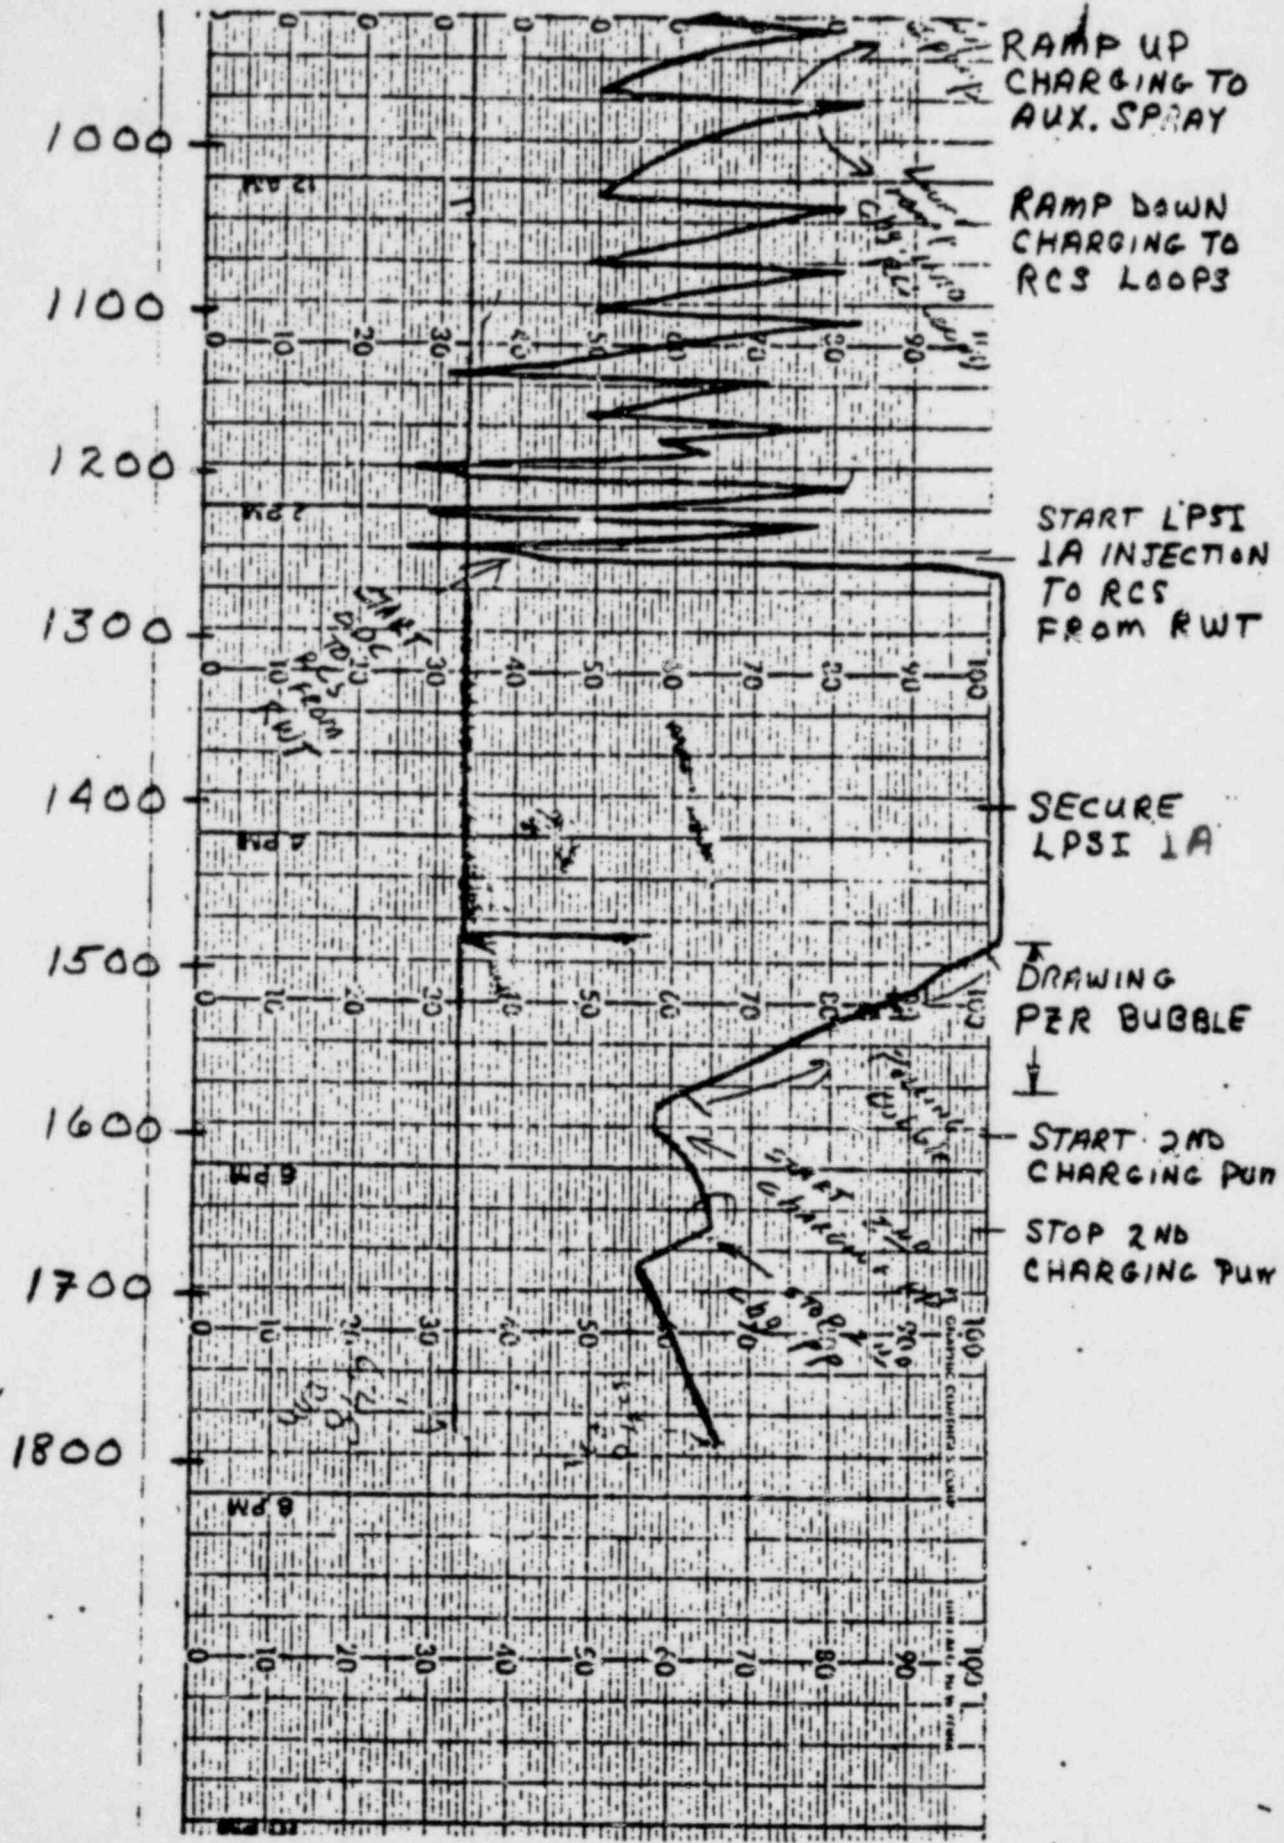
Enclosure:
Annotated record of
 pressurizer level

The natural circulation cooldown continued uneventfully until after time 0600. The highest cooldown rate achieved was approximately 65 to 70 F per hour. Between 0600 and 0630 RCS pressure was reduced from 1140 to 690 psi by charging water through the pressurizer auxiliary spray line. Pressurizer level increased rapidly around 0700 while charging via the auxiliary spray line. Pressurizer level continued variations for approximately five hours while the cooldown and depressurization continued. When charging was shifted to the RCS loops, pressurizer level decreased at rates lower than the rates of increase in level when charging through the auxiliary spray line. During a two minute interval while charging into the pressurizer auxiliary spray line at 88 gpm, pressurizer level rose at a rate approximately ten times greater than the charging flowrate.

The cause of pressurizer level variations appears to be formation of a steam void in the reactor head area due to a temperature lag with respect to bulk coolant temperature that developed because of insufficient cooling flow in that area during natural circulation cooldown. Gas concentration in a 0730 RCS sample was determined by the licensee to be 32 cc/kg hydrogen and 16 cc/kg nitrogen. These concentrations were not high enough to cause a significant volume of gas to come out of solution. The indicated subcooling margin ($T_{sat} - T_{hot}$) ranged between 220 and 150 F when the reactor head steam void developed between 0600 and 0700. The minimum required subcooling of 50 F was not approached during the cooldown until around time 1219 at a pressurizer pressure of approximately 110 psig. An annotated record of pressurizer level is enclosed only to illustrate the high amplitudes and rates of pressurizer level variations. Insufficient information is contained in the enclosure to enable detailed evaluation of the RCS behavior.

The cold calibrated pressurizer level instrument indication rose to 64 percent and remained constant while hot calibrated channels rose to 100% level. Temperature correction data for the cold calibrated level instrument didn't extend to 360 F, which was the approximate pressurizer temperature when the pressurizer indicated full. Constant level on the cold calibrated channel indicated the pressurizer was solid, but continued charging flow at 88 gpm was not causing pressure to rise above 200 psig, as it should have had the RCS been solid. Letdown had been secured while filling the pressurizer. The indications of a steam void in the reactor vessel head were no longer evident after RCS pressure increased although the exact time when the void disappeared has not been established.
