UNITED STATES OF AMERICA
NUCLEAR REGULATORY COMMISSION

In the Matter of)	
)	Docket 50-34
PORTLAND GENERAL ELECTRIC COMPANY,)	
et al)	(Control Building Proceeding)
)	
(Trojan Nuclear Plant))

AFFIDAVIT OF DONALD J. BROEHL
REGARDING LICENSEE EVENT REPORT 80-07

LER 80-07
Attachment 1

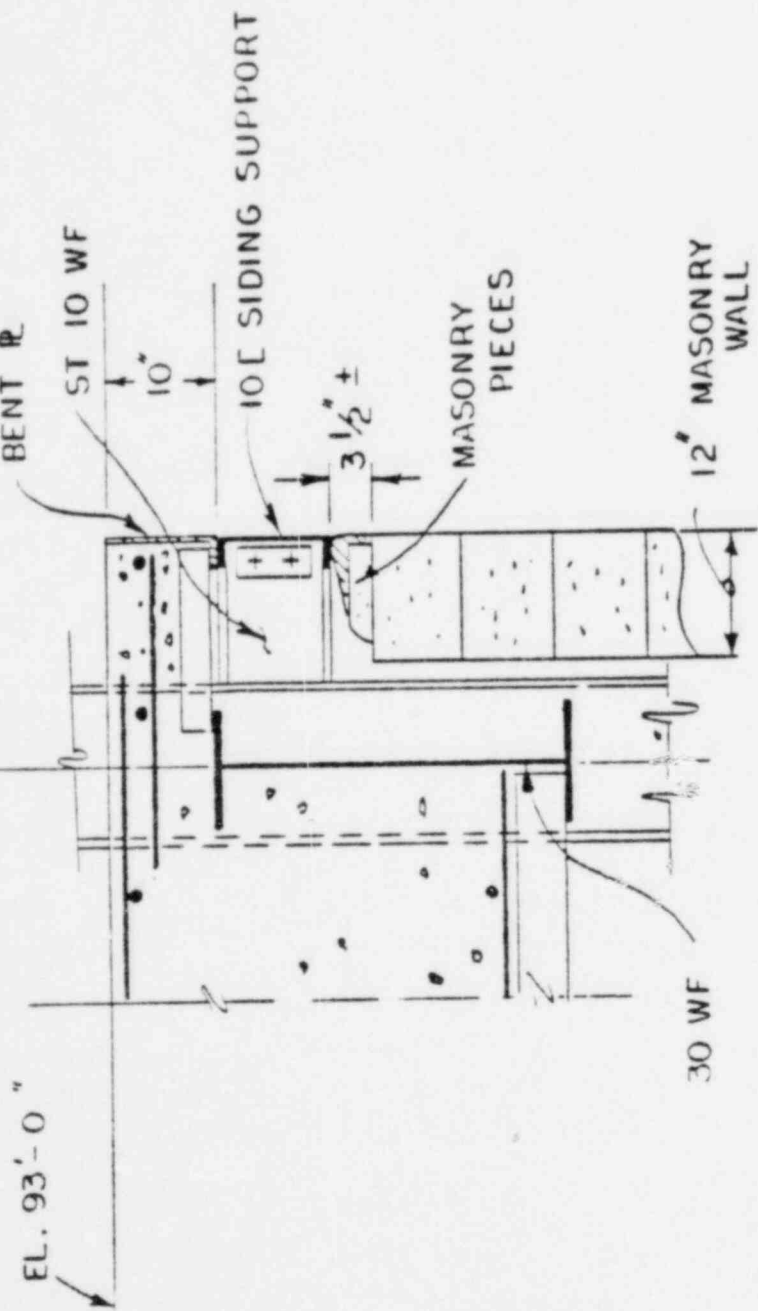
FIGURE A1

As-Built Condition of 12-in. Masonry Wall on Column Line 55,
Between F and N, at the Elevation 93 ft. Slab Interface

The as-built configuration of the 12-in. masonry wall interface with the Elevation 93 ft. reinforced concrete slab and adjacent steel elements is shown in Figure A1. The masonry wall was constructed after the structural steel framing, reinforced concrete slab, and siding support framing were completed. The interference of the 10-in. siding support channel with the continuation of the masonry wythe is apparent from Figure A1.

Detailed inspection of the interface could not be performed from either inside or outside of the Auxiliary Building without special techniques because of the difficult access. However, with use of mirrors and remote camera photographs, the as-built condition at the top of the wall was determined. For a length of the wall from about 3 ft. west of column line L to about 16 ft. west of column line F (approximately 56 ft.) it was observed that the wall masonry was terminated at the standard course dimension which is approximately 3-1/2 in. below the bottom of the siding support channel. No reinforcing steel dowels were observed projecting down from the reinforced concrete slab to match with the masonry reinforcing spacing, no masonry reinforcing projected above the top of the masonry, and no lateral ties were observed between the masonry and adjacent structural steel beam. The top-of-wall closure was finished to the underside of the siding support channel with cut sections of masonry block mortared to the top of the wall and finished on the exterior with mortar.

For the length of wall from about 3 ft. west of column line L to column line N (approximately 16 ft.), the containment airlock access slab extends over the masonry wall. In this length of wall, the existence of reinforcing steel dowels from the slab into the wall was confirmed by visual observation after removal of some of the mortar with a pneumatic chipping tool.

3. The corrective action designed to restore the structural capability of the Auxiliary Building wall where the initial deficiency was identified, involved making a positive connection between the wall and floor slab with grouted reinforcing steel, and between the wall and adjacent structural steel with through-bolts and structural steel shapes. This corrective action was completed on June 6, 1980.
