Portland General Electric Company

Trojan Nuclear Plant  
Docket 50-344  
License NPF-1

STATUS REPORT  
NONDESTRUCTIVE EXAMINATION RESULTS OF  
U-BENDS REMOVED FROM TROJAN STEAM GENERATOR D  
JULY 1980

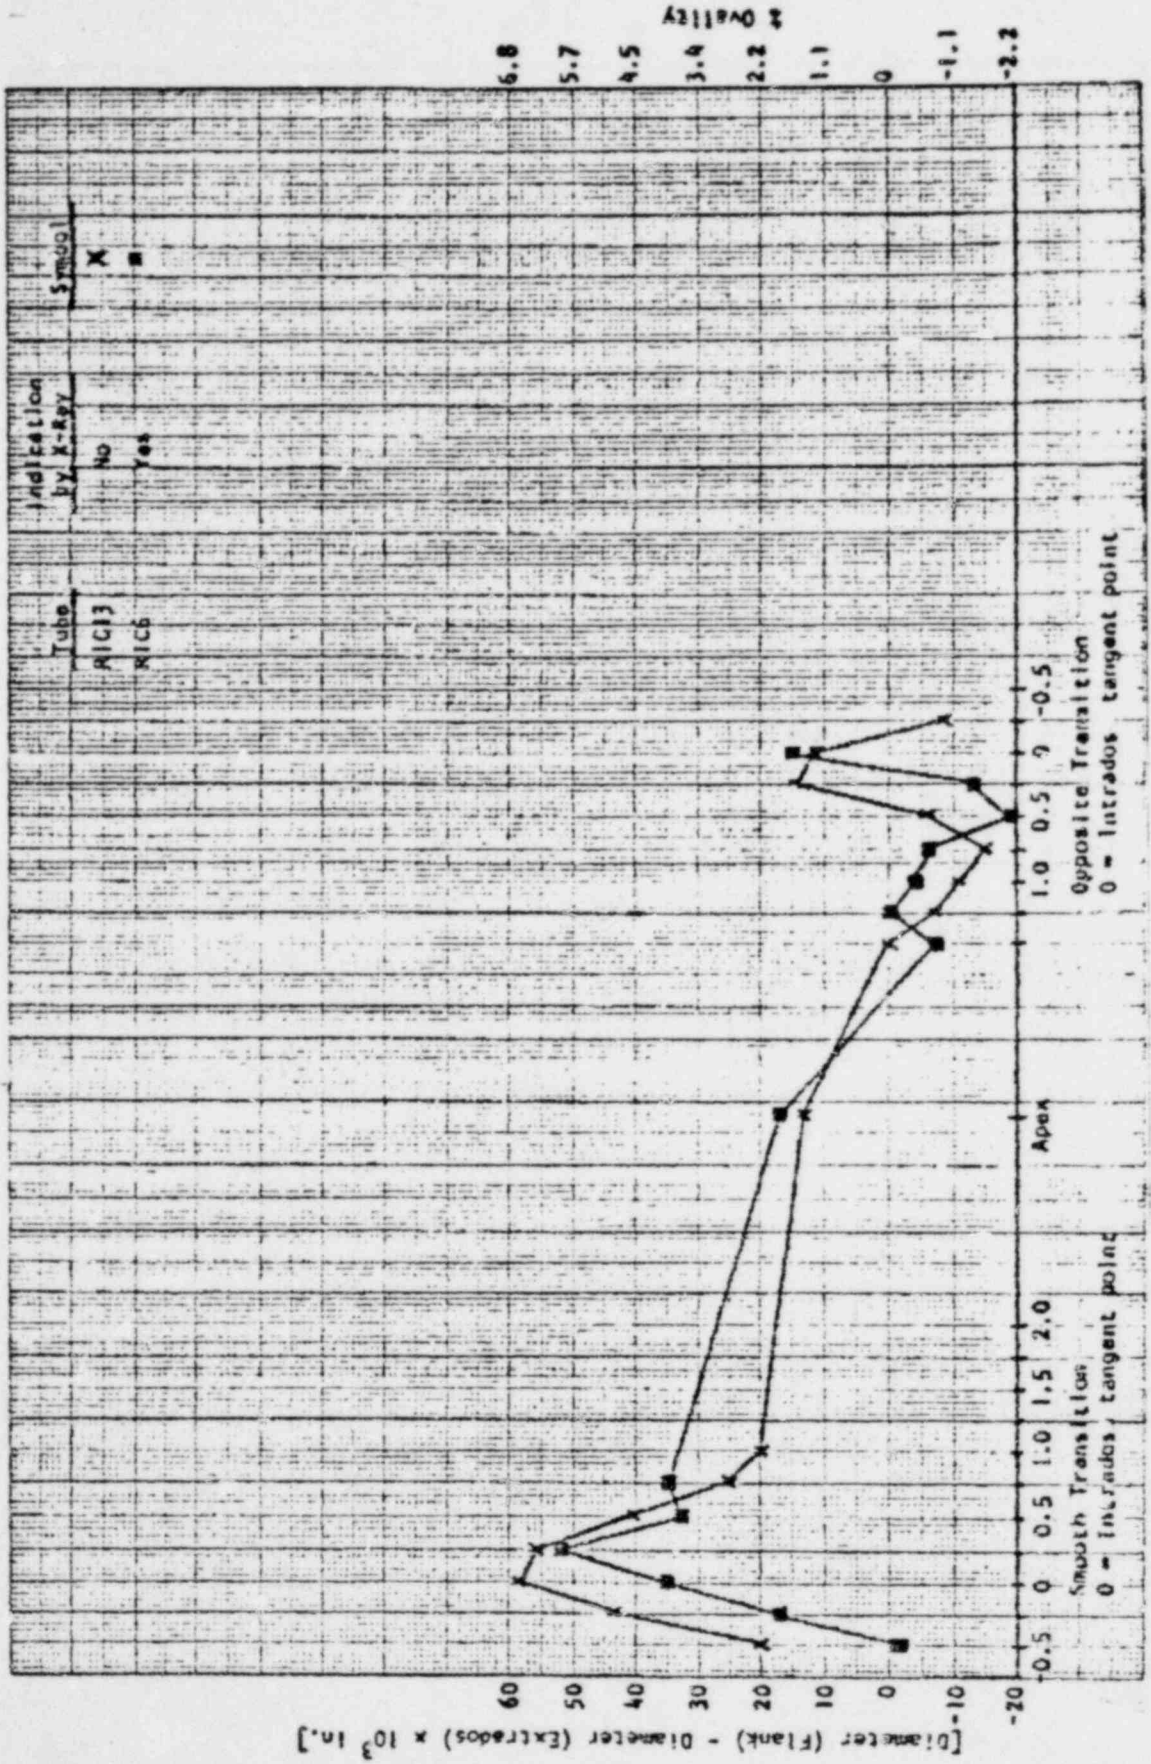
FIGURE 1

More detailed ovality measurements, taken at 1/4-in. axial increments above and below the hot- and cold-leg tangent points, have been developed on the three bends with indications of cracking (RIC6, RIC7 and RIC26) and have been compared with similar measurements taken on three tubes with no obvious cracking (RIC4, RIC13 and RIC18). Again, there does not appear to be any correlation between the maximum value of ovality and cracking. In fact, as shown in Table 1, the ovalities at the particular tangent points which are cracked, the cold leg in each of these three cases, are essentially equal or less than the ovalities at the corresponding hot-leg tangent points which are not believed to be cracked, and are well below the ovalities observed in many of the other tubes which are apparently uncracked. There does appear to be a characteristic shape to the ovality plots, however, as shown in Figure 1, which compares one of the tangent locations in two bends, arbitrarily called the "smooth" transition (because of the even contour of the bend in the transition from the straight portion) with the "opposite" transition (which does not have quite as smooth a transition). All of the cracks reported in Table 1 are believed to be located in the "opposite" transition, but as shown in Figure 1, there does not appear to be an obvious distinction in this region between cracked and uncracked bends. Additional effort is underway, to be supplemented with the destructive examination results, to evaluate these characteristics.
