UNITED STATES  
NUCLEAR REGULATORY COMMISSION  
WASHINGTON, D. C. 20555

TECHNICAL STAFF ANALYSIS REPORT  
SUMMARY

PRESIDENT'S COMMISSION ON THE  
ACCIDENT AT THREE MILE ISLAND

PAST ACCIDENTS IN NUCLEAR REACTOR FACILITIES  
AND  
NUCLEAR POWER PLANT AIRBORNE RADIOACTIVITY RELEASES

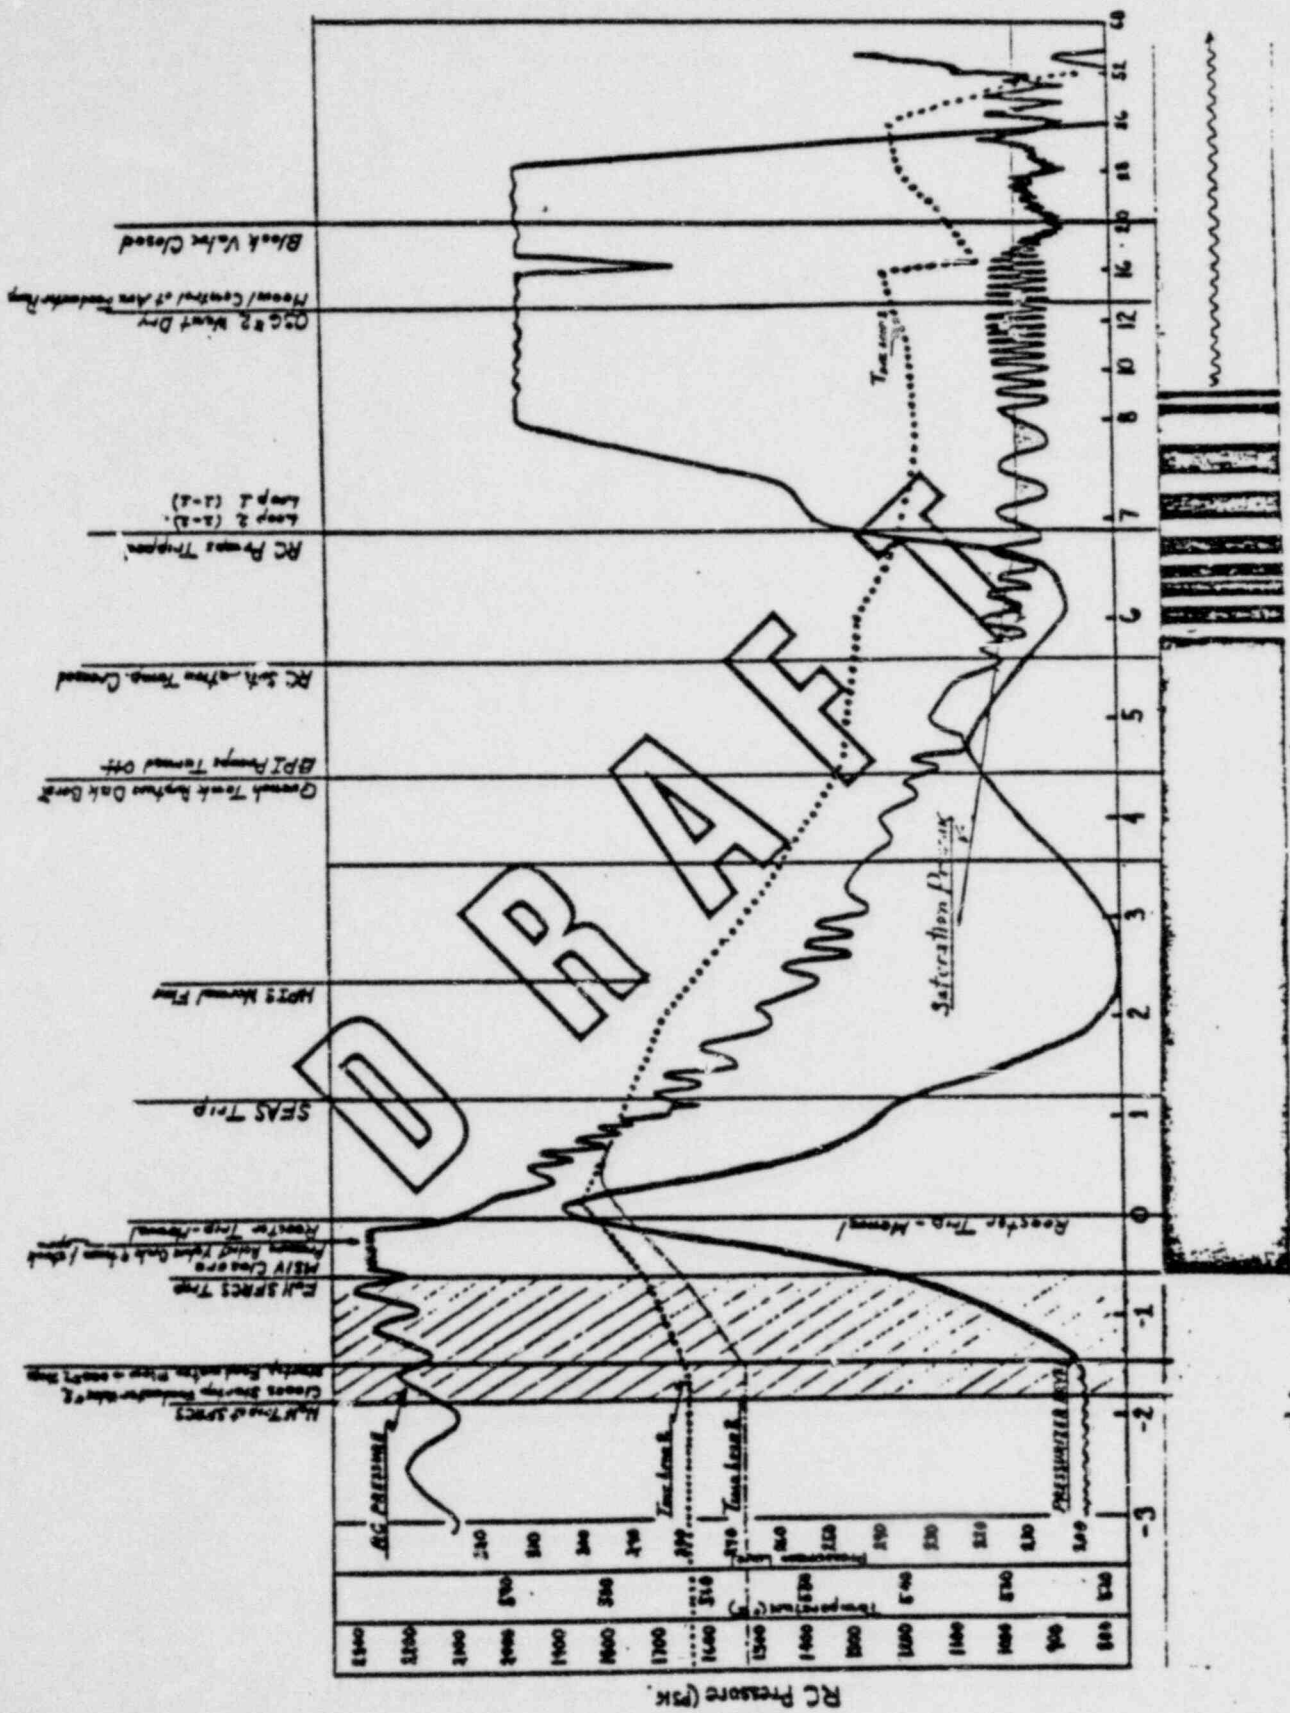
FIGURE ICG 3

Engle collected data from the incident and, after returning to Washington, plotted this data (see Figure 1(3)) Although the data plots revealed that steam formation had caused the pressurizer level to increase, Engle did not consider this finding to be significant. He also realized that the operators had secured the High Pressure Injection system before isolating the leak. However, he did not focus on whether or not this action was proper because he considered operator action to be a responsibility of I&E. 108 His primary concern was the fact that a relay such as the one that was found missing in the PORV control circuit could be removed from a system without anyone's knowledge. 109 He believed that little action could result from this concern because the system was not considered to be a safety system. He was also concerned that the investigation was being conducted unsystematically because of the number of groups involved and the lack of coordination. He informed his supervisor of this concern, but nothing was done. 110

Davis Besse, Unit 1  
 Reactor Trip from 9% Full Power at 2156 hours: September 24, 1977
