UNITED STATES
NUCLEAR REGULATORY COMMISSION
REGION I
631 PARK AVENUE
KING OF PRUSSIA, PENNSYLVANIA 19406

Docket Nos. 50-317
50-318

IE Bulletin No. 80-16

POTENTIAL MISAPPLICATION OF ROSEMOUNT INC. MODELS 1151 AND 1152 PRESSURE TRANSMITTERS WITH EITHER "A" OR "D" OUTPUT CODES

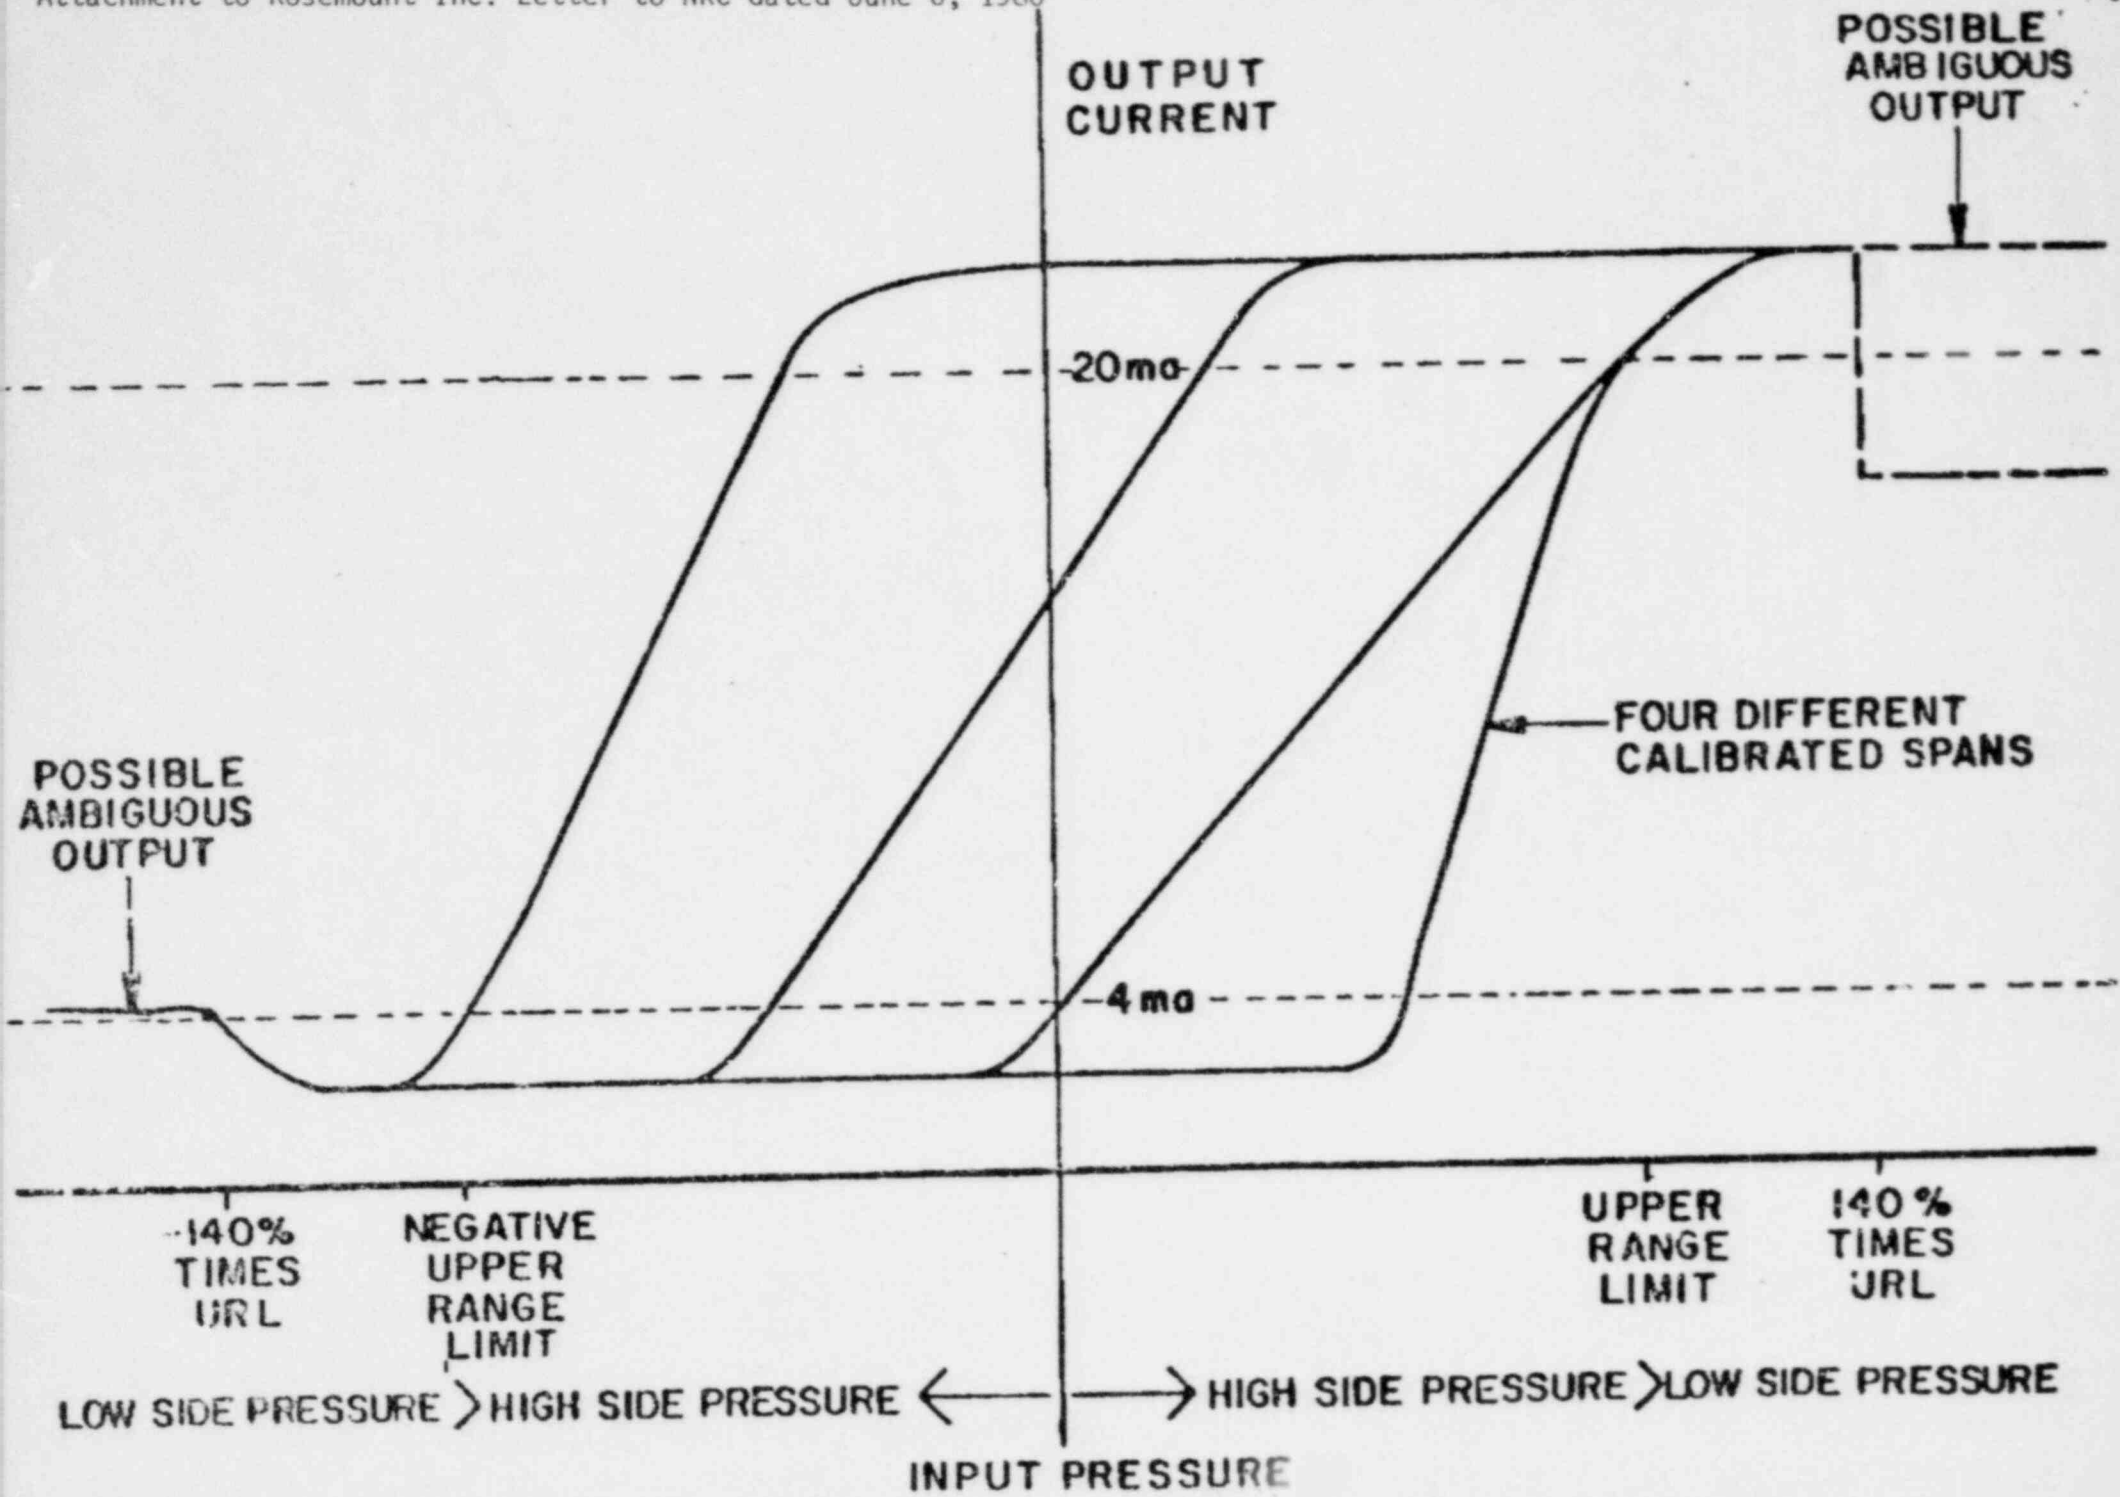
Attachment: Graph

Rosemount's Model 1152 pressure transmitter provides a specified linear output of 4 to 20 mA throughout the calibrated range of operation. The transmitter output is not specified by Rosemount for pressures outside of the calibrated range of operation. It has been observed in a limited number of transmitters that an output between 4 and 20 mA can occur with certain input pressures outside of the calibrated range. These ambiguous outputs can occur in both an over pressure condition and a reverse pressure condition. Both conditions arise when the center diaphragm of the pressure sensor bottoms out against either of the fixed capacitor plates. In each case the normal capacitance signal becomes a very high capacitance signal which affects the operation of the electronic circuit.

For the over pressure condition, the effect of the high capacitance from the sensor is a modulated output on the oscillator circuit which may cause the output current of the transmitter to drop below 20 mA. In a limited sample size, the ambiguous output during this over pressure condition occurred in 5% of the transmitters at ambient conditions. Referring to the attached graph, this does not occur until the over pressure condition is > 140% of the upper range limit regardless of span. At that point a discontinuity can occur with the output current instantaneously decreasing to less than 20 mA. As an example of this potential applications problem, the upper range limit of a range 5 1152 differential pressure transmitter (Model 1152DP5A22) is 750" H₂O. The range of this pressure transmitter can be set from 0 to 150" H₂O. If the ambiguous output in the over pressure condition is to occur, it will occur at 140% or more of the upper range limit or, in this case, at pressures > 1050" H₂O (750" H₂O x 1.4). The transmitter then could give an output less than 20 mA at a pressure that is, in this example, seven

times ($1050''\text{H}_2\text{O} \div 150''\text{H}_2\text{O}$) the upper range value. Note that the significant figure for use in determining the pressure above which an ambiguous output can occur is the specified upper range limit ($750''\text{H}_2\text{O}$ in this example) not the customer selected upper range value ($150''\text{H}_2\text{O}$ in this example).

For the reverse pressure condition, the effect of the high capacitance from the sensor is the oscillator circuit drawing more current which may cause the output current of the transmitter to exceed 4 mA. In a limited sample size, the ambiguous output during this reverse pressure condition occurred in 55% of the transmitters at ambient conditions. Referring to the attached graph, this does not occur until the reverse pressure condition exceeds 140% of the upper range limit regardless of the span. At this point the output may exceed 4 mA. As an example of this potential applications problem consider the range 5 differential transmitter in the previous paragraph. If the ambiguous output in the reverse pressure condition is to occur, it will occur at 140% or more of the upper range limit, or in this case at reversed pressures $> 1050''\text{H}_2\text{O}$ ($750''\text{H}_2\text{O} \times 1.4$). The transmitter then could give an output greater than 4 mA at a pressure that is, in this example, seven times ($1050''\text{H}_2\text{O} \div 150''\text{H}_2\text{O}$) the upper range value, but reversed. Also note that with absolute pressure units a reverse pressure is not possible since the low pressure side of the cell is evacuated. With gage units a reverse pressure is possible only if a vacuum is present on the connected part since the low pressure side of the cell is vented to ambient atmosphere. Since the maximum reverse pressure would be one atmosphere, only range 3 and 4 gage units could obtain a reverse pressure exceeding 140% of the upper range limit.

The safety system should be analyzed in view of this supplementary report to determine if a potential application problem exists and appropriate corrections to the safety system should be implemented.
