IE Bulletin No. 80-16

POTENTIAL MISAPPLICATION OF ROSEMOUNT INC. MODELS 1151 AND 1152 PRESSURE TRANSMITTERS WITH EITHER "A" OR "D" OUTPUT CODES

IE Circular No. 80-16

OPERATIONAL DEFICIENCIES IN ROSEMOUNT MODEL 510DU TRIP UNITS AND MODEL 1152  
PRESSURE TRANSMITTERS

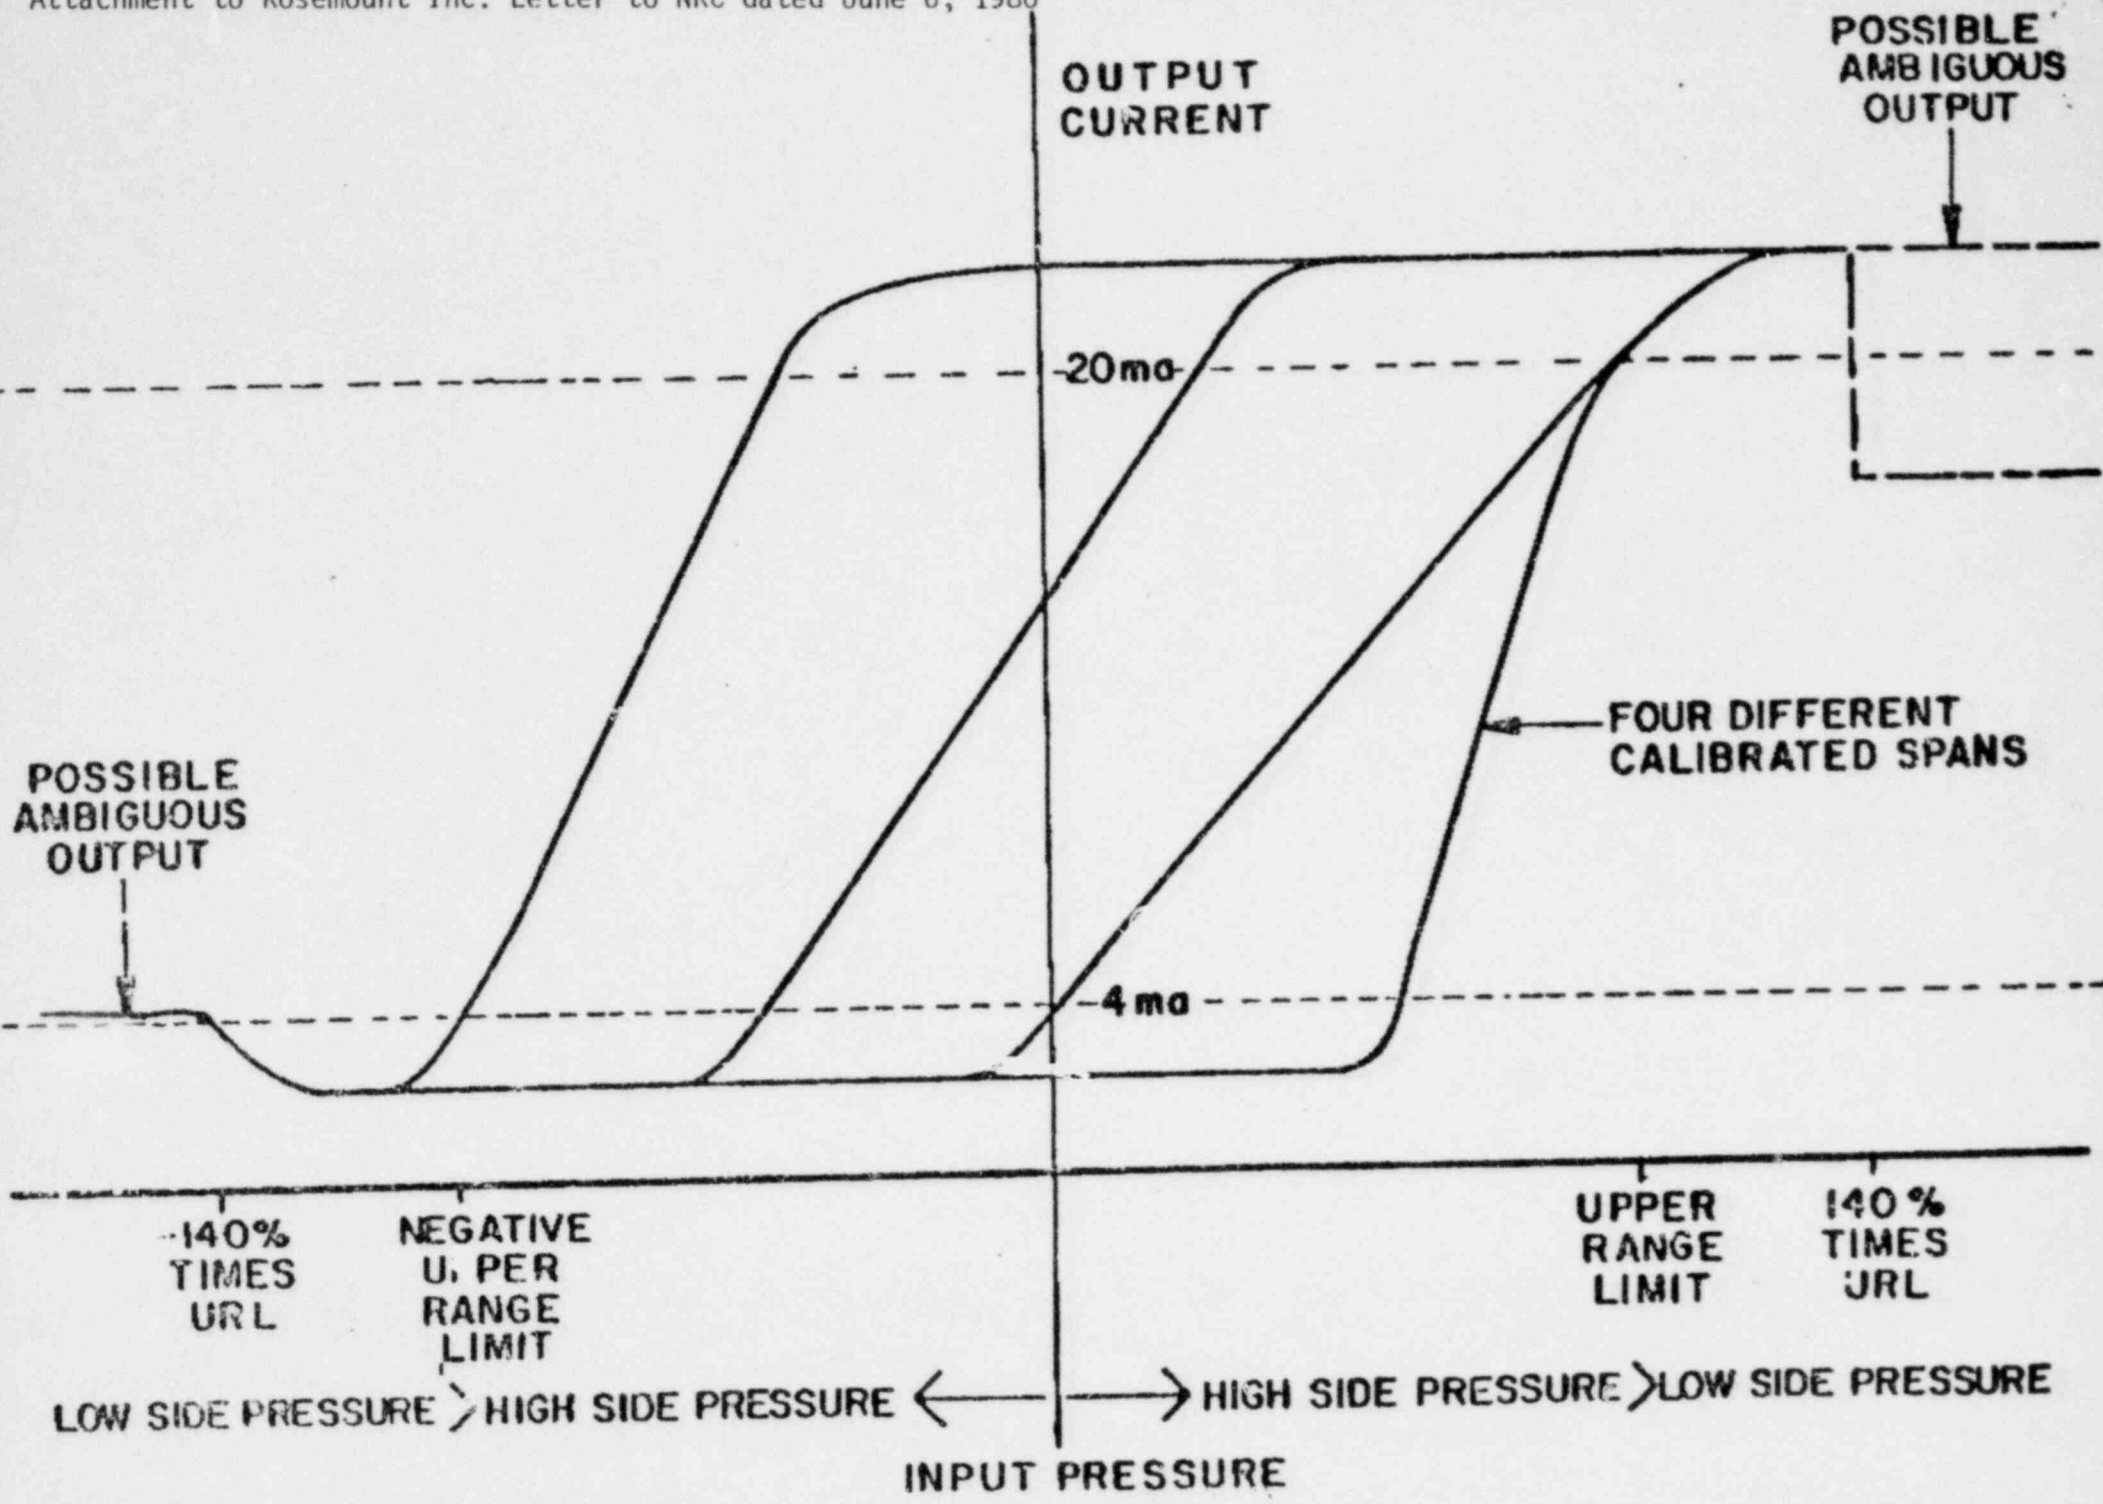
Attachment: Graph

The potential misapplication problem occurs when the above specified transmitters are exposed to excessive over or reverse pressures. These pressures can result in ambiguous signal outputs from the transmitter to control and/or indication components. These ambiguous signals could result in erroneous control action, such as an open signal to a solenoid valve rather than a closed signal, or an erroneous indication signal, such as an indication in the normal operating range when a pressure outside the normal range actually exists.

Rosemount's Model 1152 pressure transmitter provides a specified linear output of 4 to 20 mA throughout the calibrated range of operation. The transmitter output is not specified by Rosemount for pressures outside of the calibrated range of operation. It has been observed in a limited number of transmitters that an output between 4 and 20 mA can occur with certain input pressures outside of the calibrated range. These ambiguous outputs can occur in both an over pressure condition and a reverse pressure condition. Both conditions arise when the center diaphragm of the pressure sensor bottoms out against either of the fixed capacitor plates. In each case the normal capacitance signal becomes a very high capacitance signal which affects the operation of the electronic circuit.

For the over pressure condition, the effect of the high capacitance from the sensor is a modulated output on the oscillator circuit which may cause the output current of the transmitter to drop below 20 mA. In a limited sample size, the ambiguous output during this over pressure condition occurred in 5% of the transmitters at ambient conditions. Referring to the attached graph, this does not occur until the over pressure condition is  $\geq 140\%$  of the upper range limit regardless of span. At that point a discontinuity can occur with the output current instantaneously decreasing to less than 20 mA. As an example of this potential applications problem, the upper range limit of a range 5 1152 differential pressure transmitter (Model 1152DP5A22) is  $750''\text{H}_2\text{O}$ . The range of this pressure transmitter can be set from 0 to  $150''\text{H}_2\text{O}$ . If the ambiguous output in the over pressure condition is to occur, it will occur at  $140\%$  or more of the upper range limit or, in this case, at pressures  $> 1050''\text{H}_2\text{O}$  ( $750''\text{H}_2\text{O} \times 1.4$ ). The transmitter then could give an output less than 20 mA at a pressure that is, in this example, seven

times ( $1050''\text{H}_2\text{O} \div 150''\text{H}_2\text{O}$ ) the upper range value. Note that the significant figure for use in determining the pressure above which an ambiguous output can occur is the specified upper range limit ( $750''\text{H}_2\text{O}$  in this example) not the customer selected upper range value ( $150''\text{H}_2\text{O}$  in this example).

For the reverse pressure condition, the effect of the high capacitance from the sensor is the oscillator circuit drawing more current which may cause the output current of the transmitter to exceed 4 mA. In a limited sample size, the ambiguous output during this reverse pressure condition occurred in 55% of the transmitters at ambient conditions. Referring to the attached graph, this does not occur until the reverse pressure condition exceeds 140% of the upper range limit regardless of the span. At this point the output may exceed 4 mA. As an example of this potential applications problem consider the range 5 differential transmitter in the previous paragraph. If the ambiguous output in the reverse pressure condition is to occur, it will occur at 140% or more of the upper range limit, or in this case at reversed pressures  $> 1050''\text{H}_2\text{O}$  ( $750''\text{H}_2\text{O} \times 1.4$ ). The transmitter then could give an output greater than 4 mA at a pressure that is, in this example, seven times ( $1050''\text{H}_2\text{O} \div 150''\text{H}_2\text{O}$ ) the upper range value, but reversed. Also note that with absolute pressure units a reverse pressure is not possible since the low pressure side of the cell is evacuated. With gage units a reverse pressure is possible only if a vacuum is present on the connected part since the low pressure side of the cell is vented to ambient atmosphere. Since the maximum reverse pressure would be one atmosphere, only range 3 and 4 gage units could obtain a reverse pressure exceeding 140% of the upper range limit.

The safety system should be analyzed in view of this supplementary report to determine if a potential application problem exists and appropriate corrections to the safety system should be implemented.
