IE Bulletin No. 80-16

POTENTIAL MISAPPLICATION OF ROSEMOUNT INC. MODELS 1151 AND 1152 PRESSURE TRANSMITTERS WITH EITHER "A" OR "D" OUTPUT CODES

IE Circular No. 80-16

OPERATIONAL DEFICIENCIES IN ROSEMOUNT MODEL 510DU TRIP UNITS AND MODEL 1152
PRESSURE TRANSMITTERS

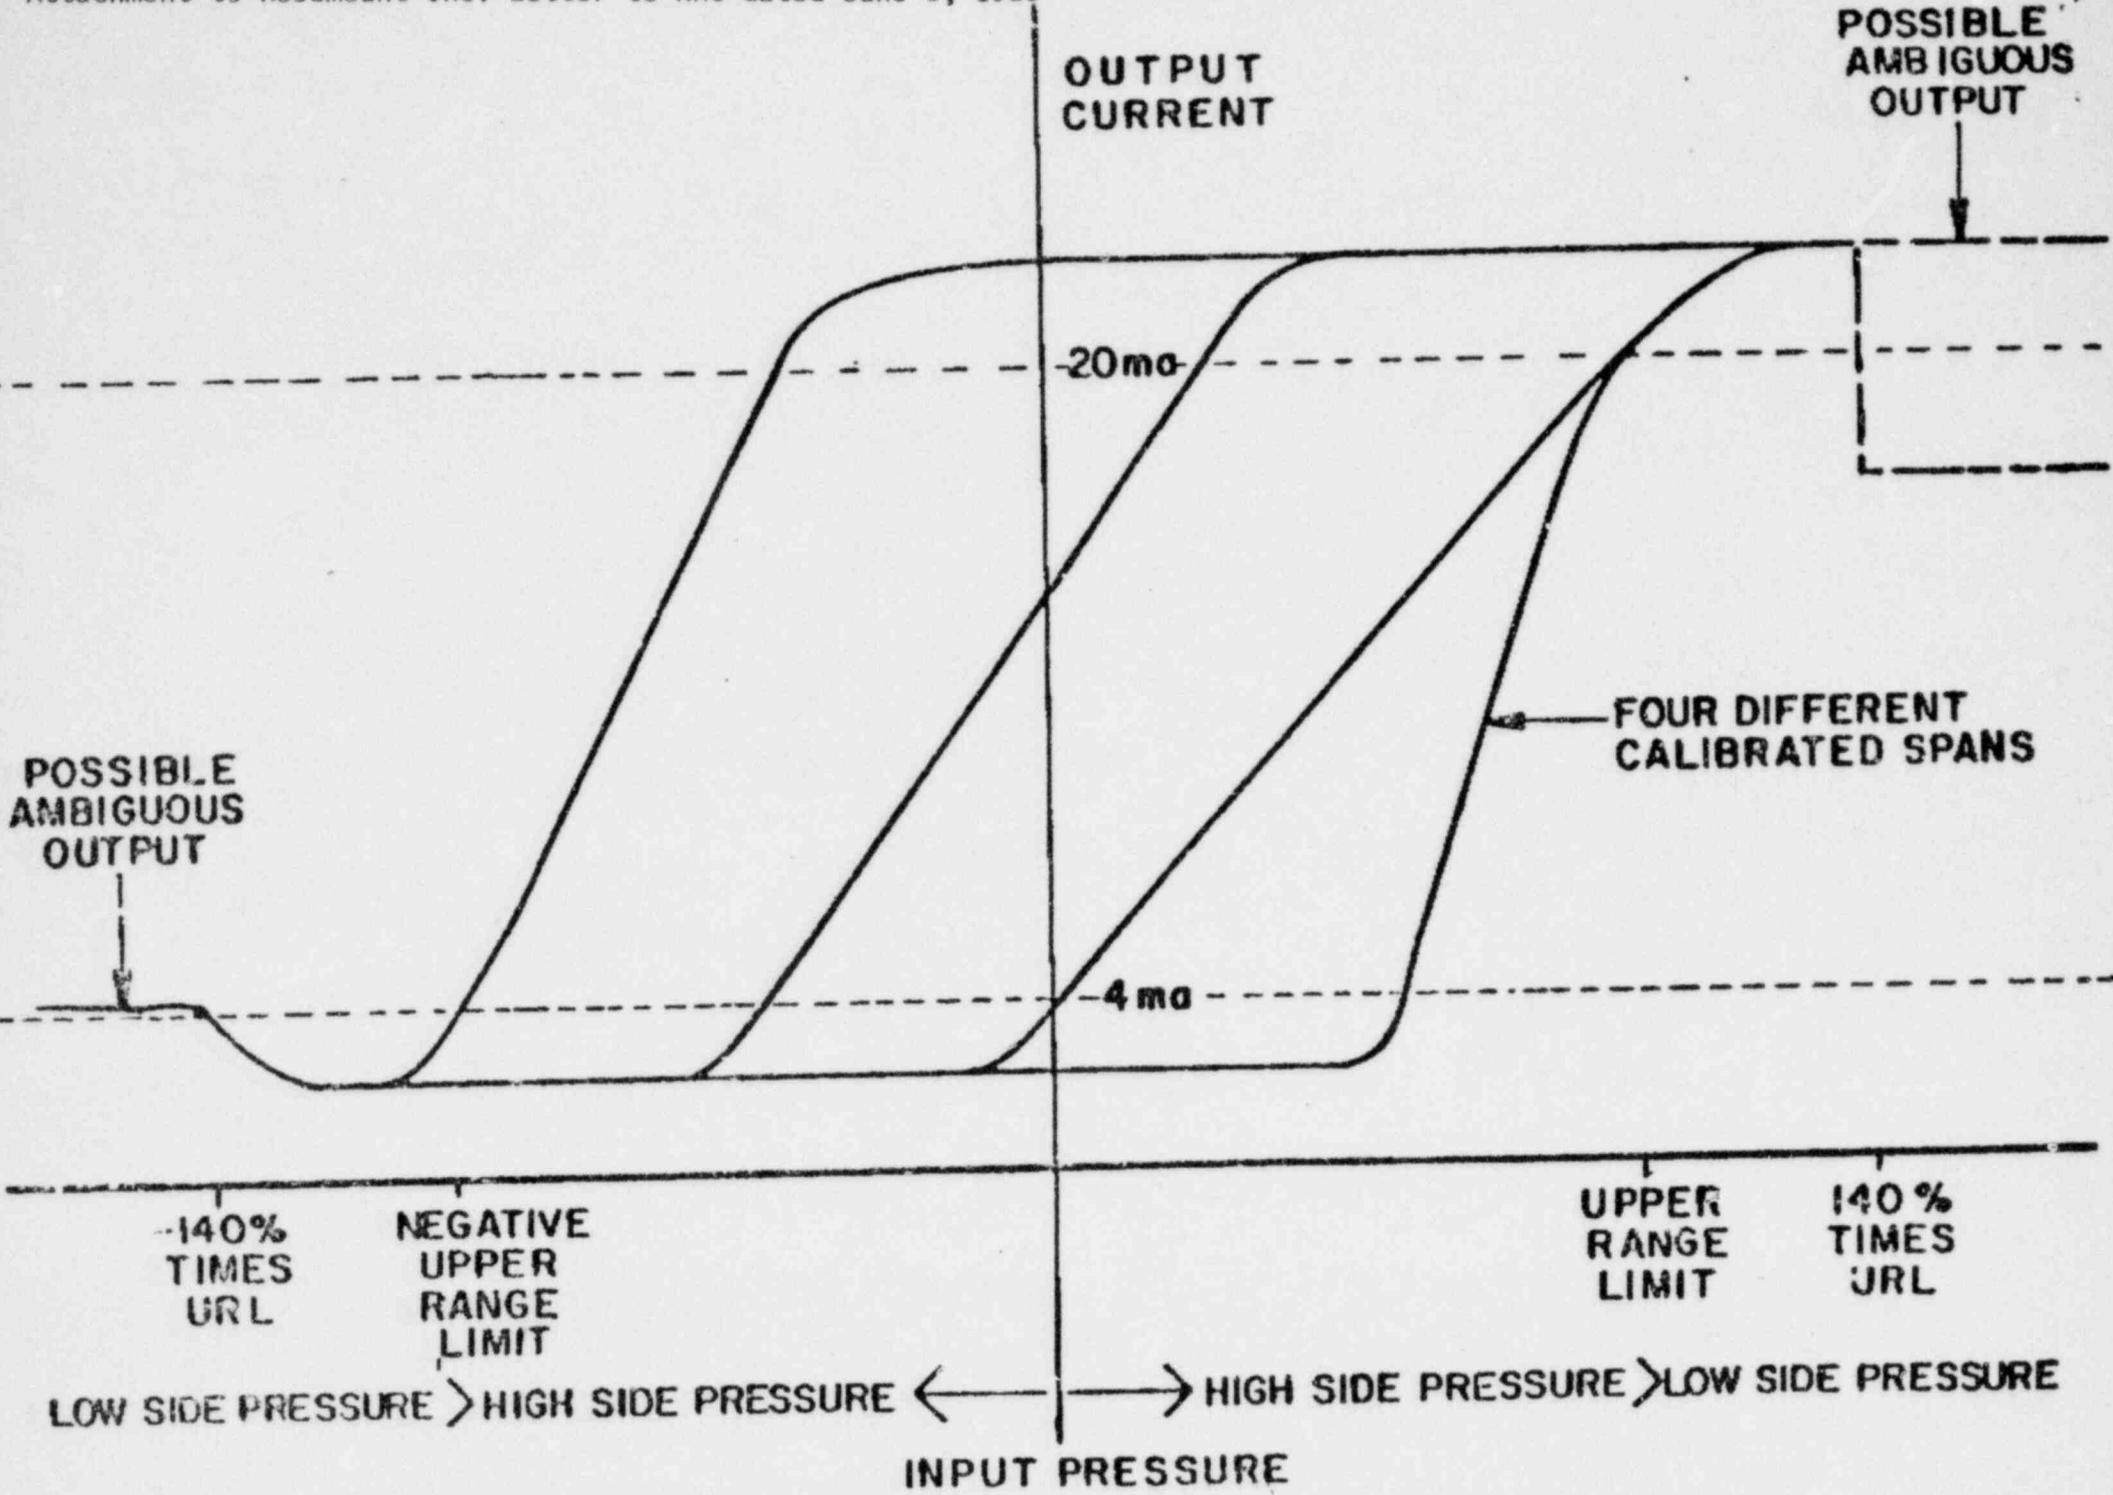
Attachment: Graph

For the over pressure condition, the effect of the high capacitance from the sensor is a modulated output on the oscillator circuit which may cause the output current of the transmitter to drop below 20 mA. In a limited sample size, the ambiguous output during this over pressure condition occurred in 5% of the transmitters at ambient conditions. Referring to the attached graph, this does not occur until the over pressure condition is $> 140\%$ of the upper range limit regardless of span. At that point a discontinuity can occur with the output current instantaneously decreasing to less than 20 mA. As an example of this potential applications problem, the upper range limit of a range 5 1152 differential pressure transmitter (Model 1152DP5A22) is $750''\text{H}_2\text{O}$. The range of this pressure transmitter can be set from 0 to $150''\text{H}_2\text{O}$. If the ambiguous output in the over pressure condition is to occur, it will occur at 140% or more of the upper range limit or, in this case, at pressures $> 1050''\text{H}_2\text{O}$ ($750''\text{H}_2\text{O} \times 1.4$). The transmitter then could give an output less than 20 mA at a pressure that is, in this example, seven

times ($1050''\text{H}_2\text{O} \div 150''\text{H}_2\text{O}$) the upper range value. Note that the significant figure for use in determining the pressure above which an ambiguous output can occur is the specified upper range limit ($750''\text{H}_2\text{O}$ in this example) not the customer selected upper range value ($150''\text{H}_2\text{O}$ in this example).

For the reverse pressure condition, the effect of the high capacitance from the sensor is the oscillator circuit drawing more current which may cause the output current of the transmitter to exceed 4 mA. In a limited sample size, the ambiguous output during this reverse pressure condition occurred in 55% of the transmitters at ambient conditions. Referring to the attached graph, this does not occur until the reverse pressure condition exceeds 140% of the upper range limit regardless of the span. At this point the output may exceed 4 mA. As an example of this potential applications problem consider the range 5 differential transmitter in the previous paragraph. If the ambiguous output in the reverse pressure condition is to occur, it will occur at 140% or more of the upper range limit, or in this case at reversed pressures $> 1050''\text{H}_2\text{O}$ ($750''\text{H}_2\text{O} \times 1.4$). The transmitter then could give an output greater than 4 mA at a pressure that is, in this example, seven times ($1050''\text{H}_2\text{O} \div 150''\text{H}_2\text{O}$) the upper range value, but reversed. Also note that with absolute pressure units a reverse pressure is not possible since the low pressure side of the cell is evacuated. With gage units a reverse pressure is possible only if a vacuum is present on the connected part since the low pressure side of the cell is vented to ambient atmosphere. Since the maximum reverse pressure would be one atmosphere, only range 3 and 4 gage units could obtain a reverse pressure exceeding 140% of the upper range limit.

The safety system should be analyzed in view of this supplementary report to determine if a potential application problem exists and appropriate corrections to the safety system should be implemented.
