IE Bulletin No. 80-16

POTENTIAL MISAPPLICATION OF ROSEMOUNT INC. MODELS 1151 AND 1152 PRESSURE TRANSMITTERS WITH EITHER "A" OR "D" OUTPUT CODES

IE Circular No. 80-16

OPERATIONAL DEFICIENCIES IN ROSEMOUNT MODEL 510DU TRIP UNITS AND MODEL 1152
PRESSURE TRANSMITTERS

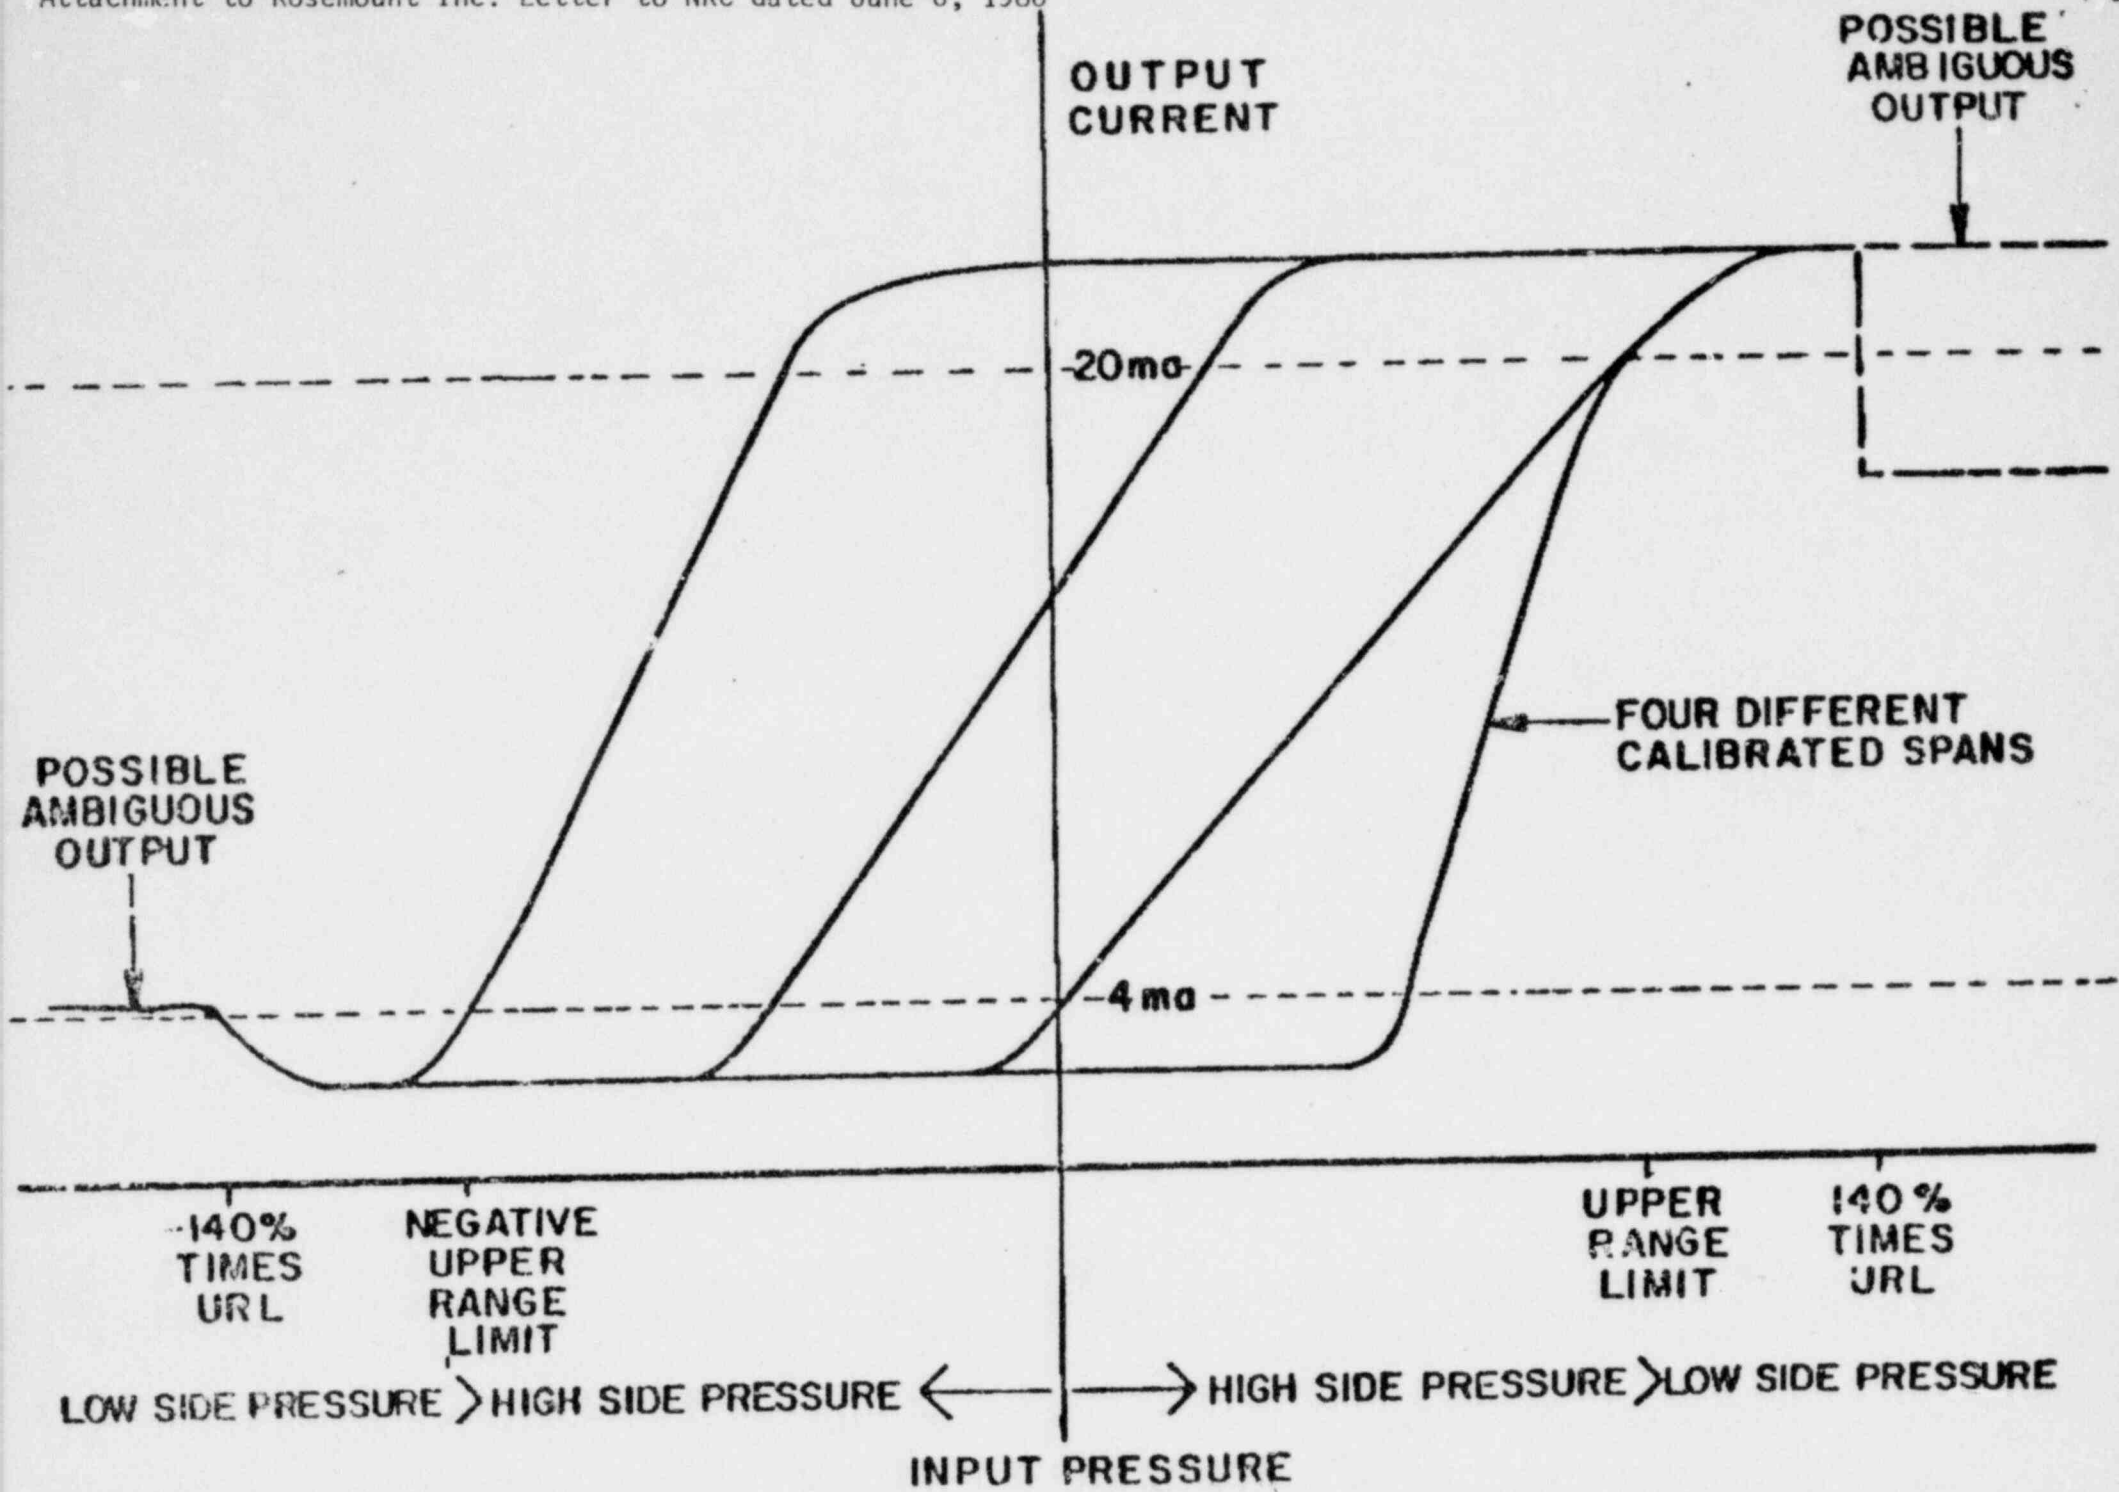
Attachment: Graph

Enclosure 1 contains Rosemount Inc.'s technical description of the potential application problems for Pressure Transmitters Model 1152. This information is applicable to Model 1151 Pressure Transmitters also. This information includes the reasons for the maloperation of the transmitters, a typical pressure versus current output curve and examples of the results of the maloperations. Available information indicates that the problem was reported to each customer who was furnished the subject transmitters by Rosemount Inc.

Rosemount's Model 1152 pressure transmitter provides a specified linear output of 4 to 20 mA throughout the calibrated range of operation. The transmitter output is not specified by Rosemount for pressures outside of the calibrated range of operation. It has been observed in a limited number of transmitters that an output between 4 and 20 mA can occur with certain input pressures outside of the calibrated range. These ambiguous outputs can occur in both an over pressure condition and a reverse pressure condition. Both conditions arise when the center diaphragm of the pressure sensor bottoms out against either of the fixed capacitor plates. In each case the normal capacitance signal becomes a very high capacitance signal which affects the operation of the electronic circuit.

For the over pressure condition, the effect of the high capacitance from the sensor is a modulated output on the oscillator circuit which may cause the output current of the transmitter to drop below 20 mA. In a limited sample size, the ambiguous output during this over pressure condition occurred in 5% of the transmitters at ambient conditions. Referring to the attached graph, this does not occur until the over pressure condition is $> 140\%$ of the upper range limit regardless of span. At that point a discontinuity can occur with the output current instantaneously decreasing to less than 20 mA. As an example of this potential applications problem, the upper range limit of a range 5 1152 differential pressure transmitter (Model 1152DP5A22) is $750''\text{H}_2\text{O}$. The range of this pressure transmitter can be set from 0 to $150''\text{H}_2\text{O}$. If the ambiguous output in the over pressure condition is to occur, it will occur at 140% or more of the upper range limit or, in this case, at pressures $> 1050''\text{H}_2\text{O}$ ($750''\text{H}_2\text{O} \times 1.4$). The transmitter then could give an output less than 20 mA at a pressure that is, in this example, seven

times ($1050''\text{H}_2\text{O} \div 150''\text{H}_2\text{O}$) the upper range value. Note that the significant figure for use in determining the pressure above which an ambiguous output can occur is the specified upper range limit ($750''\text{H}_2\text{O}$ in this example) not the customer selected upper range value ($150''\text{H}_2\text{O}$ in this example).

For the reverse pressure condition, the effect of the high capacitance from the sensor is the oscillator circuit drawing more current which may cause the output current of the transmitter to exceed 4 mA. In a limited sample size, the ambiguous output during this reverse pressure condition occurred in 55% of the transmitters at ambient conditions. Referring to the attached graph, this does not occur until the reverse pressure condition exceeds 140% of the upper range limit regardless of the span. At this point the output may exceed 4 mA. As an example of this potential applications problem consider the range 5 differential transmitter in the previous paragraph. If the ambiguous output in the reverse pressure condition is to occur, it will occur at 140% or more of the upper range limit, or in this case at reversed pressures $> 1050''\text{H}_2\text{O}$ ($750''\text{H}_2\text{O} \times 1.4$). The transmitter then could give an output greater than 4 mA at a pressure that is, in this example, seven times ($1050''\text{H}_2\text{O} \div 150''\text{H}_2\text{O}$) the upper range value, but reversed. Also note that with absolute pressure units a reverse pressure is not possible since the low pressure side of the cell is evacuated. With gage units a reverse pressure is possible only if a vacuum is present on the connected part since the low pressure side of the cell is vented to ambient atmosphere. Since the maximum reverse pressure would be one atmosphere, only range 3 and 4 gage units could obtain a reverse pressure exceeding 140% of the upper range limit.

The safety system should be analyzed in view of this supplementary report to determine if a potential application problem exists and appropriate corrections to the safety system should be implemented.
