UNITED STATES
NUCLEAR REGULATORY COMMISSION
REGION I
631 PARK AVENUE
KING OF PRUSSIA, PENNSYLVANIA 19406
June 27, 1980

IE Bulletin No. 80-16

POTENTIAL MISAPPLICATION OF ROSEMOUNT INC. MODELS 1151 AND 1152 PRESSURE TRANSMITTERS WITH EITHER "A" OR "D" OUTPUT CODES

IE Circular No. 80-16

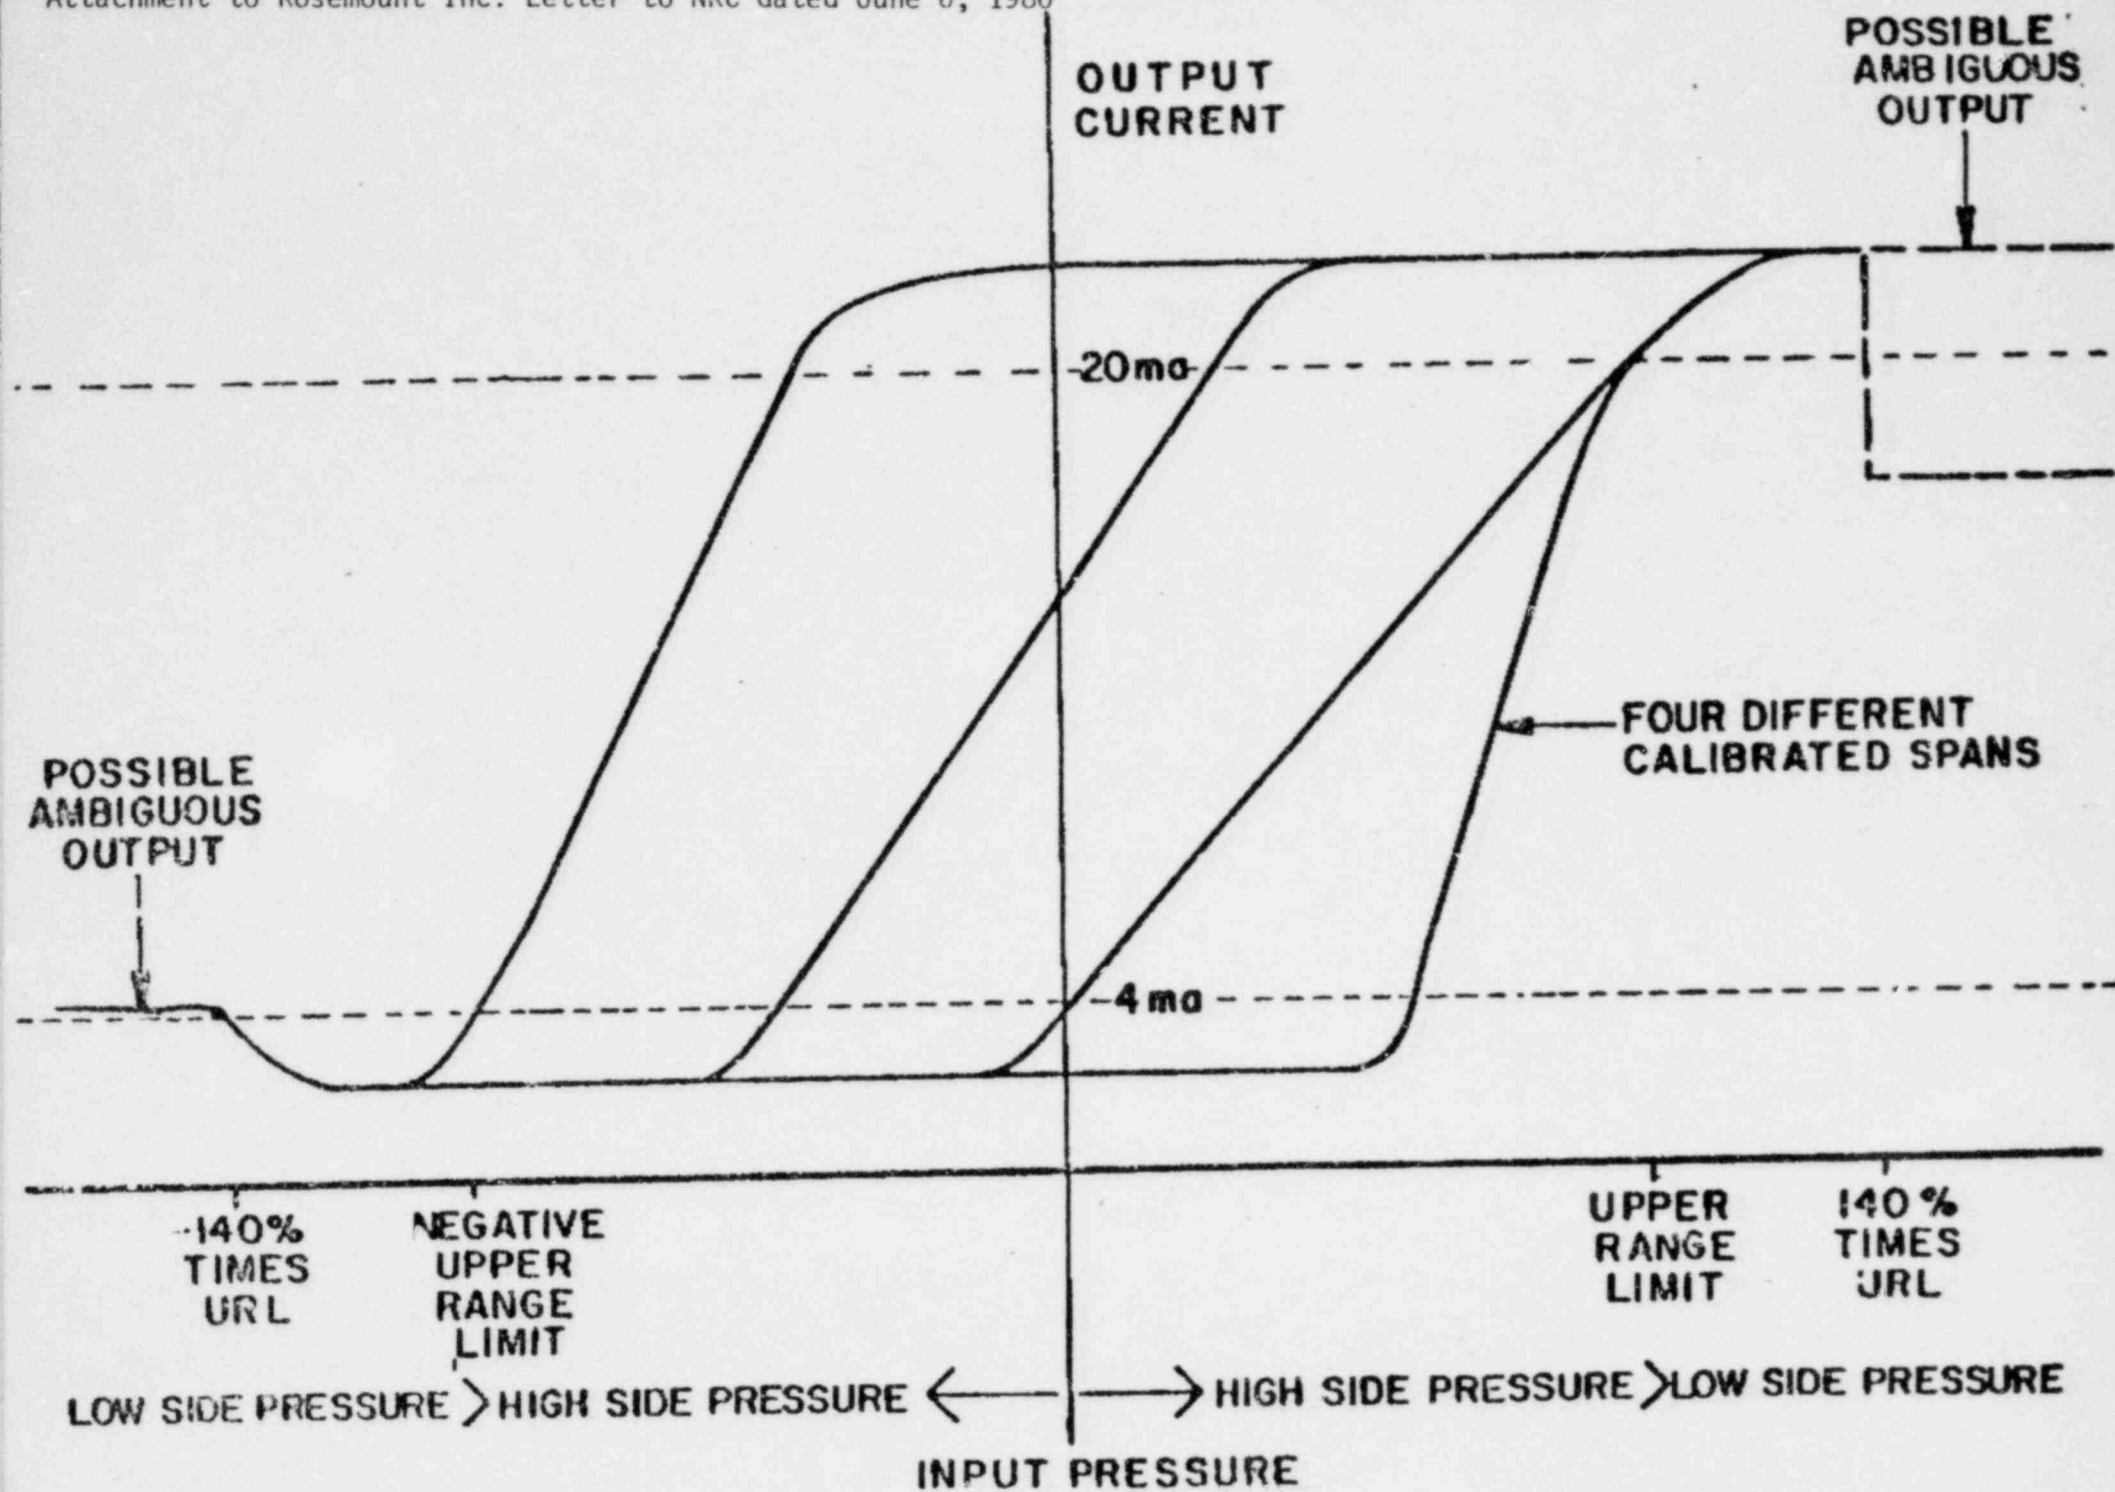
Attachment: Graph

Rosemount's Model 1152 pressure transmitter provides a specified linear output of 4 to 20 mA throughout the calibrated range of operation. The transmitter output is not specified by Rosemount for pressures outside of the calibrated range of operation. It has been observed in a limited number of transmitters that an output between 4 and 20 mA can occur with certain input pressures outside of the calibrated range. These ambiguous outputs can occur in both an over pressure condition and a reverse pressure condition. Both conditions arise when the center diaphragm of the pressure sensor bottoms out against either of the fixed capacitor plates. In each case the normal capacitance signal becomes a very high capacitance signal which affects the operation of the electronic circuit.

For the over pressure condition, the effect of the high capacitance from the sensor is a modulated output on the oscillator circuit which may cause the output current of the transmitter to drop below 20 mA. In a limited sample size, the ambiguous output during this over pressure condition occurred in 5% of the transmitters at ambient conditions. Referring to the attached graph, this does not occur until the over pressure condition is > 140% of the upper range limit regardless of span. At that point a discontinuity can occur with the output current instantaneously decreasing to less than 20 mA. As an example of this potential applications problem, the upper range limit of a range 5 1152 differential pressure transmitter (Model 1152DP5A22) is 750" H₂O. The range of this pressure transmitter can be set from 0 to 150" H₂O. If the ambiguous output in the over pressure condition is to occur, it will occur at 140% or more of the upper range limit or, in this case, at pressures > 1050" H₂O (750" H₂O x 1.4). The transmitter then could give an output less than 20 mA at a pressure that is, in this example, seven

times ($1050''\text{H}_2\text{O} \div 150''\text{H}_2\text{O}$) the upper range value. Note that the significant figure for use in determining the pressure above which an ambiguous output can occur is the specified upper range limit ($750''\text{H}_2\text{O}$ in this example) not the customer selected upper range value ($150''\text{H}_2\text{O}$ in this example).

For the reverse pressure condition, the effect of the high capacitance from the sensor is the oscillator circuit drawing more current which may cause the output current of the transmitter to exceed 4 mA. In a limited sample size, the ambiguous output during this reverse pressure condition occurred in 55% of the transmitters at ambient conditions. Referring to the attached graph, this does not occur until the reverse pressure condition exceeds 140% of the upper range limit regardless of the span. At this point the output may exceed 4 mA. As an example of this potential applications problem consider the range 5 differential transmitter in the previous paragraph. If the ambiguous output in the reverse pressure condition is to occur, it will occur at 140% or more of the upper range limit, or in this case at reversed pressures $> 1050''\text{H}_2\text{O}$ ($750''\text{H}_2\text{O} \times 1.4$). The transmitter then could give an output greater than 4 mA at a pressure that is, in this example, seven times ($1050''\text{H}_2\text{O} \div 150''\text{H}_2\text{O}$) the upper range value, but reversed. Also note that with absolute pressure units a reverse pressure is not possible since the low pressure side of the cell is evacuated. With gage units a reverse pressure is possible only if a vacuum is present on the connected part since the low pressure side of the cell is vented to ambient atmosphere. Since the maximum reverse pressure would be one atmosphere, only range 3 and 4 gage units could obtain a reverse pressure exceeding 140% of the upper range limit.

The safety system should be analyzed in view of this supplementary report to determine if a potential application problem exists and appropriate corrections to the safety system should be implemented.
