UNITED STATES  
NUCLEAR REGULATORY COMMISSION  
REGION I  
631 PARK AVENUE  
KING OF PRUSSIA, PENNSYLVANIA 19406  
June 27, 1980

Docket Nos. 50-289  
50-320

IE Bulletin No. 80-16

POTENTIAL MISAPPLICATION OF ROSEMOUNT INC. MODELS 1151 AND 1152 PRESSURE TRANSMITTERS WITH EITHER "A" OR "D" OUTPUT CODES

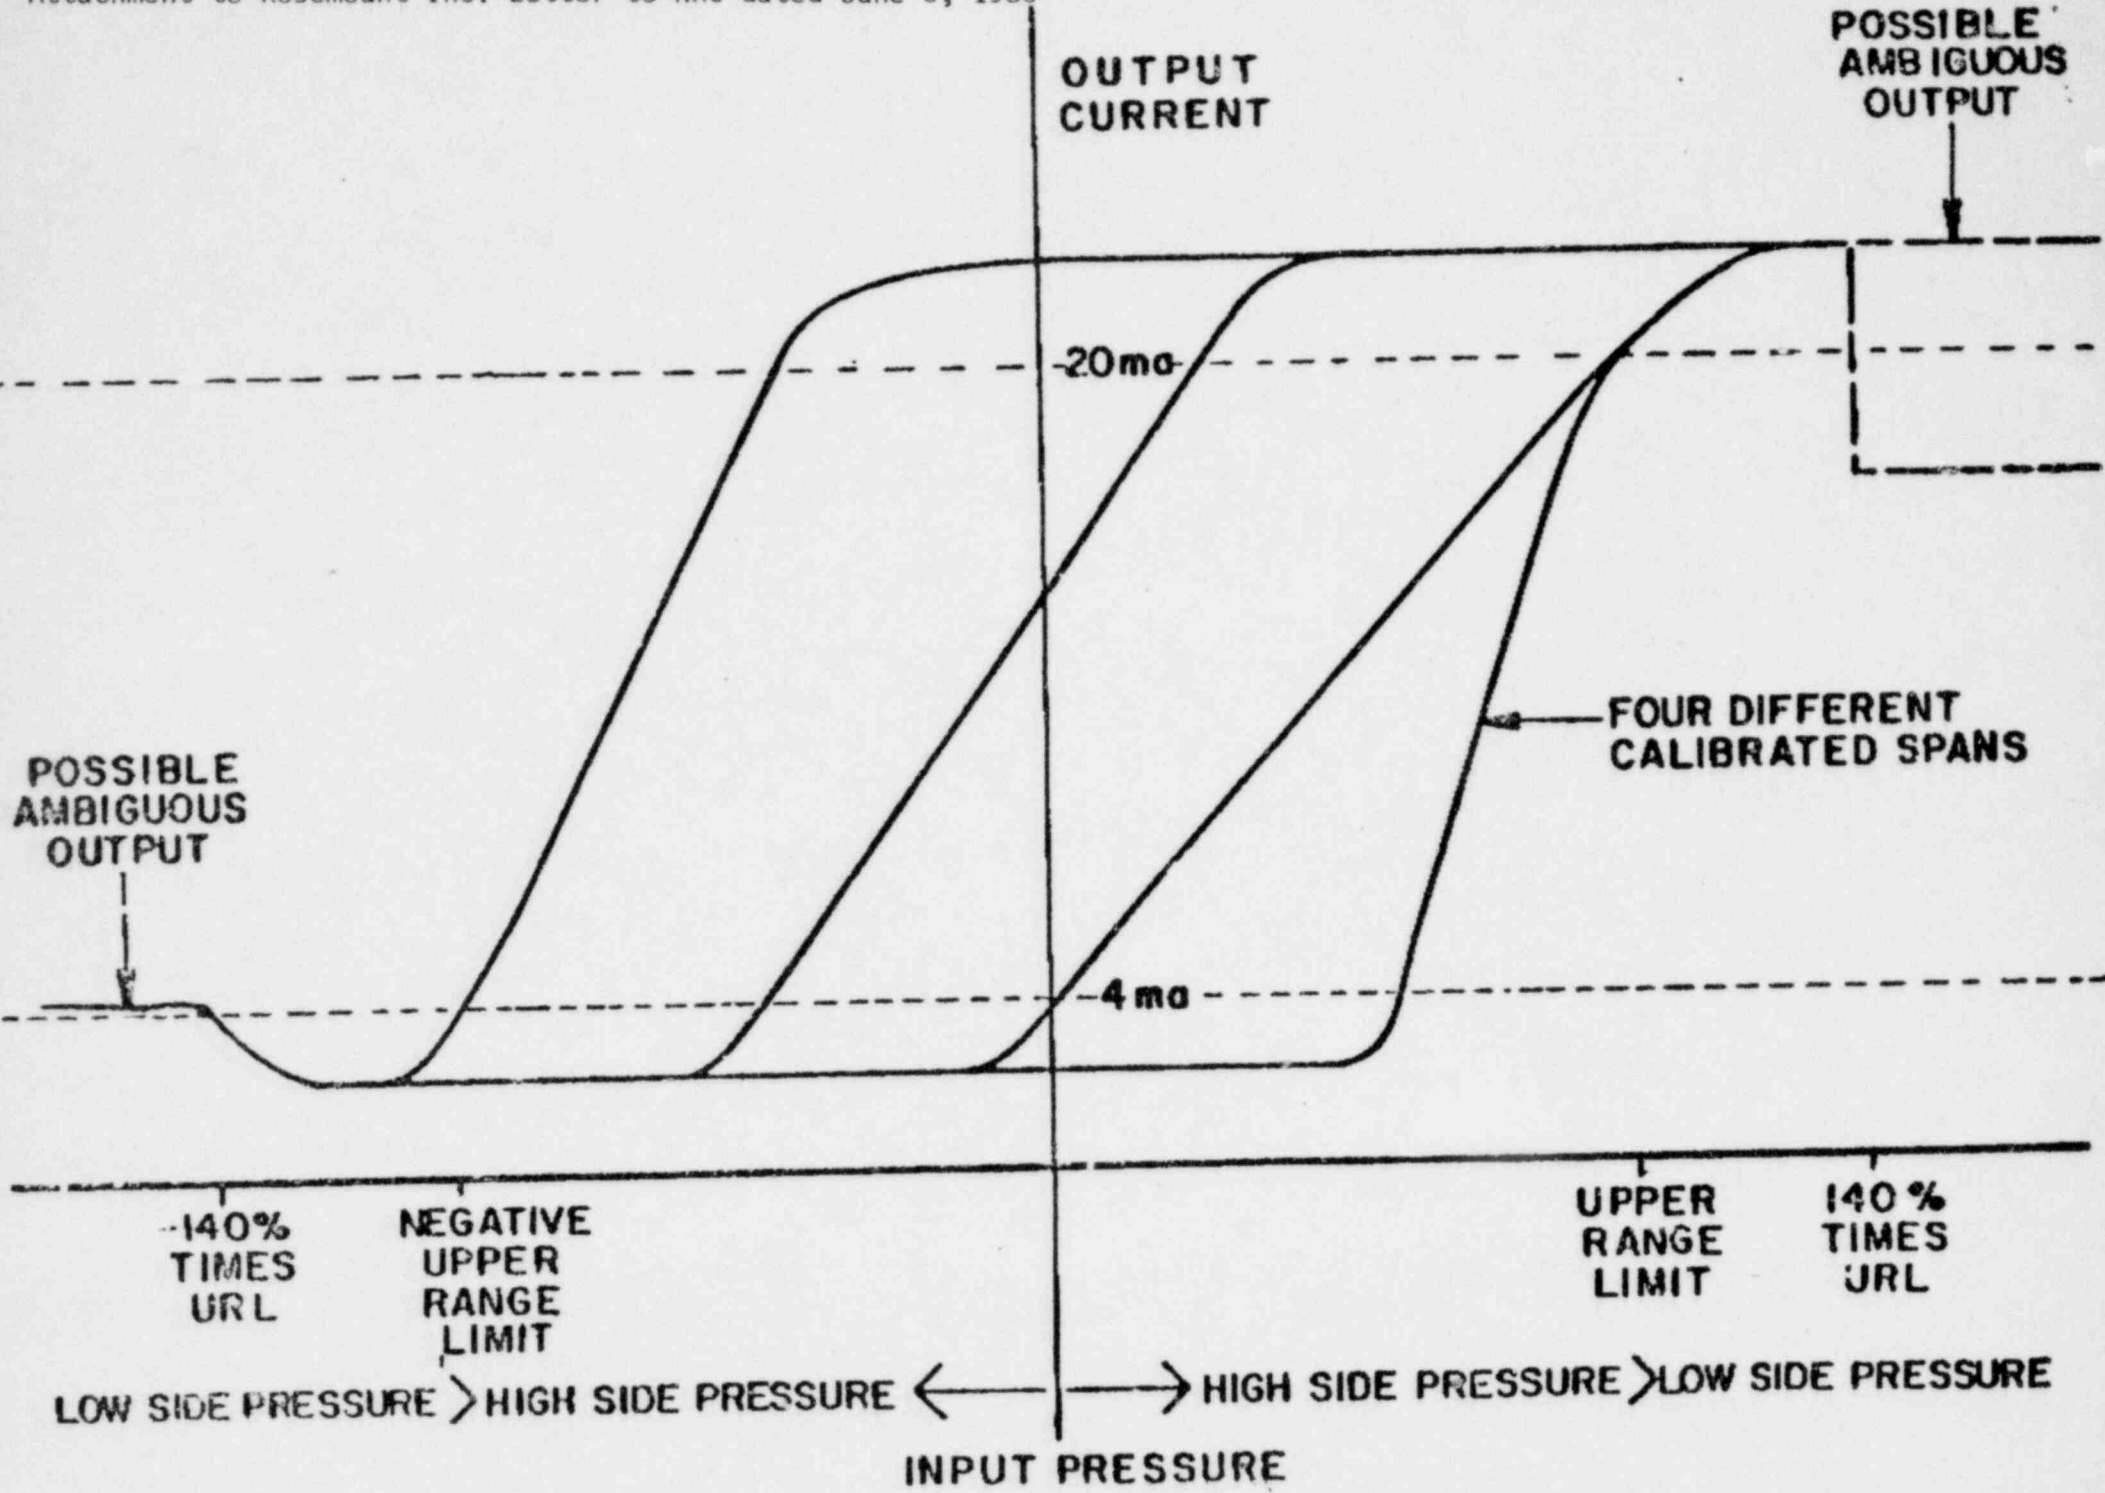
Attachment: Graph

Rosemount's Model 1152 pressure transmitter provides a specified linear output of 4 to 20 mA throughout the calibrated range of operation. The transmitter output is not specified by Rosemount for pressures outside of the calibrated range of operation. It has been observed in a limited number of transmitters that an output between 4 and 20 mA can occur with certain input pressures outside of the calibrated range. These ambiguous outputs can occur in both an over pressure condition and a reverse pressure condition. Both conditions arise when the center diaphragm of the pressure sensor bottoms out against either of the fixed capacitor plates. In each case the normal capacitance signal becomes a very high capacitance signal which affects the operation of the electronic circuit.

For the over pressure condition, the effect of the high capacitance from the sensor is a modulated output on the oscillator circuit which may cause the output current of the transmitter to drop below 20 mA. In a limited sample size, the ambiguous output during this over pressure condition occurred in 5% of the transmitters at ambient conditions. Referring to the attached graph, this does not occur until the over pressure condition is  $> 140\%$  of the upper range limit regardless of span. At that point a discontinuity can occur with the output current instantaneously decreasing to less than 20 mA. As an example of this potential applications problem, the upper range limit of a range 5 1152 differential pressure transmitter (Model 1152DP5A22) is  $750''\text{H}_2\text{O}$ . The range of this pressure transmitter can be set from 0 to  $150''\text{H}_2\text{O}$ . If the ambiguous output in the over pressure condition is to occur, it will occur at  $140\%$  or more of the upper range limit or, in this case, at pressures  $> 1050''\text{H}_2\text{O}$  ( $750''\text{H}_2\text{O} \times 1.4$ ). The transmitter then could give an output less than 20 mA at a pressure that is, in this example, seven

times ( $1050''\text{H}_2\text{O} \div 150''\text{H}_2\text{O}$ ) the upper range value. Note that the significant figure for use in determining the pressure above which an ambiguous output can occur is the specified upper range limit ( $750''\text{H}_2\text{O}$  in this example) not the customer selected upper range value ( $150''\text{H}_2\text{O}$  in this example).

For the reverse pressure condition, the effect of the high capacitance from the sensor is the oscillator circuit drawing more current which may cause the output current of the transmitter to exceed 4 mA. In a limited sample size, the ambiguous output during this reverse pressure condition occurred in 55% of the transmitters at ambient conditions. Referring to the attached graph, this does not occur until the reverse pressure condition exceeds 140% of the upper range limit regardless of the span. At this point the output may exceed 4 mA. As an example of this potential applications problem consider the range 5 differential transmitter in the previous paragraph. If the ambiguous output in the reverse pressure condition is to occur, it will occur at 140% or more of the upper range limit, or in this case at reversed pressures  $> 1050''\text{H}_2\text{O}$  ( $750''\text{H}_2\text{O} \times 1.4$ ). The transmitter then could give an output greater than 4 mA at a pressure that is, in this example, seven times ( $1050''\text{H}_2\text{O} \div 150''\text{H}_2\text{O}$ ) the upper range value, but reversed. Also note that with absolute pressure units a reverse pressure is not possible since the low pressure side of the cell is evacuated. With gage units a reverse pressure is possible only if a vacuum is present on the connected part since the low pressure side of the cell is vented to ambient atmosphere. Since the maximum reverse pressure would be one atmosphere, only range 3 and 4 gage units could obtain a reverse pressure exceeding 140% of the upper range limit.

The safety system should be analyzed in view of this supplementary report to determine if a potential application problem exists and appropriate corrections to the safety system should be implemented.
