IE Bulletin No. 80-16

POTENTIAL MISAPPLICATION OF ROSEMOUNT INC. MODELS 1151 AND 1152 PRESSURE TRANSMITTERS WITH EITHER "A" OR "D" OUTPUT CODES

IE Circular No. 80-16

OPERATIONAL DEFICIENCIES IN ROSEMOUNT MODEL 510DU TRIP UNITS AND MODEL 1152
PRESSURE TRANSMITTERS

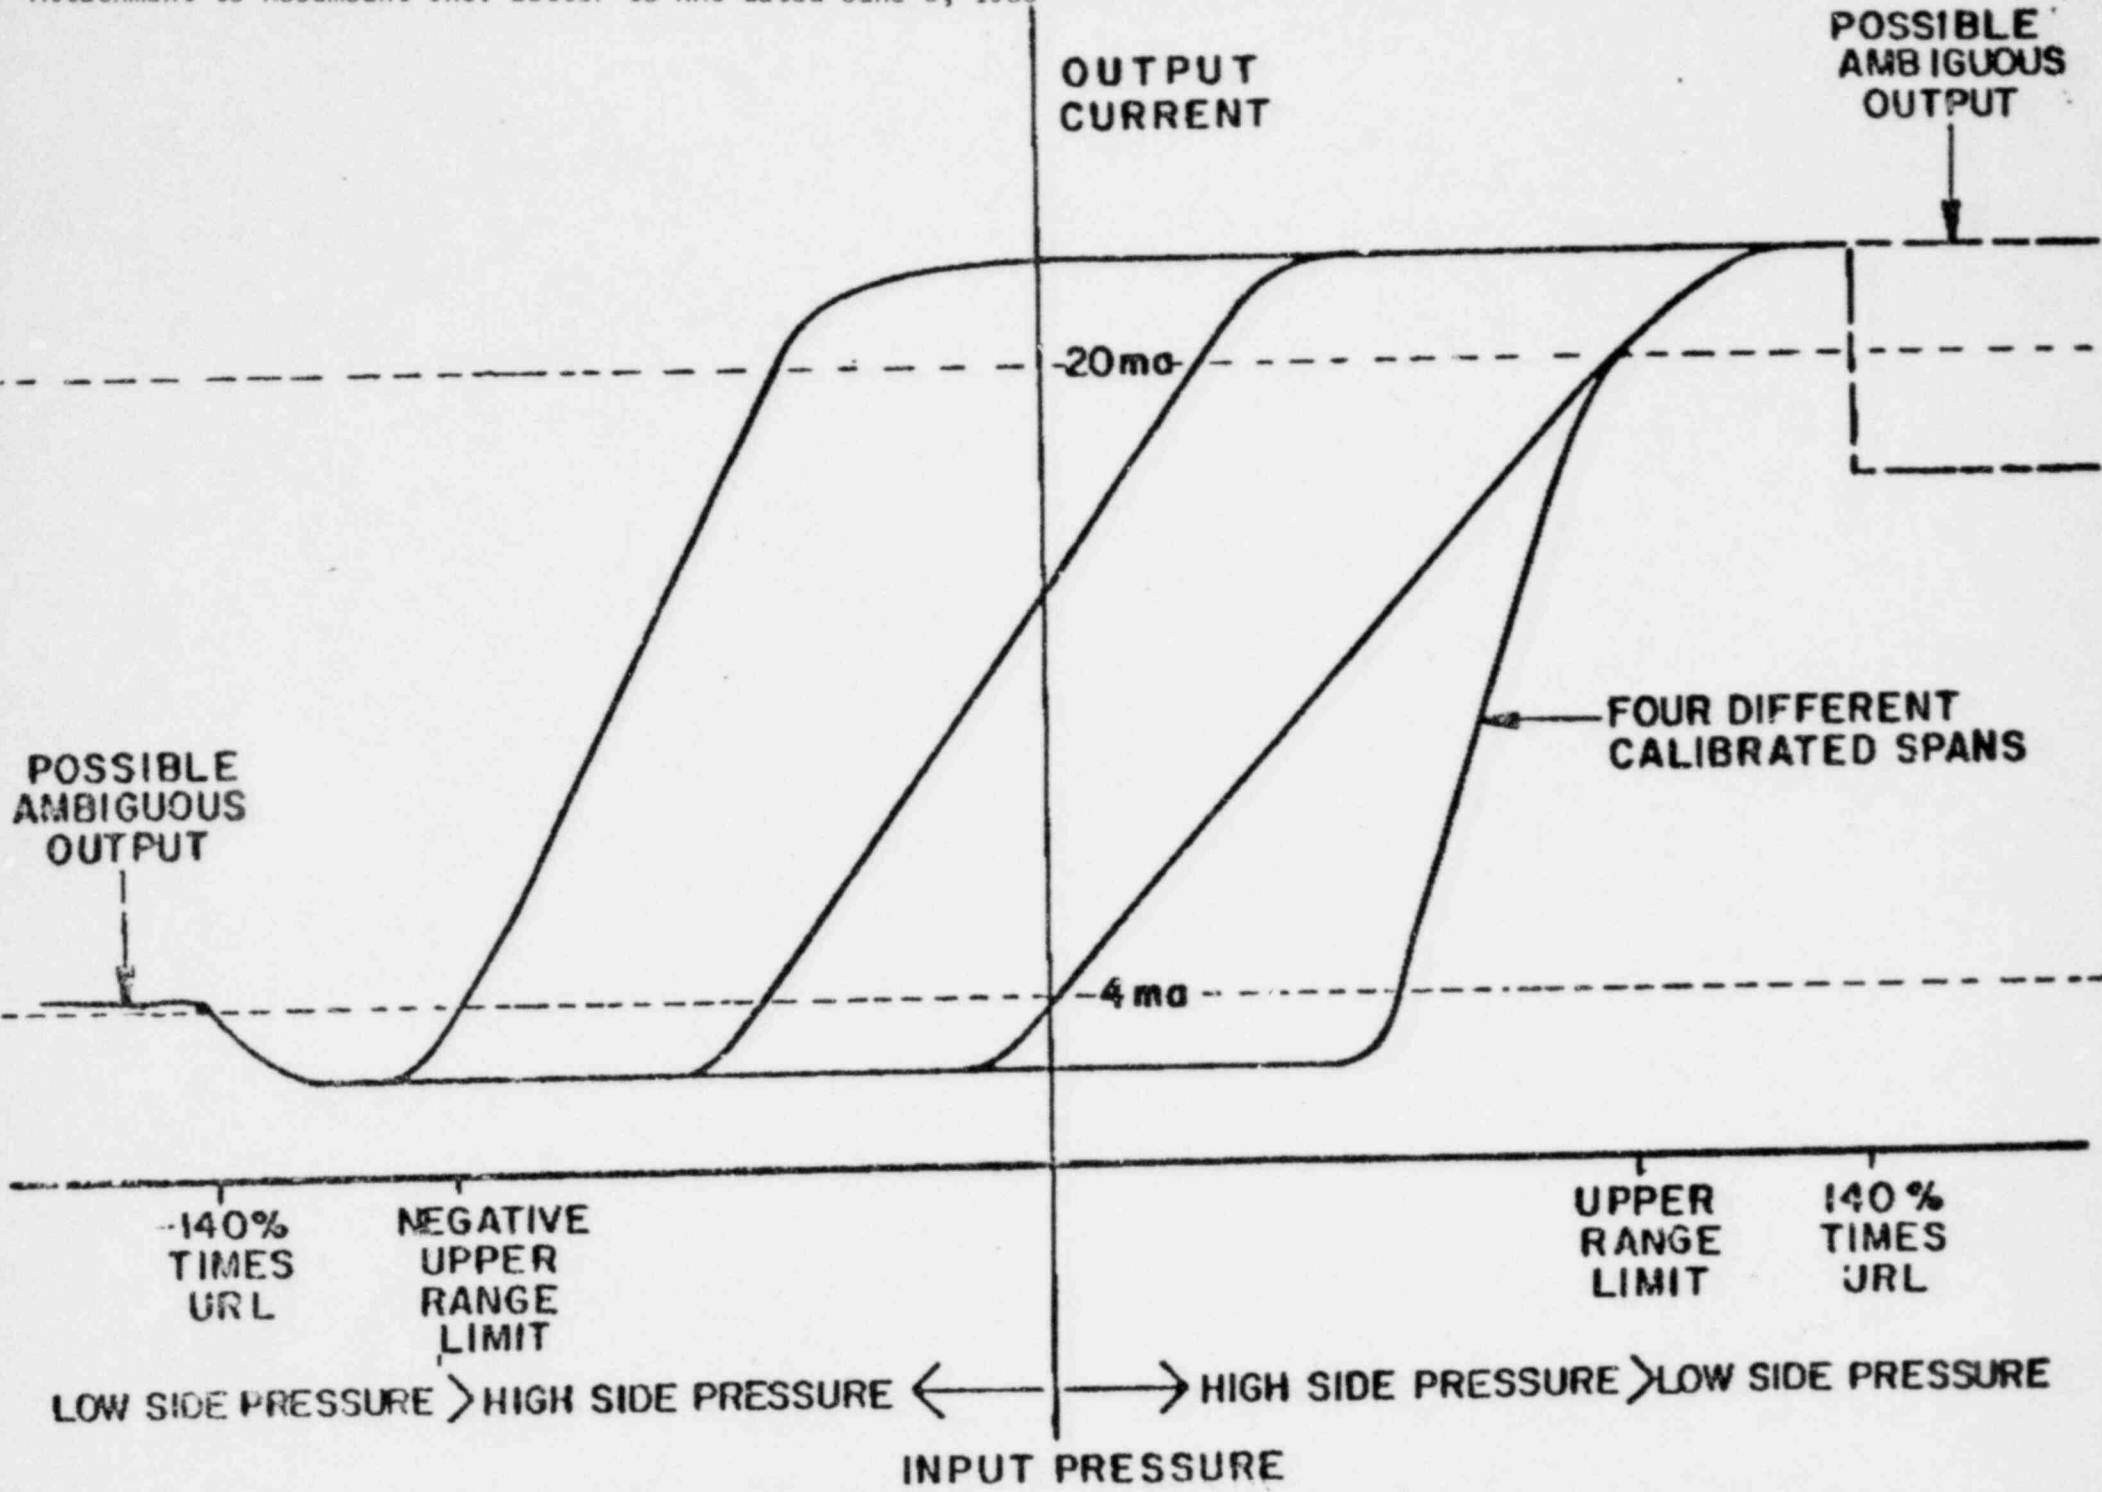
Attachment: Graph

For the over pressure condition, the effect of the high capacitance from the sensor is a modulated output on the oscillator circuit which may cause the output current of the transmitter to drop below 20 mA. In a limited sample size, the ambiguous output during this over pressure condition occurred in 5% of the transmitters at ambient conditions. Referring to the attached graph, this does not occur until the over pressure condition is > 140% of the upper range limit regardless of span. At that point a discontinuity can occur with the output current instantaneously decreasing to less than 20 mA. As an example of this potential applications problem, the upper range limit of a range 5 1152 differential pressure transmitter (Model 1152DP5A22) is 750" H₂O. The range of this pressure transmitter can be set from 0 to 150" H₂O. If the ambiguous output in the over pressure condition is to occur, it will occur at 140% or more of the upper range limit or, in this case, at pressures > 1050" H₂O (750" H₂O x 1.4). The transmitter then could give an output less than 20 mA at a pressure that is, in this example, seven

times ($1050''\text{H}_2\text{O} \div 150''\text{H}_2\text{O}$) the upper range value. Note that the significant figure for use in determining the pressure above which an ambiguous output can occur is the specified upper range limit ($750''\text{H}_2\text{O}$ in this example) not the customer selected upper range value ($150''\text{H}_2\text{O}$ in this example).

For the reverse pressure condition, the effect of the high capacitance from the sensor is the oscillator circuit drawing more current which may cause the output current of the transmitter to exceed 4 mA. In a limited sample size, the ambiguous output during this reverse pressure condition occurred in 55% of the transmitters at ambient conditions. Referring to the attached graph, this does not occur until the reverse pressure condition exceeds 140% of the upper range limit regardless of the span. At this point the output may exceed 4 mA. As an example of this potential applications problem consider the range 5 differential transmitter in the previous paragraph. If the ambiguous output in the reverse pressure condition is to occur, it will occur at 140% or more of the upper range limit, or in this case at reversed pressures $> 1050''\text{H}_2\text{O}$ ($750''\text{H}_2\text{O} \times 1.4$). The transmitter then could give an output greater than 4 mA at a pressure that is, in this example, seven times ($1050''\text{H}_2\text{O} \div 150''\text{H}_2\text{O}$) the upper range value, but reversed. Also note that with absolute pressure units a reverse pressure is not possible since the low pressure side of the cell is evacuated. With gage units a reverse pressure is possible only if a vacuum is present on the connected part since the low pressure side of the cell is vented to ambient atmosphere. Since the maximum reverse pressure would be one atmosphere, only range 3 and 4 gage units could obtain a reverse pressure exceeding 140% of the upper range limit.

The safety system should be analyzed in view of this supplementary report to determine if a potential application problem exists and appropriate corrections to the safety system should be implemented.
