IE Bulletin No. 80-16

POTENTIAL MISAPPLICATION OF ROSEMOUNT INC. MODELS 1151 AND 1152 PRESSURE TRANSMITTERS WITH EITHER "A" OR "D" OUTPUT CODES

IE Circular No. 80-16

OPERATIONAL DEFICIENCIES IN ROSEMOUNT MODEL 510DU TRIP UNITS AND MODEL 1152
PRESSURE TRANSMITTERS

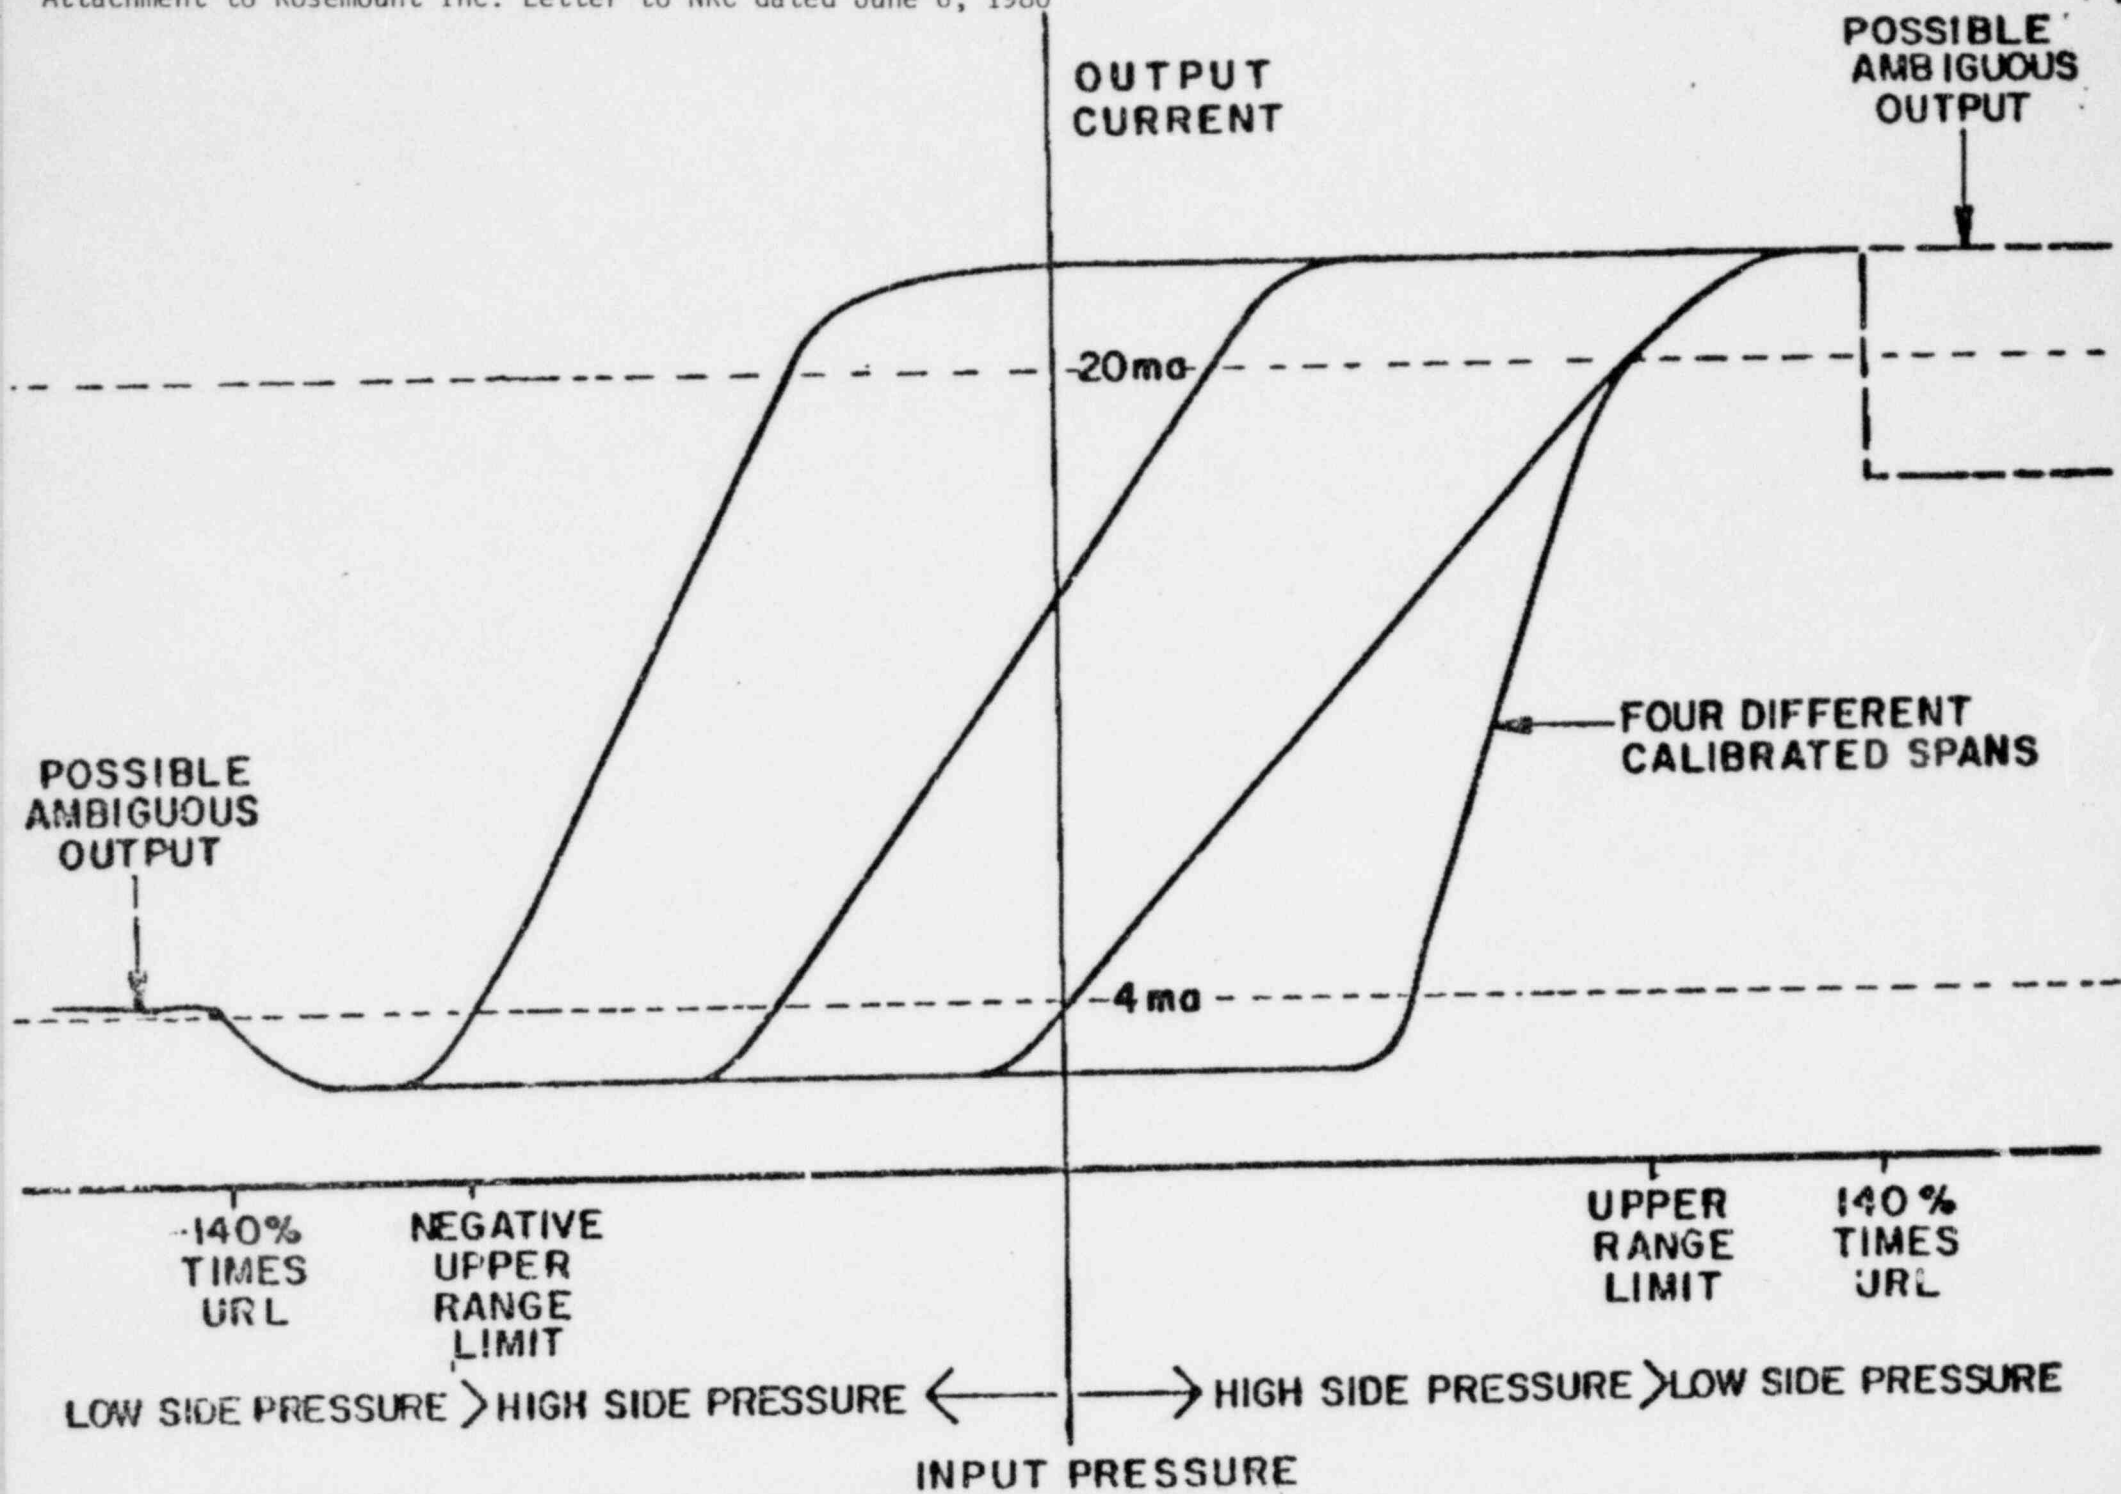
Attachment: Graph

Rosemount's Model 1152 pressure transmitter provides a specified linear output of 4 to 20 mA throughout the calibrated range of operation. The transmitter output is not specified by Rosemount for pressures outside of the calibrated range of operation. It has been observed in a limited number of transmitters that an output between 4 and 20 mA can occur with certain input pressures outside of the calibrated range. These ambiguous outputs can occur in both an over pressure condition and a reverse pressure condition. Both conditions arise when the center diaphragm of the pressure sensor bottoms out against either of the fixed capacitor plates. In each case the normal capacitance signal becomes a very high capacitance signal which affects the operation of the electronic circuit.

For the over pressure condition, the effect of the high capacitance from the sensor is a modulated output on the oscillator circuit which may cause the output current of the transmitter to drop below 20 mA. In a limited sample size, the ambiguous output during this over pressure condition occurred in 5% of the transmitters at ambient conditions. Referring to the attached graph, this does not occur until the over pressure condition is > 140% of the upper range limit regardless of span. At that point a discontinuity can occur with the output current instantaneously decreasing to less than 20 mA. As an example of this potential applications problem, the upper range limit of a range 5 1152 differential pressure transmitter (Model 1152DP5A22) is 750" H₂O. The range of this pressure transmitter can be set from 0 to 150" H₂O. If the ambiguous output in the over pressure condition is to occur, it will occur at 140% or more of the upper range limit or, in this case, at pressures > 1050" H₂O (750" H₂O x 1.4). The transmitter then could give an output less than 20 mA at a pressure that is, in this example, seven

times ($1050''\text{H}_2\text{O} \div 150''\text{H}_2\text{O}$) the upper range value. Note that the significant figure for use in determining the pressure above which an ambiguous output can occur is the specified upper range limit ($750''\text{H}_2\text{O}$ in this example) not the customer selected upper range value ($150''\text{H}_2\text{O}$ in this example).

For the reverse pressure condition, the effect of the high capacitance from the sensor is the oscillator circuit drawing more current which may cause the output current of the transmitter to exceed 4 mA. In a limited sample size, the ambiguous output during this reverse pressure condition occurred in 55% of the transmitters at ambient conditions. Referring to the attached graph, this does not occur until the reverse pressure condition exceeds 140% of the upper range limit regardless of the span. At this point the output may exceed 4 mA. As an example of this potential applications problem consider the range 5 differential transmitter in the previous paragraph. If the ambiguous output in the reverse pressure condition is to occur, it will occur at 140% or more of the upper range limit, or in this case at reversed pressures $> 1050''\text{H}_2\text{O}$ ($750''\text{H}_2\text{O} \times 1.4$). The transmitter then could give an output greater than 4 mA at a pressure that is, in this example, seven times ($1050''\text{H}_2\text{O} \div 150''\text{H}_2\text{O}$) the upper range value, but reversed. Also note that with absolute pressure units a reverse pressure is not possible since the low pressure side of the cell is evacuated. With gage units a reverse pressure is possible only if a vacuum is present on the connected part since the low pressure side of the cell is vented to ambient atmosphere. Since the maximum reverse pressure would be one atmosphere, only range 3 and 4 gage units could obtain a reverse pressure exceeding 140% of the upper range limit.

The safety system should be analyzed in view of this supplementary report to determine if a potential application problem exists and appropriate corrections to the safety system should be implemented.
