June 27, 1980

Docket No. 50-29

IE Bulletin No. 80-16

POTENTIAL MISAPPLICATION OF ROSEMOUNT INC. MODELS 1151 AND 1152 PRESSURE TRANSMITTERS WITH EITHER "A" OR "D" OUTPUT CODES

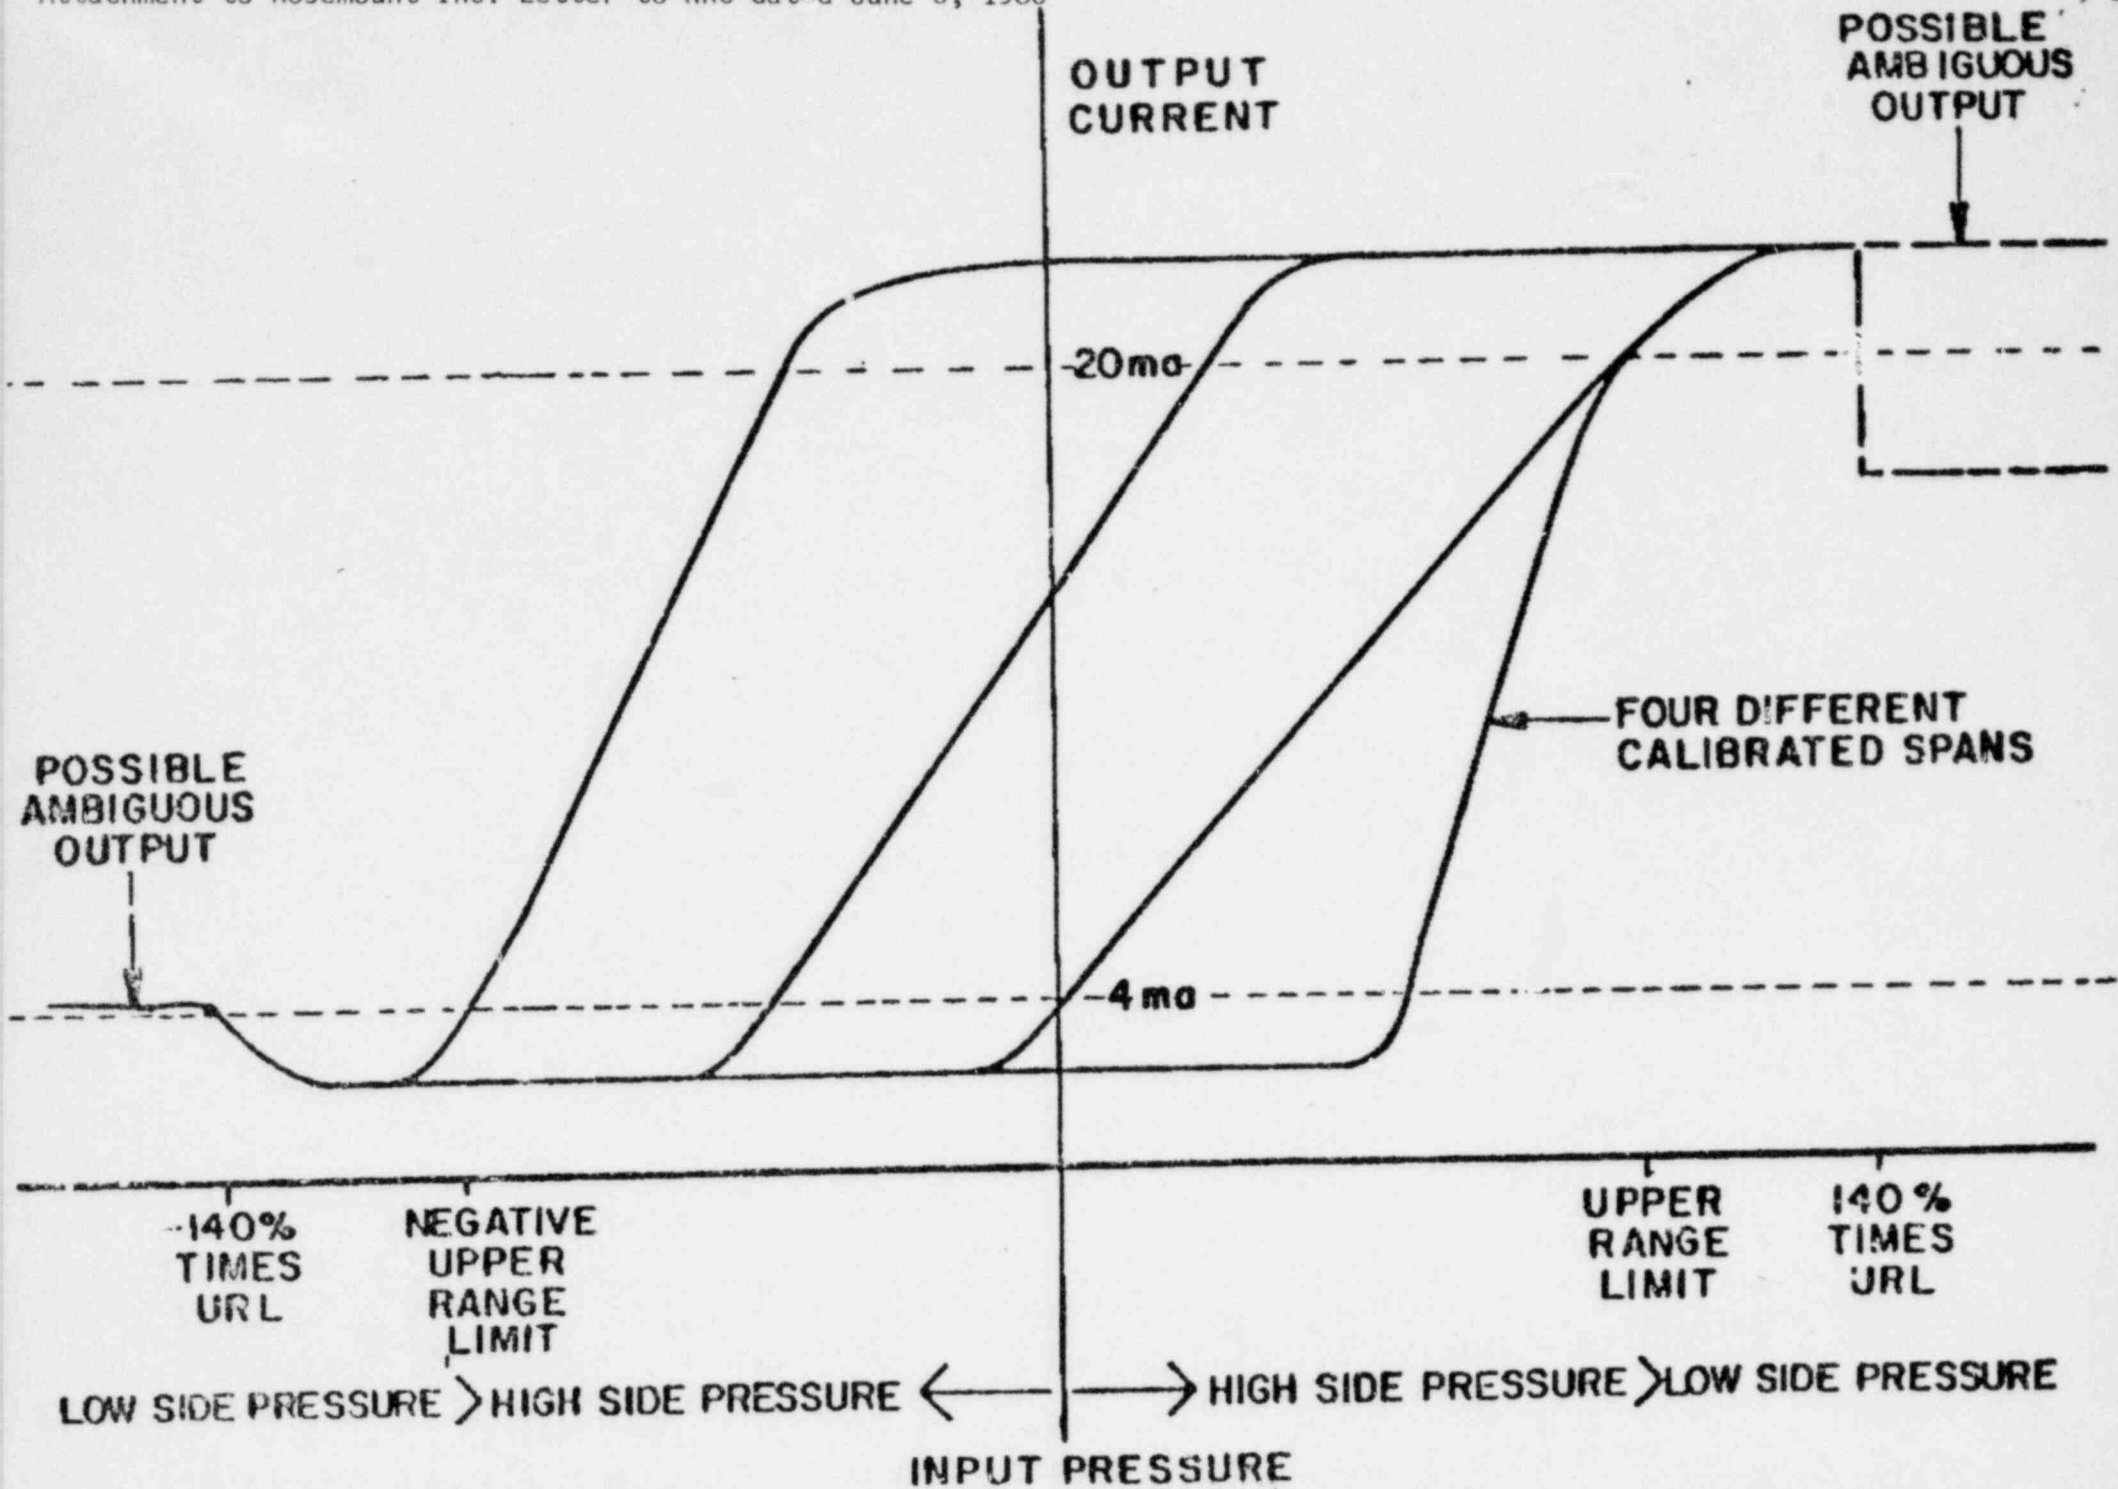
Attachment: Graph

Enclosure 1 contains Rosemount Inc.'s technical description of the potential application problems for Pressure Transmitters Model 1152. This information is applicable to Model 1151 Pressure Transmitters also. This information includes the reasons for the maloperation of the transmitters, a typical pressure versus current output curve and examples of the results of the maloperations. Available information indicates that the problem was reported to each customer who was furnished the subject transmitters by Rosemount Inc.

For the over pressure condition, the effect of the high capacitance from the sensor is a modulated output on the oscillator circuit which may cause the output current of the transmitter to drop below 20 mA. In a limited sample size, the ambiguous output during this over pressure condition occurred in 5% of the transmitters at ambient conditions. Referring to the attached graph, this does not occur until the over pressure condition is  $> 140\%$  of the upper range limit regardless of span. At that point a discontinuity can occur with the output current instantaneously decreasing to less than 20 mA. As an example of this potential applications problem, the upper range limit of a range 5 1152 differential pressure transmitter (Model 1152DP5A22) is  $750''\text{H}_2\text{O}$ . The range of this pressure transmitter can be set from 0 to  $150''\text{H}_2\text{O}$ . If the ambiguous output in the over pressure condition is to occur, it will occur at  $140\%$  or more of the upper range limit or, in this case, at pressures  $> 1050''\text{H}_2\text{O}$  ( $750''\text{H}_2\text{O} \times 1.4$ ). The transmitter then could give an output less than 20 mA at a pressure that is, in this example, seven

times ( $1050''\text{H}_2\text{O} \div 150''\text{H}_2\text{O}$ ) the upper range value. Note that the significant figure for use in determining the pressure above which an ambiguous output can occur is the specified upper range limit ( $750''\text{H}_2\text{O}$  in this example) not the customer selected upper range value ( $150''\text{H}_2\text{O}$  in this example).

For the reverse pressure condition, the effect of the high capacitance from the sensor is the oscillator circuit drawing more current which may cause the output current of the transmitter to exceed 4 mA. In a limited sample size, the ambiguous output during this reverse pressure condition occurred in 55% of the transmitters at ambient conditions. Referring to the attached graph, this does not occur until the reverse pressure condition exceeds 140% of the upper range limit regardless of the span. At this point the output may exceed 4 mA. As an example of this potential applications problem consider the range 5 differential transmitter in the previous paragraph. If the ambiguous output in the reverse pressure condition is to occur, it will occur at 140% or more of the upper range limit, or in this case at reversed pressures  $> 1050''\text{H}_2\text{O}$  ( $750''\text{H}_2\text{O} \times 1.4$ ). The transmitter then could give an output greater than 4 mA at a pressure that is, in this example, seven times ( $1050''\text{H}_2\text{O} \div 150''\text{H}_2\text{O}$ ) the upper range value, but reversed. Also note that with absolute pressure units a reverse pressure is not possible since the low pressure side of the cell is evacuated. With gage units a reverse pressure is possible only if a vacuum is present on the connected part since the low pressure side of the cell is vented to ambient atmosphere. Since the maximum reverse pressure would be one atmosphere, only range 3 and 4 gage units could obtain a reverse pressure exceeding 140% of the upper range limit.

The safety system should be analyzed in view of this supplementary report to determine if a potential application problem exists and appropriate corrections to the safety system should be implemented.
