IE Bulletin No. 80-16

POTENTIAL MISAPPLICATION OF ROSEMOUNT INC. MODELS 1151 AND 1152 PRESSURE TRANSMITTERS WITH EITHER "A" OR "D" OUTPUT CODES

IE Circular No. 80-16

OPERATIONAL DEFICIENCIES IN ROSEMOUNT MODEL 510DU TRIP UNITS AND MODEL 1152  
PRESSURE TRANSMITTERS

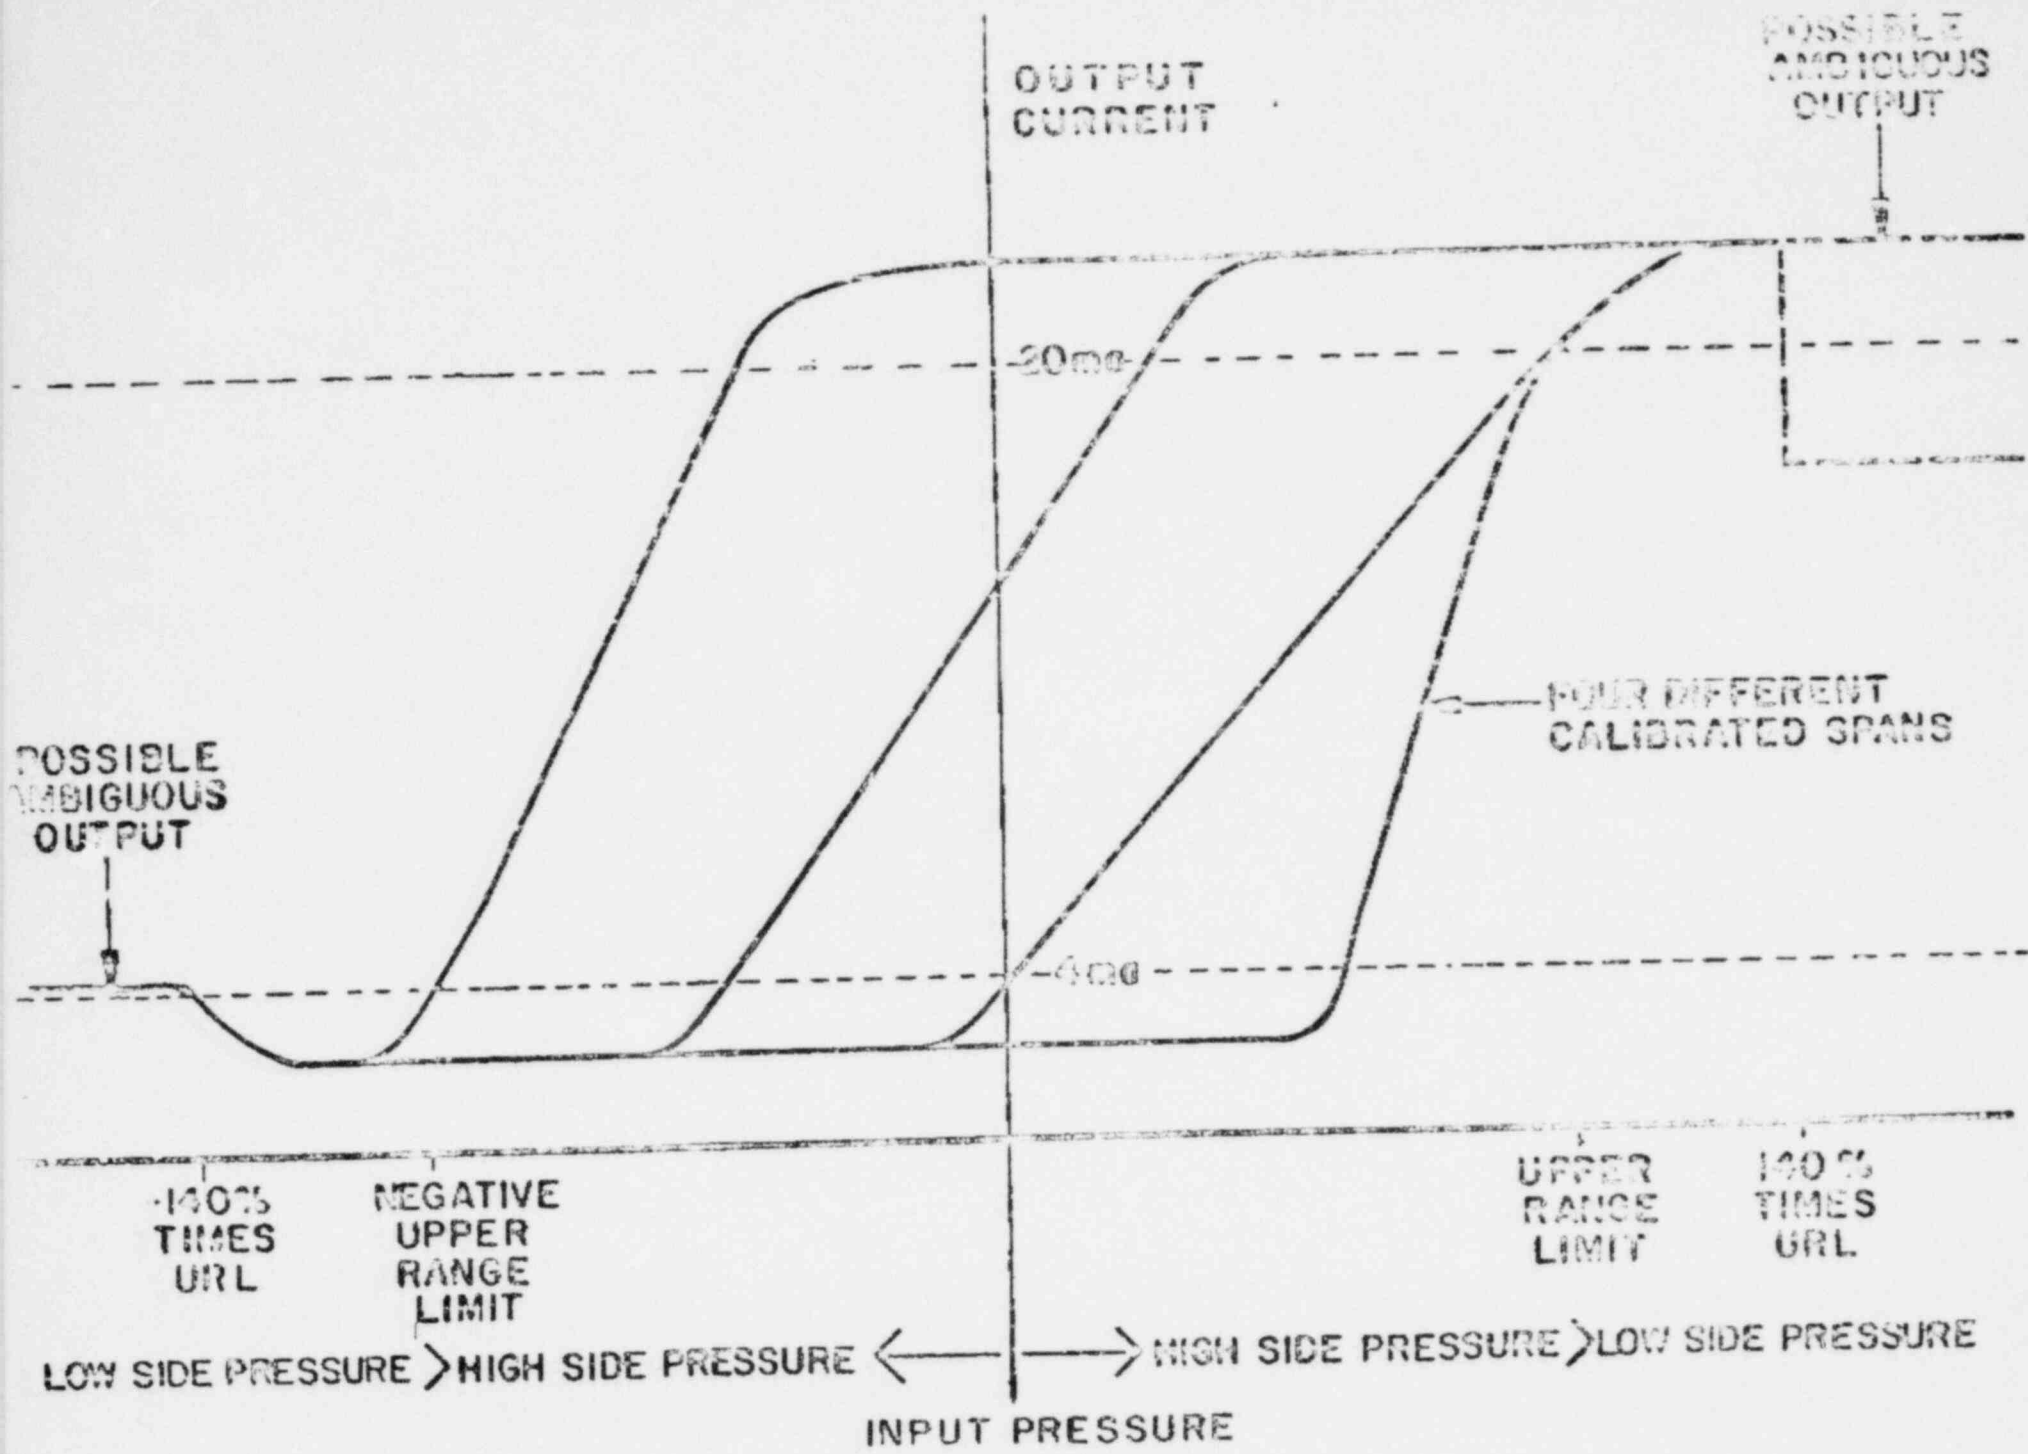
Rosemount's Model 1152 pressure transmitter provides a specified linear output of 4 to 20 mA throughout the calibrated range of operation. The transmitter output is not specified by Rosemount for pressures outside of the calibrated range of operation. It has been observed in a limited number of transmitters that an output between 4 and 20 mA can occur with certain input pressures outside of the calibrated range. These ambiguous outputs can occur in both an over pressure condition and a reverse pressure condition. Both conditions arise when the center diaphragm of the pressure sensor bottoms out against either of the fixed capacitor plates. In each case the normal capacitance signal becomes a very high capacitance signal which affects the operation of the electronic circuit.

For the over pressure condition, the effect of the high capacitance from the sensor is a modulated output on the oscillator circuit which may cause the output current of the transmitter to drop below 20 mA. In a limited sample size, the ambiguous output during this over pressure condition occurred in 5% of the transmitters at ambient conditions. Referring to the attached graph, this does not occur until the over pressure condition is  $\geq 140\%$  of the upper range limit regardless of span. At that point a discontinuity can occur with the output current instantaneously decreasing to less than 20 mA. As an example of this potential applications problem, the upper range limit of a range 5 1152 differential pressure transmitter (Model 1152DP5A22) is 750" H<sub>2</sub>O. The range of this pressure transmitter can be set from 0 to 150" H<sub>2</sub>O. If the ambiguous output in the over pressure condition is to occur, it will occur at 140% or more of the upper range limit or, in this case, at pressures  $\geq 1050$ " H<sub>2</sub>O (750" H<sub>2</sub>O x 1.4). The transmitter then could give an output less than 20 mA at a pressure that is, in this example, seven

times ( $1050''\text{H}_2\text{O} \div 150''\text{H}_2\text{O}$ ) the upper range value. Note that the significant figure for use in determining the pressure above which an ambiguous output can occur is the specified upper range limit ( $750''\text{H}_2\text{O}$  in this example) not the customer selected upper range value ( $150''\text{H}_2\text{O}$  in this example).

For the reverse pressure condition, the effect of the high capacitance from the sensor is the oscillator circuit drawing more current which may cause the output current of the transmitter to exceed 4 mA. In a limited sample size, the ambiguous output during this reverse pressure condition occurred in 55% of the transmitters at ambient conditions. Referring to the attached graph, this does not occur until the reverse pressure condition exceeds 140% of the upper range limit regardless of the span. At this point the output may exceed 4 mA. As an example of this potential applications problem consider the range 5 differential transmitter in the previous paragraph. If the ambiguous output in the reverse pressure condition is to occur, it will occur at 140% or more of the upper range limit, or in this case at reversed pressures  $\geq 1050''\text{H}_2\text{O}$  ( $750''\text{H}_2\text{O} \times 1.4$ ). The transmitter then could give an output greater than 4 mA at a pressure that is, in this example, seven times ( $1050''\text{H}_2\text{O} \div 150''\text{H}_2\text{O}$ ) the upper range value, but reversed. Also note that with absolute pressure units a reverse pressure is not possible since the low pressure side of the cell is evacuated. With gage units a reverse pressure is possible only if a vacuum is present on the connected part since the low pressure side of the cell is vented to ambient atmosphere. Since the maximum reverse pressure would be one atmosphere, only range 3 and 4 gage units could obtain a reverse pressure exceeding 140% of the upper range limit.

The safety system should be analyzed in view of this supplementary report to determine if a potential application problem exists and appropriate corrections to the safety system should be implemented.
