IE Bulletin No. 80-16

POTENTIAL MISAPPLICATION OF ROSEMOUNT INC. MODELS 1151 AND 1152 PRESSURE TRANSMITTERS WITH EITHER "A" OR "D" OUTPUT CODES

IE Circular No. 80-16

OPERATIONAL DEFICIENCIES IN ROSEMOUNT MODEL 510DU TRIP UNITS AND MODEL 1152 PRESSURE TRANSMITTERS

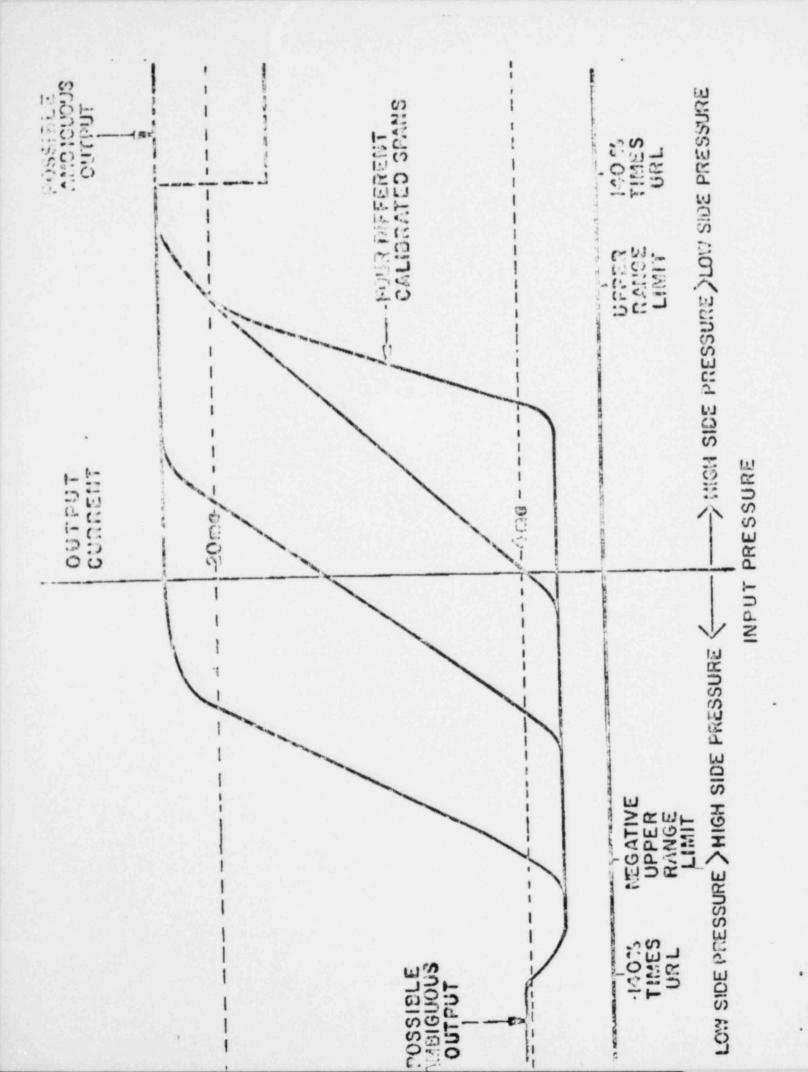
Rosemount's Model 1152 pressure transmitter provides a specified linear output of 4 to 20 mA throughout the calibrated range of operation. The transmitter output is not specified by Rosemount for pressures outside of the calibrated range of operation. It has been observed in a limited number of transmitters that an output between 4 and 20 mA can occur with certain input pressures outside of the calibrated range. These ambiguous outputs can occur in both an over pressure condition and a reverse pressure condition. Both conditions arise when the center diaphragm of the pressure sensor bottoms out against either of the fixed capacitor plates. In each case the normal capacitance signal becomes a very high capacitance signal which affects the operation of the electronic circuit.

For the over pressure condition, the effect of the high capacitance from the sensor is a modulated output on the oscillator circuit which may cause the output current of the transmitter to drop below 20 mA. In a limited sample size, the ambiguous output during this over pressure condition occurred in 5% of the transmitters at ambient conditions. Referring to the attached graph, this does not occur until the over pressure condition is > 140% of the upper range limit regardless of span. At that point a discontinuity can occur with the output current instantaneously decreasing to less than 20 mA. As an example of this potential applications problem, the upper range limit of a range 5 1152 differential pressure transmitter (Model 1152DP5A22) is 750"HoO. The range of this pressure transmitter can be set from 0 to 150"H20. If the ambiguous output in the over pressure condition is to occur, it will occur at 140% or more of the upper range limit or, in this case, at pressures > 1050"H 0 (750"H<sub>2</sub>0 x 1.4). The transmitter then could give an output less than 20 mA at a pressure that is, in this example, seven

times (1050"H $_2$ 0  $\div$  150"H $_2$ 0) the upper range value. Note that the significant figure for use in determining the pressure above which an ambiguous output can occur is the specified upper range limit (750"H $_2$ 0 in this example) not the customer selected upper range value (150"H $_2$ 0 in this example).

For the reverse pressure condition, the effect of the high capacitance from the sensor is the oscillator circuit drawing more current which may cause the output current of the transmitter to exceed 4 mA. In a limited sample size, the ambiguous output during this reverse pressure condition occurred in 55% of the transmitters at ambient conditions. Referring to the attached graph, this does not occur until the reverse pressure condition exceeds 140% of the upper range limit regardless of the span. At this point the output may exceed 4 mA. As an example of this potential applications problem consider the range 5 differential transmitter in the previous paragraph. If the ambiguous output in the reverse pressure condition is to occur, it will occur at 140% or more of the upper range limit, or in this case at reversed pressures > 1050" H<sub>0</sub>O (750"H O x 1.4). The transmitter then could give an output greater than 4 mA at a pressure that is, in this example, seven times (1050" HaO ÷ 150" HaO) the upper range value, but reversed. Also note that with absolute pressure units a reverse pressure is not possible since the low pressure side of the cell is evacuated. With gage units a reverse pressure is possible only if a vacuum is present on the connected part since the low pressure side of the cell is vented to ambient atmosphere. Since the maximum reverse pressure would be one atmosphere, only range 3 and 4 gage units could obtain a reverse pressure exceeding 140% of the upper range limit.

The safety system should be analyzed in view of this supplementary report to determine if a potential application problem exists and appropriate corrections to the safety system should be implemented.
