IE Bulletin No. 80-16

POTENTIAL MISAPPLICATION OF ROSEMOUNT INC. MODELS 1151 AND 1152 PRESSURE TRANSMITTERS WITH EITHER "A" OR "D" OUTPUT CODES

IE Circular No. 80-16

OPERATIONAL DEFICIENCIES IN ROSEMOUNT MODEL 510DU TRIP UNITS AND MODEL 1152
PRESSURE TRANSMITTERS

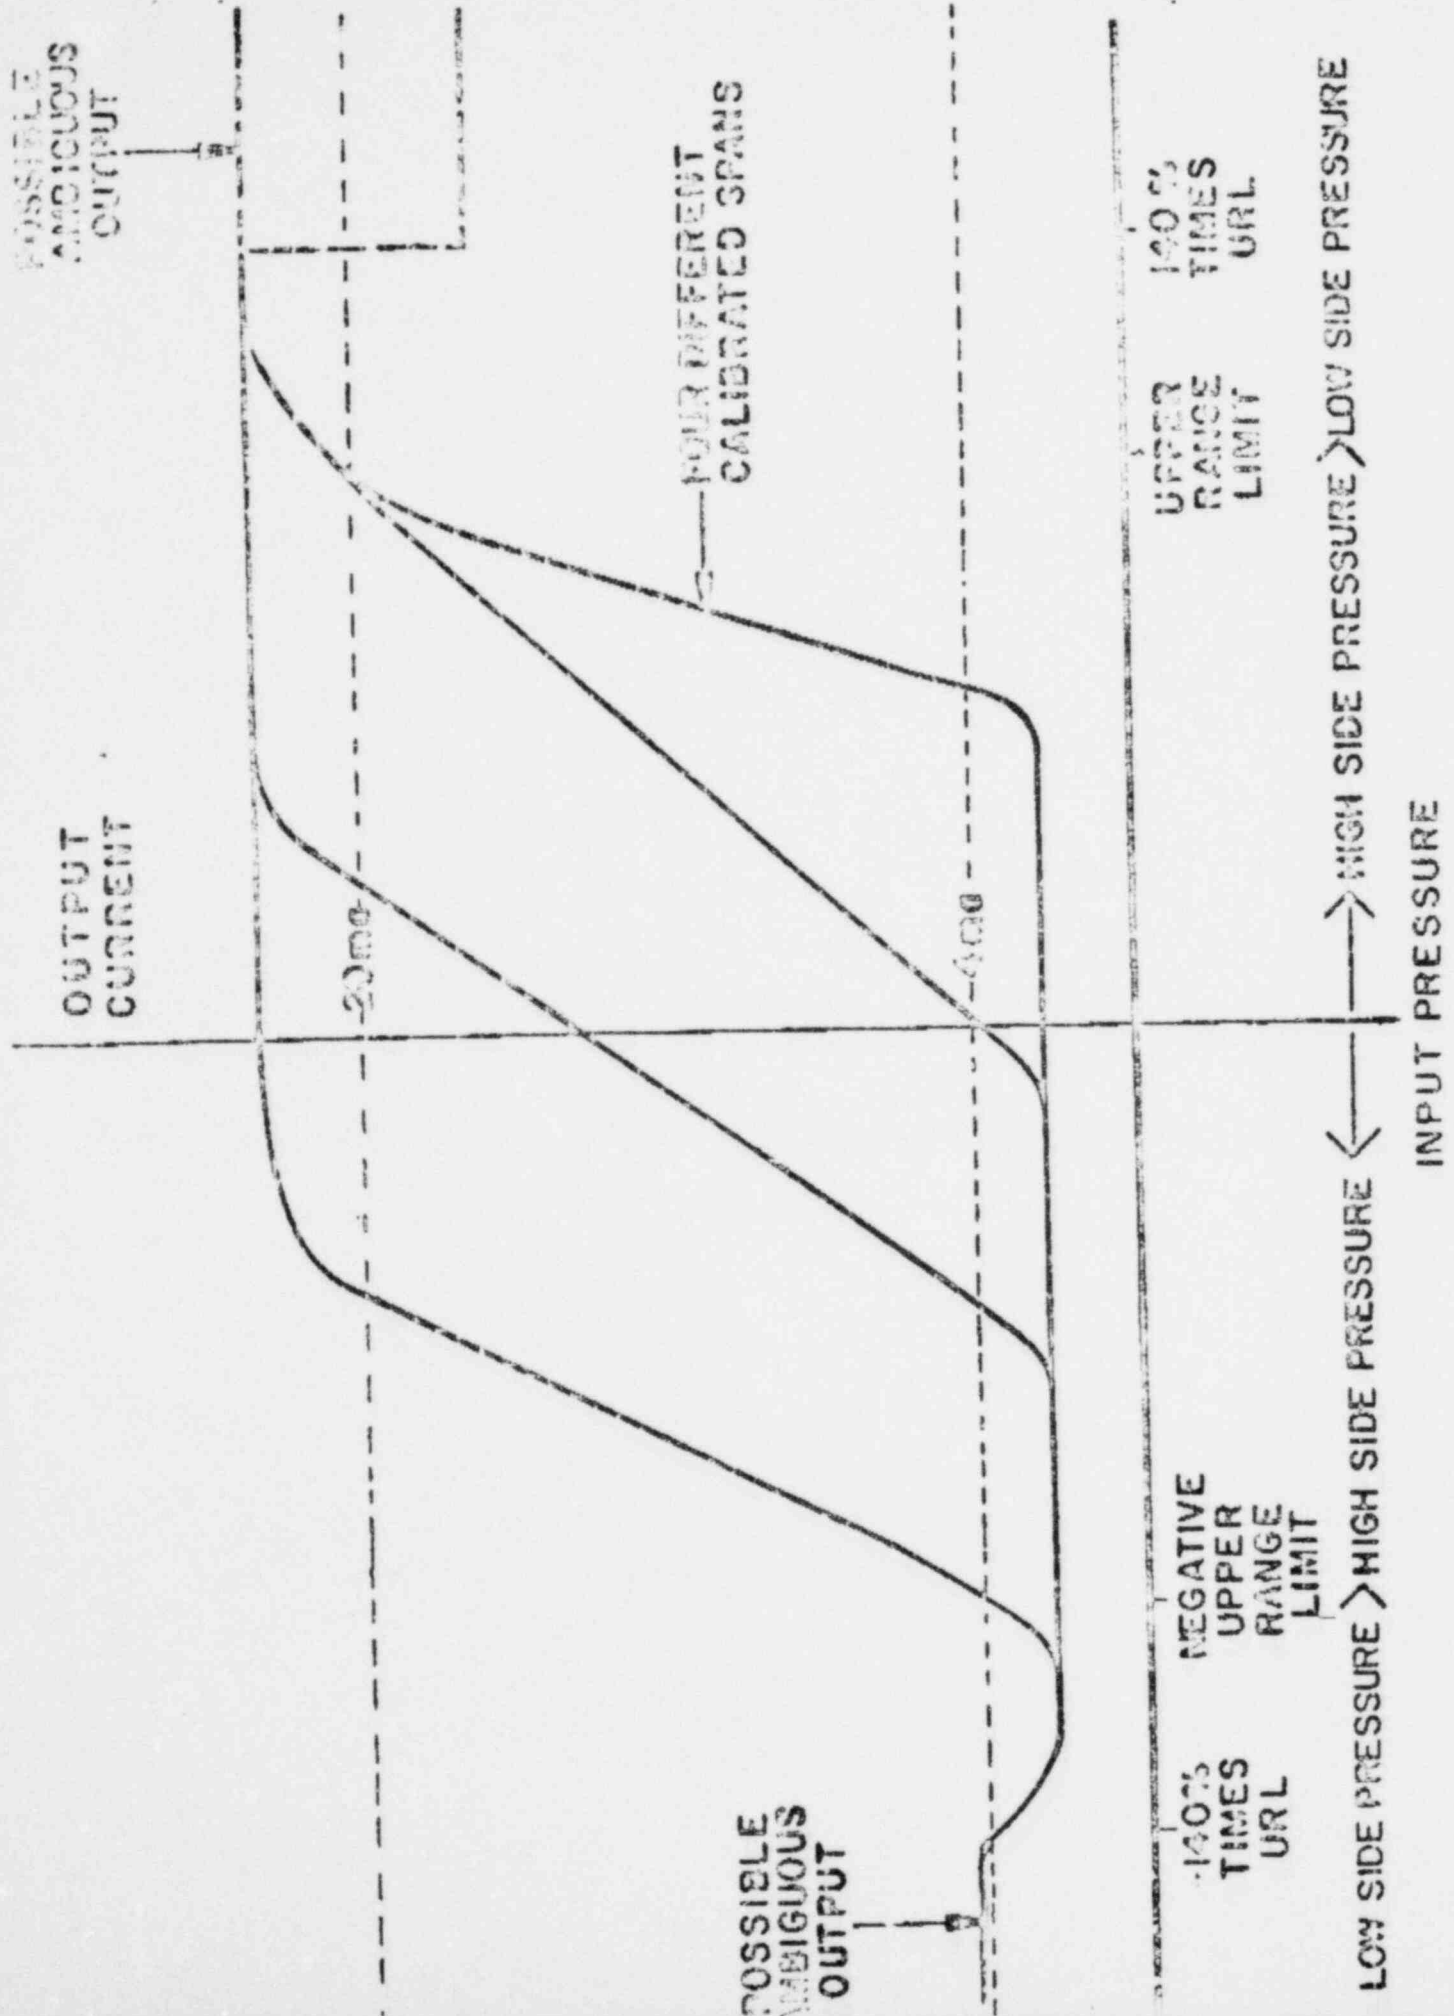
For the over pressure condition, the effect of the high capacitance from the sensor is a modulated output on the oscillator circuit which may cause the output current of the transmitter to drop below 20 mA. In a limited sample size, the ambiguous output during this over pressure condition occurred in 5% of the transmitters at ambient conditions. Referring to the attached graph, this does not occur until the over pressure condition is $\geq 140\%$ of the upper range limit regardless of span. At that point a discontinuity can occur with the output current instantaneously decreasing to less than 20 mA. As an example of this potential applications problem, the upper range limit of a range 5 1152 differential pressure transmitter (Model 1152DP5A22) is 750" H₂O. The range of this pressure transmitter can be set from 0 to 150" H₂O. If the ambiguous output in the over pressure condition is to occur, it will occur at 140% or more of the upper range limit or, in this case, at pressures ≥ 1050 " H₂O (750" H₂O x 1.4). The transmitter then could give an output less than 20 mA at a pressure that is, in this example, seven

times ($1050''\text{H}_2\text{O} \div 150''\text{H}_2\text{O}$) the upper range value. Note that the significant figure for use in determining the pressure above which an ambiguous output can occur is the specified upper range limit ($750''\text{H}_2\text{O}$ in this example) not the customer selected upper range value ($150''\text{H}_2\text{O}$ in this example).

For the reverse pressure condition, the effect of the high capacitance from the sensor is the oscillator circuit drawing more current which may cause the output current of the transmitter to exceed 4 mA. In a limited sample size, the ambiguous output during this reverse pressure condition occurred in 55% of the transmitters at ambient conditions. Referring to the attached graph, this does not occur until the reverse pressure condition exceeds 140% of the upper range limit regardless of the span. At this point the output may exceed 4 mA. As an example of this potential applications problem consider the range 5 differential transmitter in the previous paragraph. If the ambiguous output in the reverse pressure condition is to occur, it will occur at 140% or more of the upper range limit, or in this case at reversed pressures $\geq 1050''\text{H}_2\text{O}$ ($750''\text{H}_2\text{O} \times 1.4$). The transmitter then could give an output greater than 4 mA at a pressure that is, in this example, seven times ($1050''\text{H}_2\text{O} \div 150''\text{H}_2\text{O}$) the upper range value, but reversed. Also note that with absolute pressure units a reverse pressure is not possible since the low pressure side of the cell is evacuated. With gage units a reverse pressure is possible only if a vacuum is present on the connected part since the low pressure side of the cell is vented to ambient atmosphere. Since the maximum reverse pressure would be one atmosphere, only range 3 and 4 gage units could obtain a reverse pressure exceeding 140% of the upper range limit.

The safety system should be analyzed in view of this supplementary report to determine if a potential application problem exists and appropriate corrections to the safety system should be implemented.
