IE Bulletin No. 80-16

POTENTIAL MISAPPLICATION OF ROSEMOUNT INC. MODELS 1151 AND 1152 PRESSURE TRANSMITTERS WITH EITHER "A" OR "D" OUTPUT CODES

IE Circular No. 80-16

OPERATIONAL DEFICIENCIES IN ROSEMOUNT MODEL 510DU TRIP UNITS AND MODEL 1152
PRESSURE TRANSMITTERS

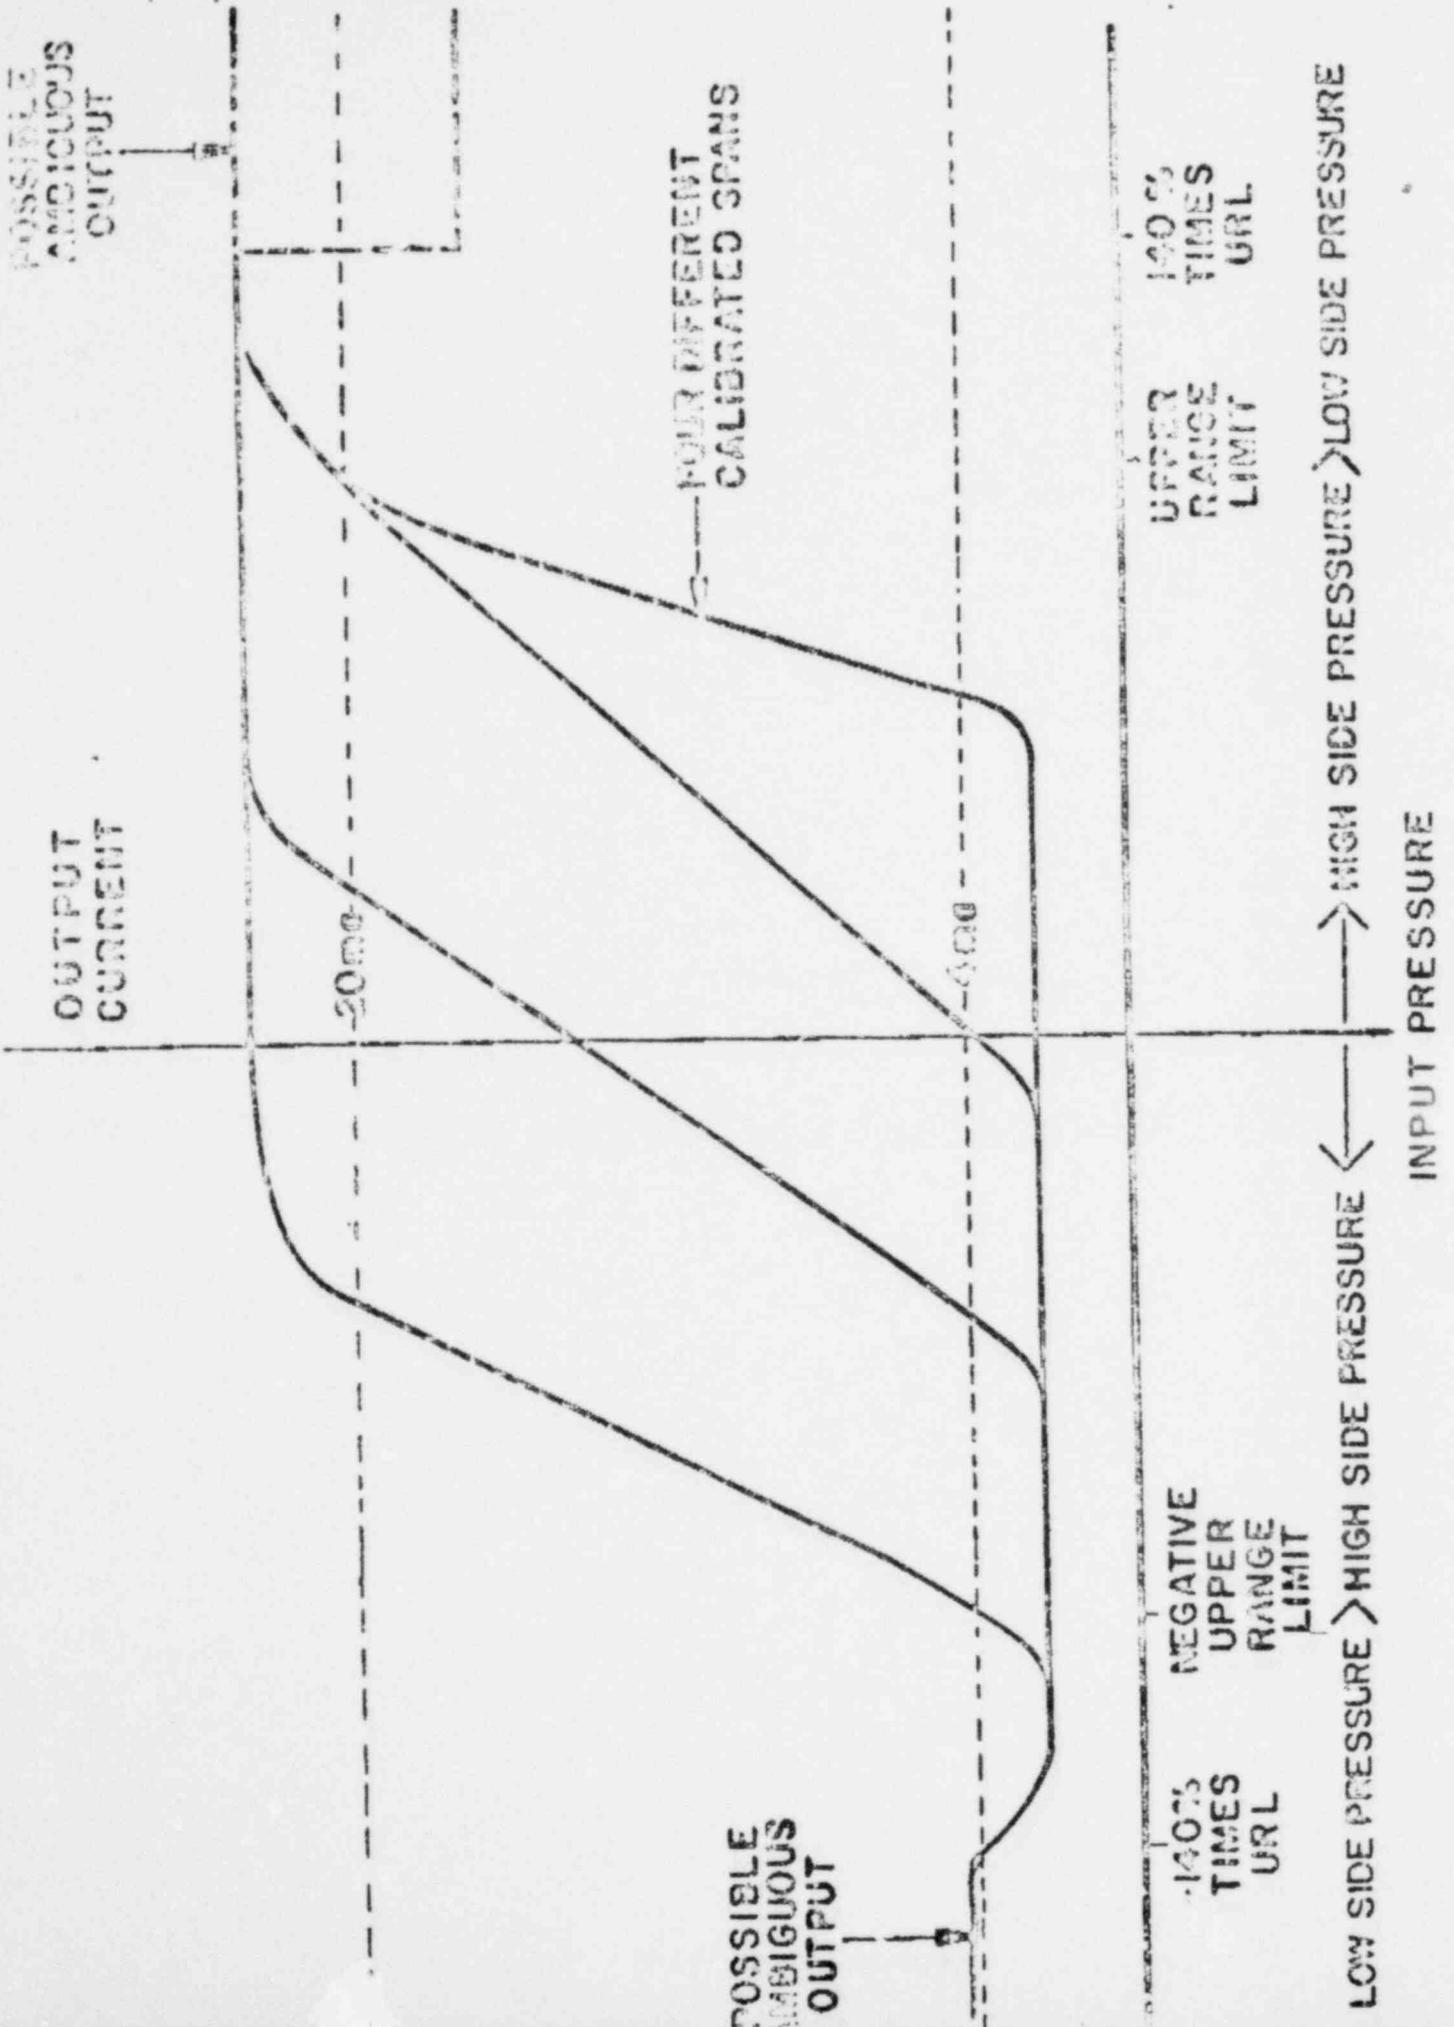
For the over pressure condition, the effect of the high capacitance from the sensor is a modulated output on the oscillator circuit which may cause the output current of the transmitter to drop below 20 mA. In a limited sample size, the ambiguous output during this over pressure condition occurred in 5% of the transmitters at ambient conditions. Referring to the attached graph, this does not occur until the over pressure condition is $\geq 140\%$ of the upper range limit regardless of span. At that point a discontinuity can occur with the output current instantaneously decreasing to less than 20 mA. As an example of this potential applications problem, the upper range limit of a range 5 1152 differential pressure transmitter (Model 1152DP5A22) is 750" H₂O. The range of this pressure transmitter can be set from 0 to 150" H₂O. If the ambiguous output in the over pressure condition is to occur, it will occur at 140% or more of the upper range limit or, in this case, at pressures ≥ 1050 " H₂O (750" H₂O x 1.4). The transmitter then could give an output less than 20 mA at a pressure that is, in this example, seven

times ($1050''\text{H}_2\text{O} \div 150''\text{H}_2\text{O}$) the upper range value. Note that the significant figure for use in determining the pressure above which an ambiguous output can occur is the specified upper range limit ($750''\text{H}_2\text{O}$ in this example) not the customer selected upper range value ($150''\text{H}_2\text{O}$ in this example).
