UNITED STATES  
NUCLEAR REGULATORY COMMISSION

Houston Lighting & Power Company  
ATTN: Mr. E. A. Turner, Vice President  
Power Plant Construction and  
Technical Services  
Post Office Box 1700  
Houston, Texas 77001

IE Bulletin No. 80-16

POTENTIAL MISAPPLICATION OF ROSEMOUNT INC. MODELS 1151 AND 1152 PRESSURE TRANSMITTERS WITH EITHER "A" OR "D" OUTPUT CODES

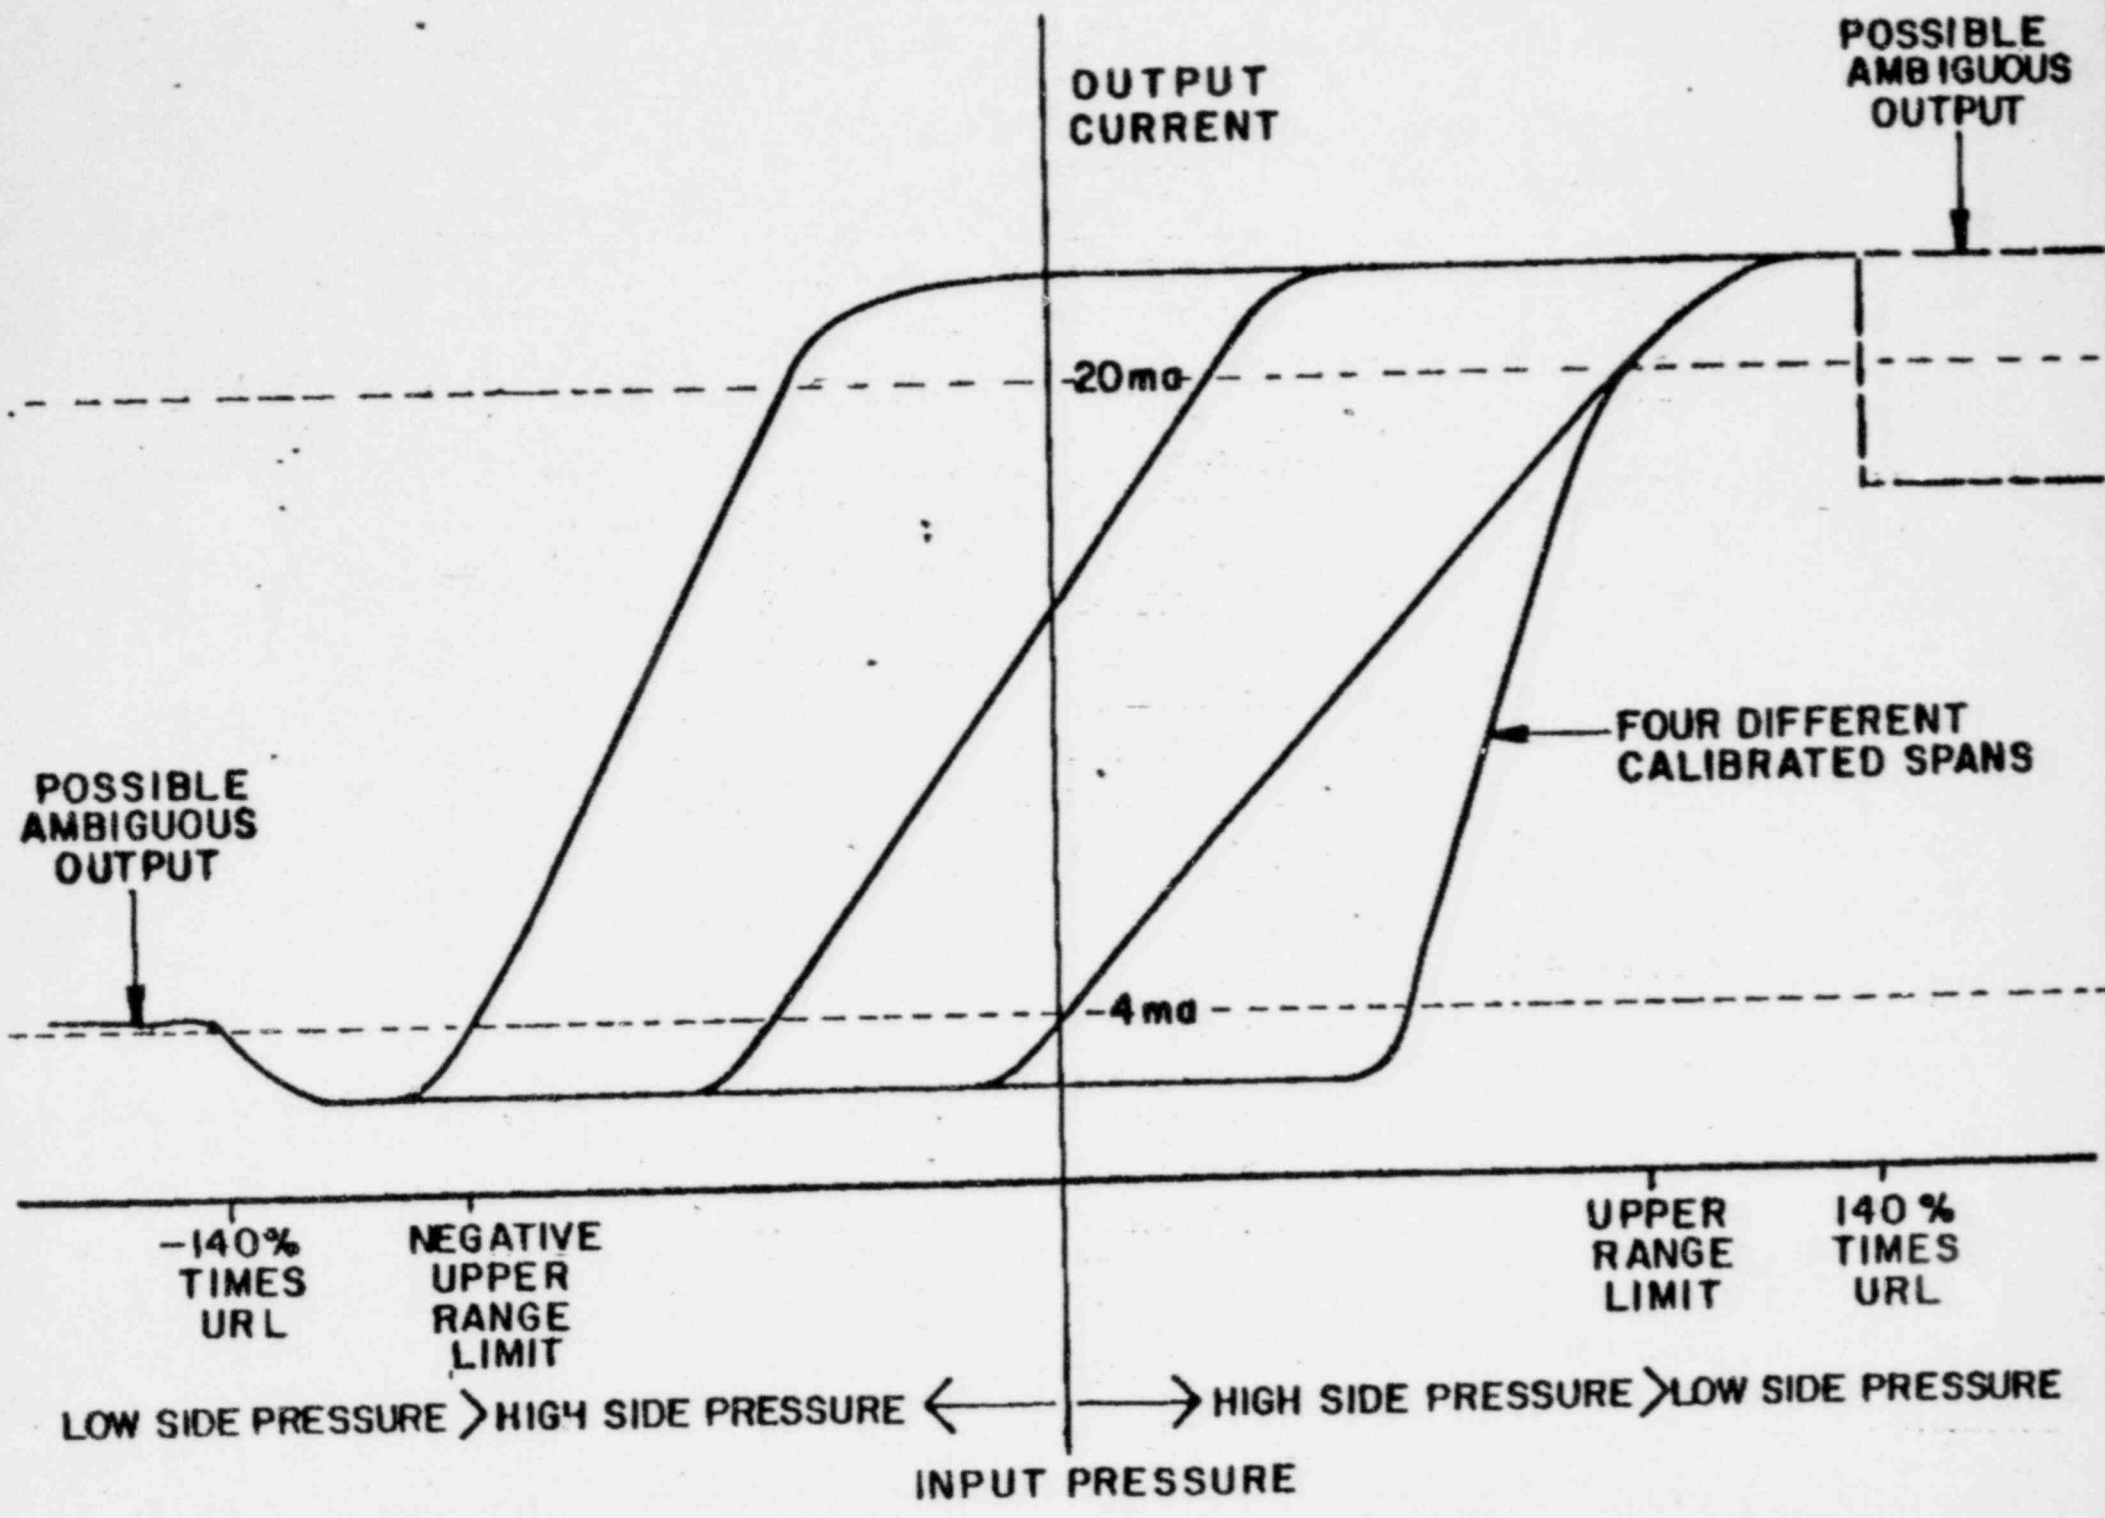
Attachment:

Enclosure 1 contains Rosemount Inc.'s technical description of the potential application problems for Pressure Transmitters Model 1152. This information is applicable to Model 1151 Pressure Transmitters also. This information includes the reasons for the maloperation of the transmitters, a typical pressure versus current output curve and examples of the results of the maloperations. Available information indicates that the problem was reported to each customer who was furnished the subject transmitters by Rosemount Inc.

For the over pressure condition, the effect of the high capacitance from the sensor is a modulated output on the oscillator circuit which may cause the output current of the transmitter to drop below 20 mA. In a limited sample size, the ambiguous output during this over pressure condition occurred in 5% of the transmitters at ambient conditions. Referring to the attached graph, this does not occur until the over pressure condition is  $\geq 140\%$  of the upper range limit regardless of span. At that point a discontinuity can occur with the output current instantaneously decreasing to less than 20 mA. As an example of this potential applications problem, the upper range limit of a range 5 1152 differential pressure transmitter (Model 1152DP5A22) is 750" H<sub>2</sub>O. The range of this pressure transmitter can be set from 0 to 150" H<sub>2</sub>O. If the ambiguous output in the over pressure condition is to occur, it will occur at 140% or more of the upper range limit or, in this case, at pressures  $\geq 1050$ " H<sub>2</sub>O (750" H<sub>2</sub>O x 1.4). The transmitter than could give an output less than 20 mA at a pressure that is, in this example, seven

times (1050"H<sub>2</sub>O + 150"H<sub>2</sub>O) the upper range value. Note that the significant figure for use in determining the pressure above which an ambiguous output can occur is the specified upper range limit (750" H<sub>2</sub>O in this example) not the customer selected upper range value (150"H<sub>2</sub>O in this example).

For the reverse pressure condition, the effect of the high capacitance from the sensor is the oscillator circuit drawing more current which may cause the output current of the transmitter to exceed 4 mA. In a limited sample size, the ambiguous output during this reverse pressure condition occurred in 55% of the transmitters at ambient conditions. Referring to the attached graph, this does not occur until the reverse pressure condition exceeds 140% of the upper range limit regardless of the span. At this point the output may exceed 4 mA. As an example of this potential applications problem consider the range 5 differential transmitter in the previous paragraph. If the ambiguous output in the reverse pressure condition is to occur, it will occur at 140% or more of the upper range limit, or in this case at reversed pressures  $\geq 1050"$  H<sub>2</sub>O (750"H<sub>2</sub>O x 1.4). The transmitter then could give an output greater than 4 mA at a pressure that is, in this example, seven times (1050" H<sub>2</sub>O + 150" H<sub>2</sub>O) the upper range value, but reversed. Also note that with absolute pressure units a reverse pressure is not possible since the low pressure side of the cell is evacuated. With gage units a reverse pressure is possible only if a vacuum is present on the connected part since the low pressure side of the cell is vented to ambient atmosphere. Since the maximum reverse pressure would be one atmosphere, only range 3 and 4 gage units could obtain a reverse pressure exceeding 140% of the upper range limit.

The safety system should be analyzed in view of this supplementary report to determine if a potential application problem exists and appropriate corrections to the safety system should be implemented.
