IE Bulletin No. 80-16

POTENTIAL MISAPPLICATION OF ROSEMOUNT INC. MODELS 1151 AND 1152 PRESSURE TRANSMITTERS WITH EITHER "A" OR "D" OUTPUT CODES

IE Circular No. 80-16

OPERATIONAL DEFICIENCIES IN ROSEMOUNT MODEL 510DU TRIP UNITS AND MODEL 1152
PRESSURE TRANSMITTERS

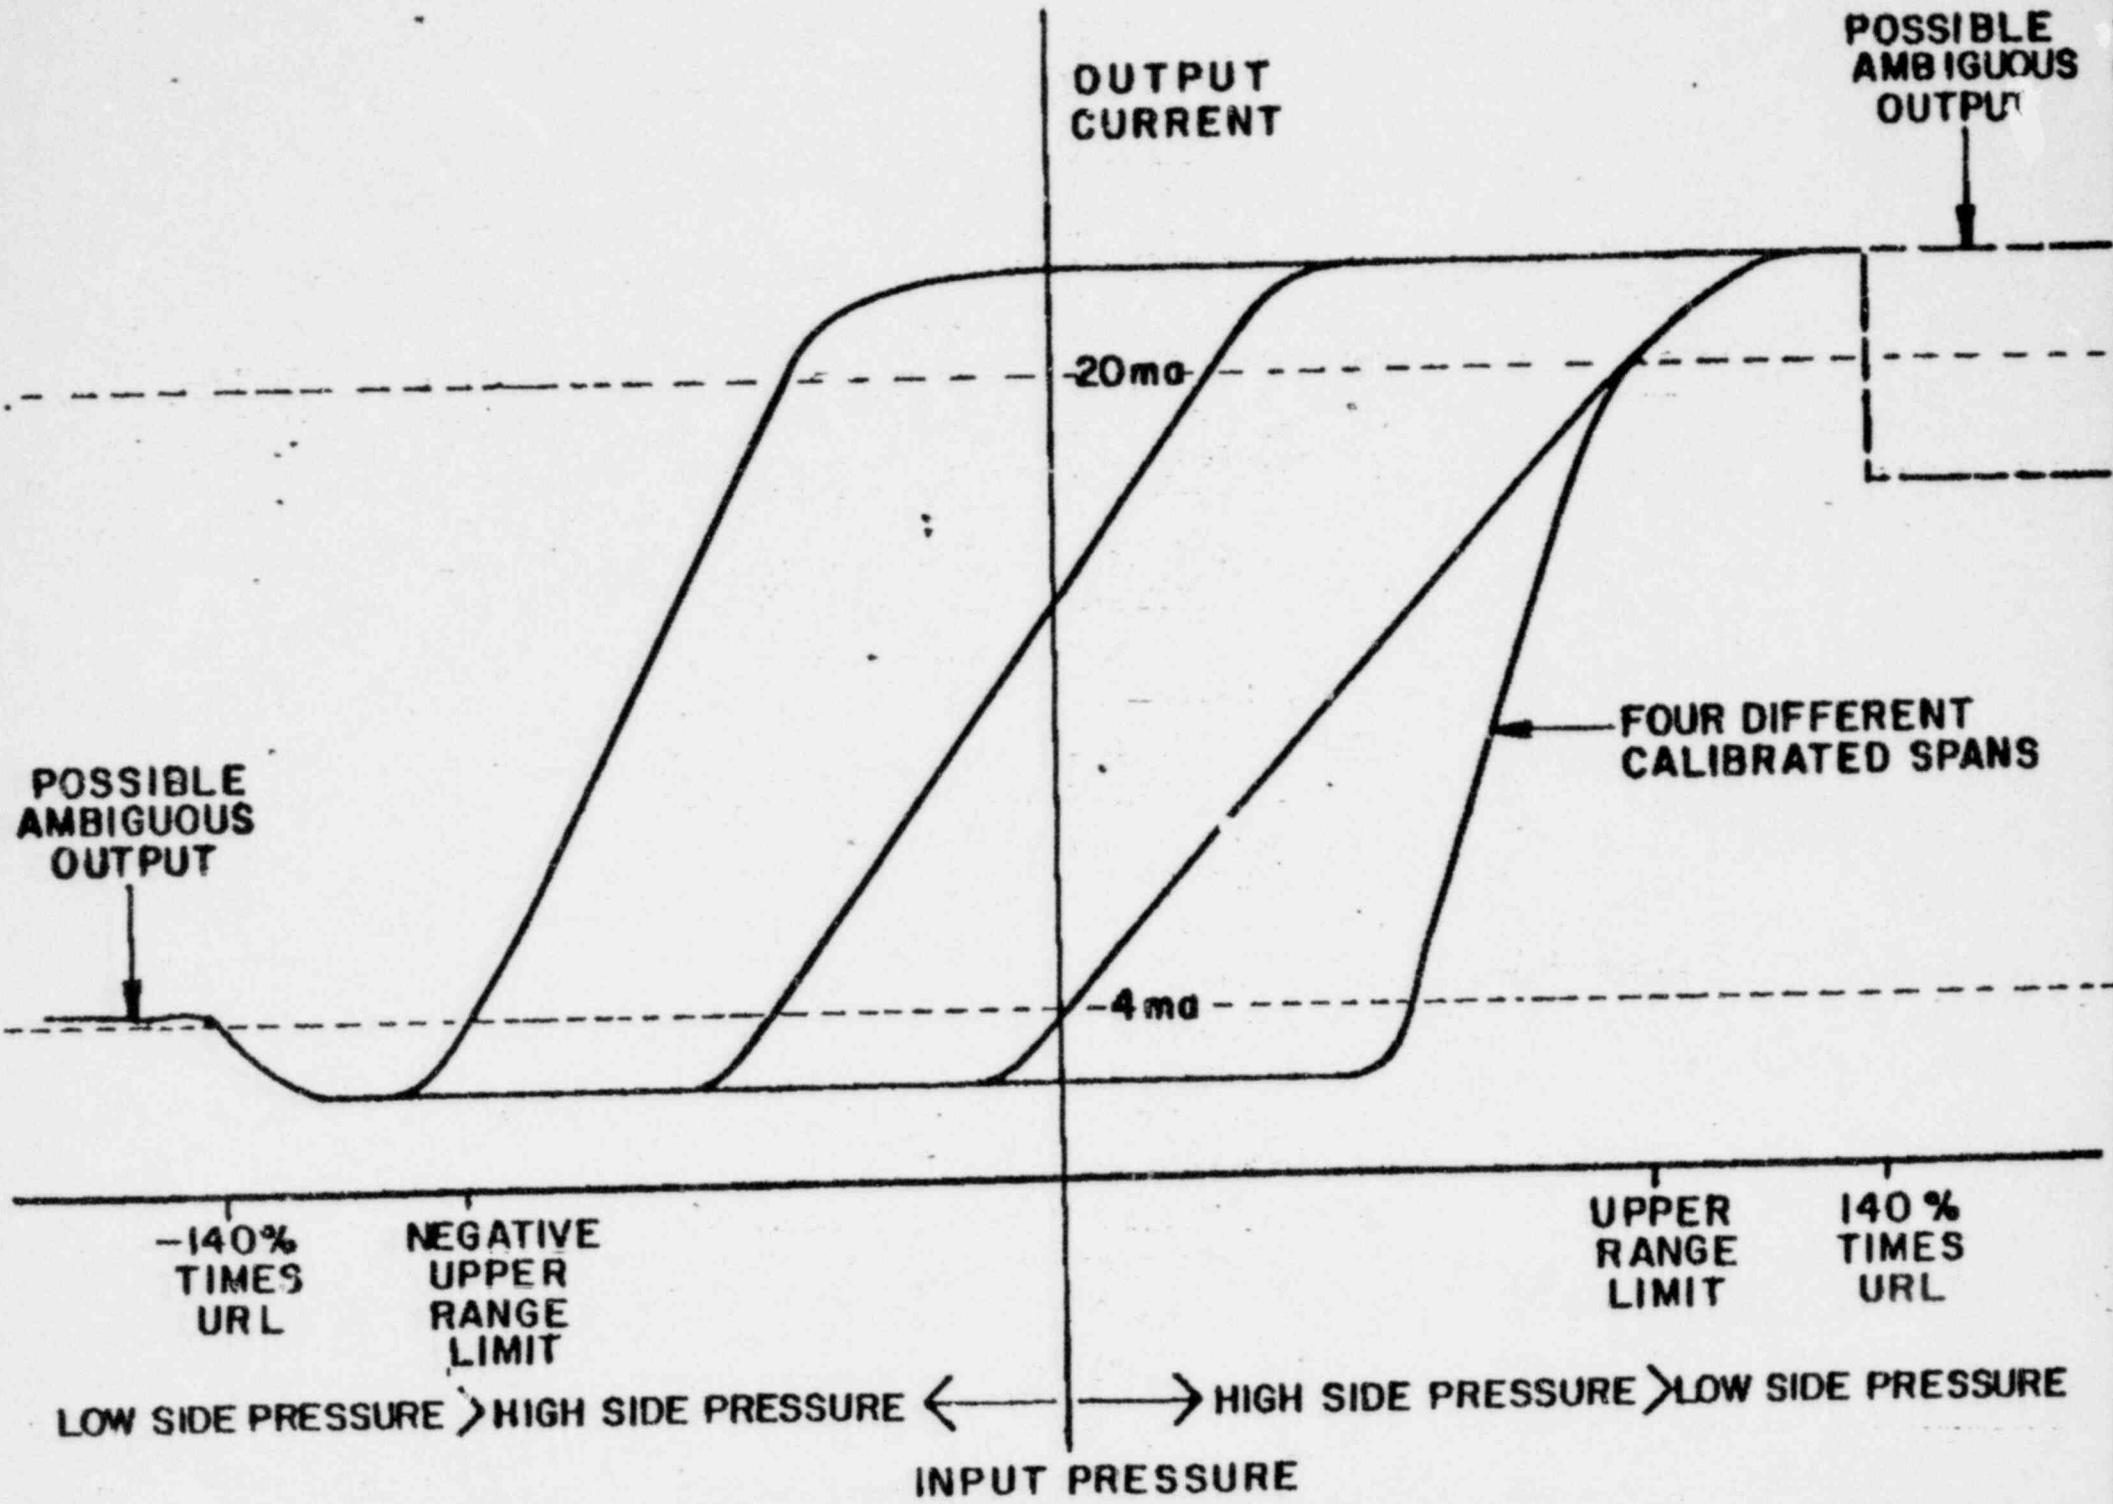
Attachment:

Enclosure 1 contains Rosemount Inc.'s technical description of the potential application problems for Pressure Transmitters Model 1152. This information is applicable to Model 1151 Pressure Transmitters also. This information includes the reasons for the maloperation of the transmitters, a typical pressure versus current output curve and examples of the results of the maloperations. Available information indicates that the problem was reported to each customer who was furnished the subject transmitters by Rosemount Inc.

For the over pressure condition, the effect of the high capacitance from the sensor is a modulated output on the oscillator circuit which may cause the output current of the transmitter to drop below 20 mA. In a limited sample size, the ambiguous output during this over pressure condition occurred in 5% of the transmitters at ambient conditions. Referring to the attached graph, this does not occur until the over pressure condition is $\geq 140\%$ of the upper range limit regardless of span. At that point a discontinuity can occur with the output current instantaneously decreasing to less than 20 mA. As an example of this potential applications problem, the upper range limit of a range 5 1152 differential pressure transmitter (Model 1152DP5A22) is 750"H₂O. The range of this pressure transmitter can be set from 0 to 150"H₂O. If the ambiguous output in the over pressure condition is to occur, it will occur at 140% or more of the upper range limit or, in this case, at pressures ≥ 1050 "H₂O (750"H₂O x 1.4). The transmitter than could give an output less than 20 mA at a pressure that is, in this example, seven

times (1050"H₂O + 150"H₂O) the upper range value. Note that the significant figure for use in determining the pressure above which an ambiguous output can occur is the specified upper range limit (750" H₂O in this example) not the customer selected upper range value (150"H₂O in this example).

For the reverse pressure condition, the effect of the high capacitance from the sensor is the oscillator circuit drawing more current which may cause the output current of the transmitter to exceed 4 mA. In a limited sample size, the ambiguous output during this reverse pressure condition occurred in 55% of the transmitters at ambient conditions. Referring to the attached graph, this does not occur until the reverse pressure condition exceeds 140% of the upper range limit regardless of the span. At this point the output may exceed 4 mA. As an example of this potential applications problem consider the range 5 differential transmitter in the previous paragraph. If the ambiguous output in the reverse pressure condition is to occur, it will occur at 140% or more of the upper range limit, or in this case at reversed pressures $\geq 1050"$ H₂O (750"H₂O x 1.4). The transmitter then could give an output greater than 4 mA at a pressure that is, in this example, seven times (1050" H₂O + 150" H₂O) the upper range value, but reversed. Also note that with absolute pressure units a reverse pressure is not possible since the low pressure side of the cell is evacuated. With gage units a reverse pressure is possible only if a vacuum is present on the connected part since the low pressure side of the cell is vented to ambient atmosphere. Since the maximum reverse pressure would be one atmosphere, only range 3 and 4 gage units could obtain a reverse pressure exceeding 140% of the upper range limit.

The safety system should be analyzed in view of this supplementary report to determine if a potential application problem exists and appropriate corrections to the safety system should be implemented.
