Docket No. STN 50-482/IE Bulletin No. 80-16

IE Bulletin No. 80-16

POTENTIAL MISAPPLICATION OF ROSEMOUNT INC. MODELS 1151 AND 1152 PRESSURE TRANSMITTERS WITH EITHER "A" OR "D" OUTPUT CODES

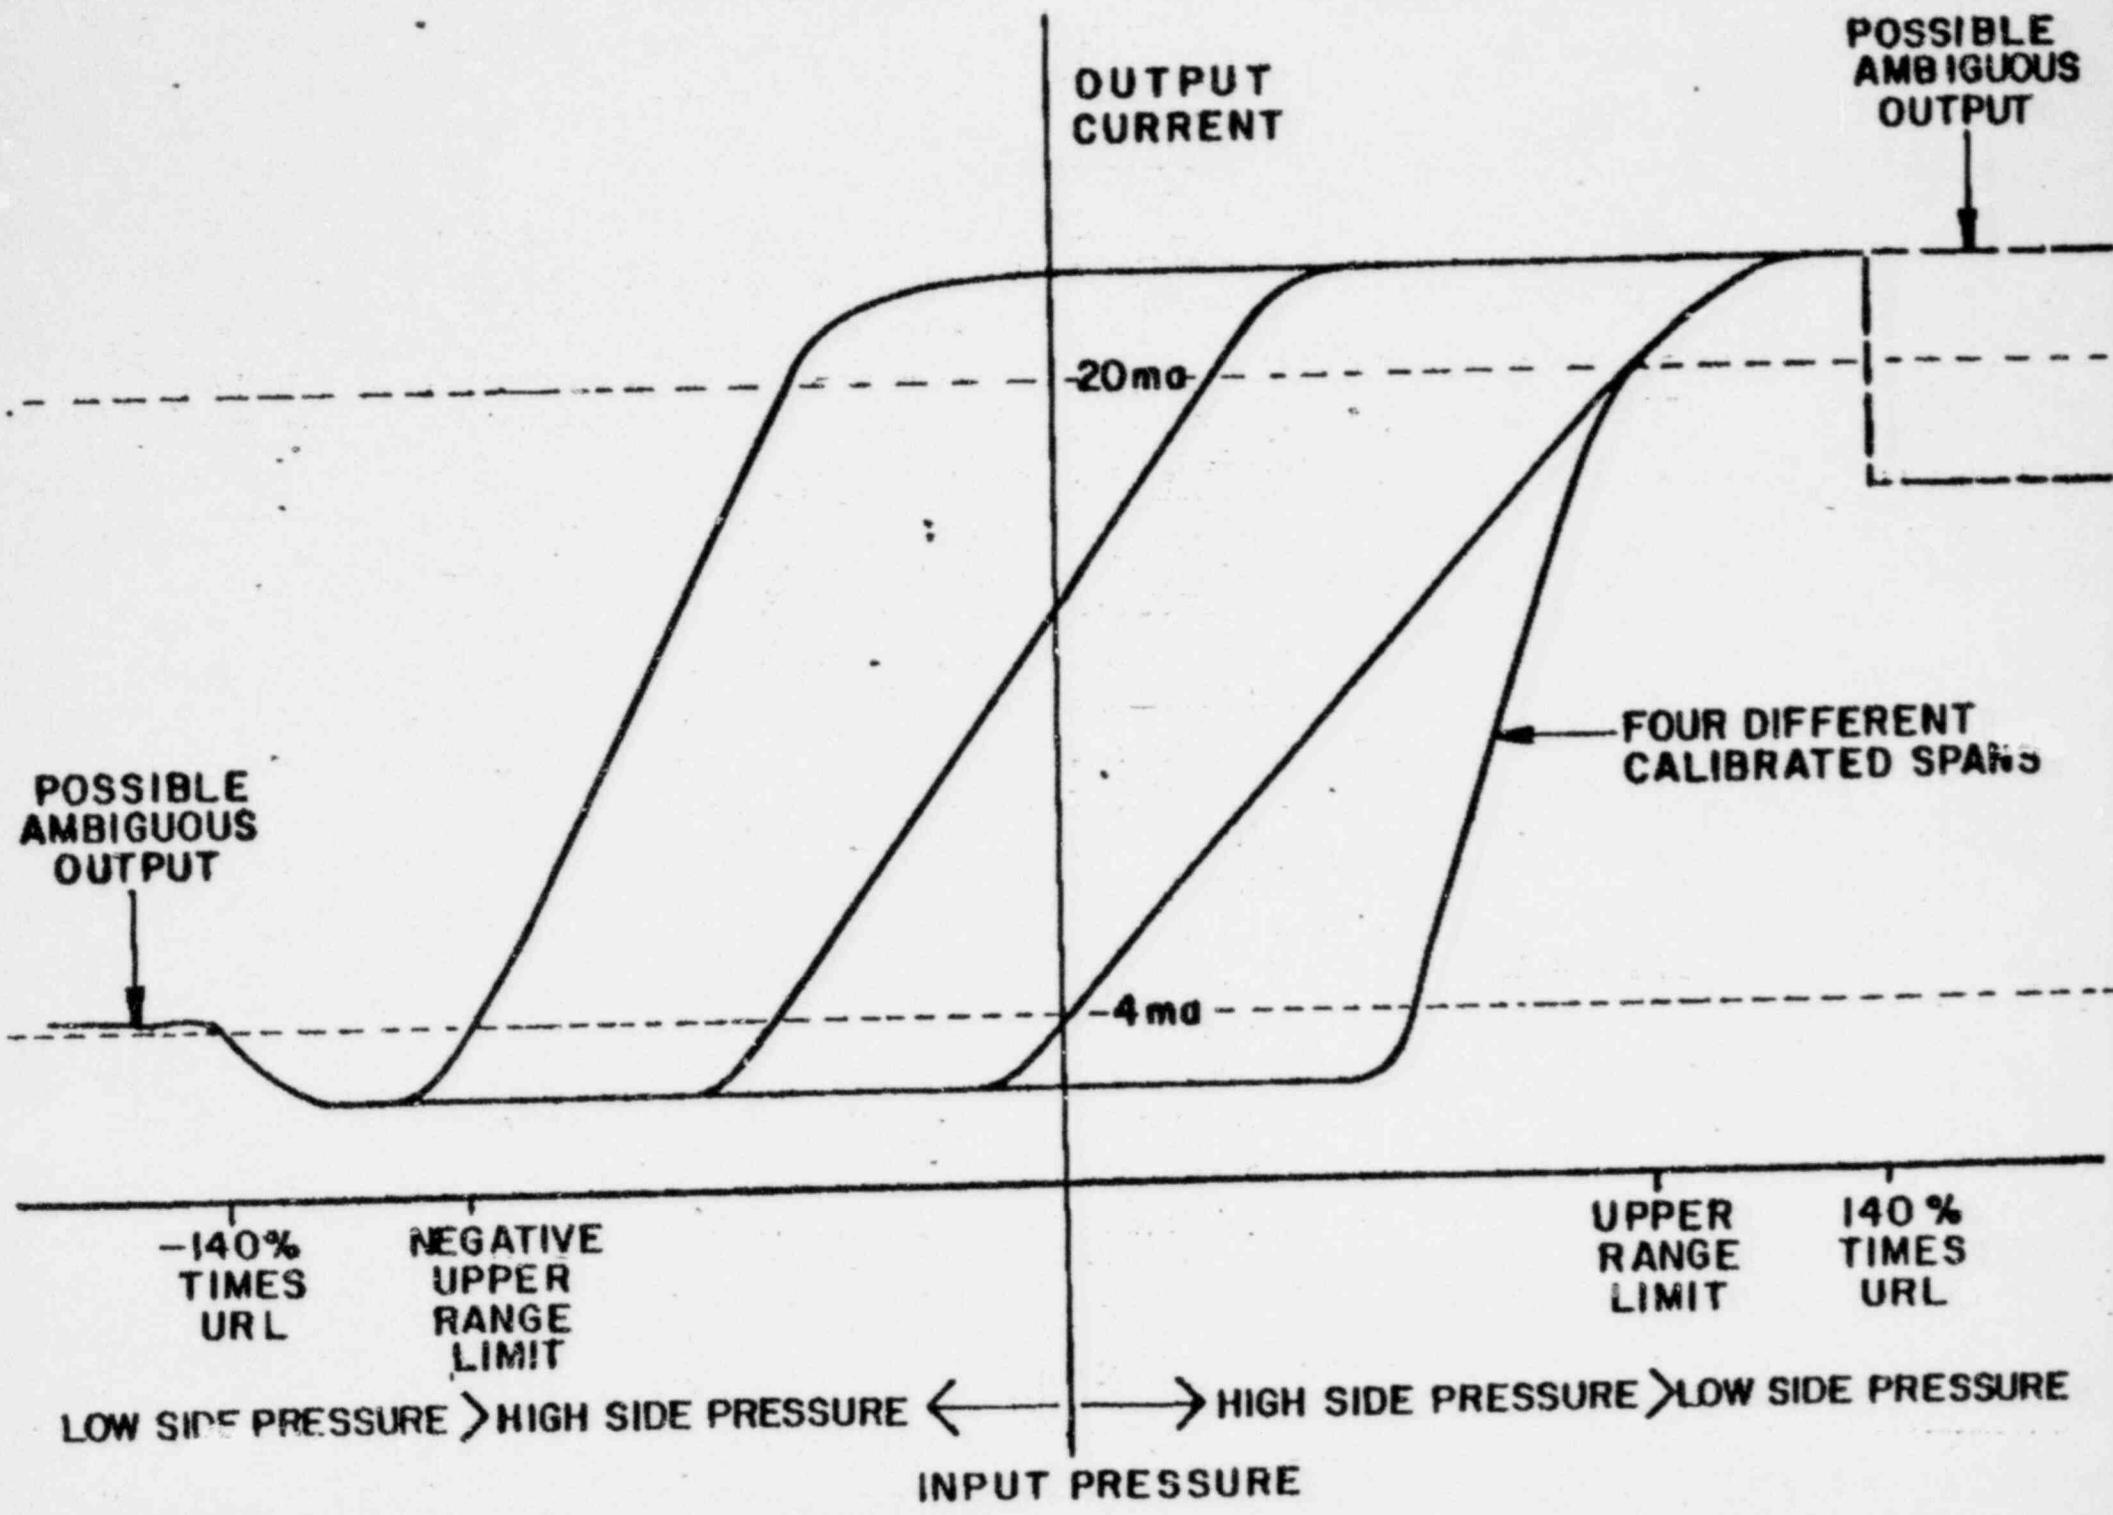
Attachment:

For the over pressure condition, the effect of the high capacitance from the sensor is a modulated output on the oscillator circuit which may cause the output current of the transmitter to drop below 20 mA. In a limited sample size, the ambiguous output during this over pressure condition occurred in 5% of the transmitters at ambient conditions. Referring to the attached graph, this does not occur until the over pressure condition is $\geq 140\%$ of the upper range limit regardless of span. At that point a discontinuity can occur with the output current instantaneously decreasing to less than 20 mA. As an example of this potential applications problem, the upper range limit of a range 5 1152 differential pressure transmitter (Model 1152DPSA22) is $750''\text{H}_2\text{O}$. The range of this pressure transmitter can be set from 0 to $150''\text{H}_2\text{O}$. If the ambiguous output in the over pressure condition is to occur, it will occur at 140% or more of the upper range limit or, in this case, at pressures $\geq 1050''\text{H}_2\text{O}$ ($750''\text{H}_2\text{O} \times 1.4$). The transmitter that could give an output less than 20 mA at a pressure that is, in this example, seven

times (1050" H₂O + 150" H₂O) the upper range value. Note that the significant figure for use in determining the pressure above which an ambiguous output can occur is the specified upper range limit (750" H₂O in this example) not the customer selected upper range value (150" H₂O in this example).

For the reverse pressure condition, the effect of the high capacitance from the sensor is the oscillator circuit drawing more current which may cause the output current of the transmitter to exceed 4 mA. In a limited sample size, the ambiguous output during this reverse pressure condition occurred in 55% of the transmitters at ambient conditions. Referring to the attached graph, this does not occur until the reverse pressure condition exceeds 140% of the upper range limit regardless of the span. At this point the output may exceed 4 mA. As an example of this potential applications problem consider the range 5 differential transmitter in the previous paragraph. If the ambiguous output in the reverse pressure condition is to occur, it will occur at 140% or more of the upper range limit, or in this case at reversed pressures $\geq 1050"$ H₂O (750" H₂O x 1.4). The transmitter then could give an output greater than 4 mA at a pressure that is, in this example, seven times (1050" H₂O + 150" H₂O) the upper range value, but reversed. Also note that with absolute pressure units a reverse pressure is not possible since the low pressure side of the cell is evacuated. With gage units a reverse pressure is possible only if a vacuum is present on the connected part since the low pressure side of the cell is vented to ambient atmosphere. Since the maximum reverse pressure would be one atmosphere, only range 3 and 4 gage units could obtain a reverse pressure exceeding 140% of the upper range limit.

The safety system should be analyzed in view of this supplementary report to determine if a potential application problem exists and appropriate corrections to the safety system should be implemented.
