UNITED STATES
NUCLEAR REGULATORY COMMISSION

Gulf States Utilities

IE Bulletin No. 80-16

POTENTIAL MISAPPLICATION OF ROSEMOUNT INC. MODELS 1151 AND 1152 PRESSURE TRANSMITTERS WITH EITHER "A" OR "D" OUTPUT CODES

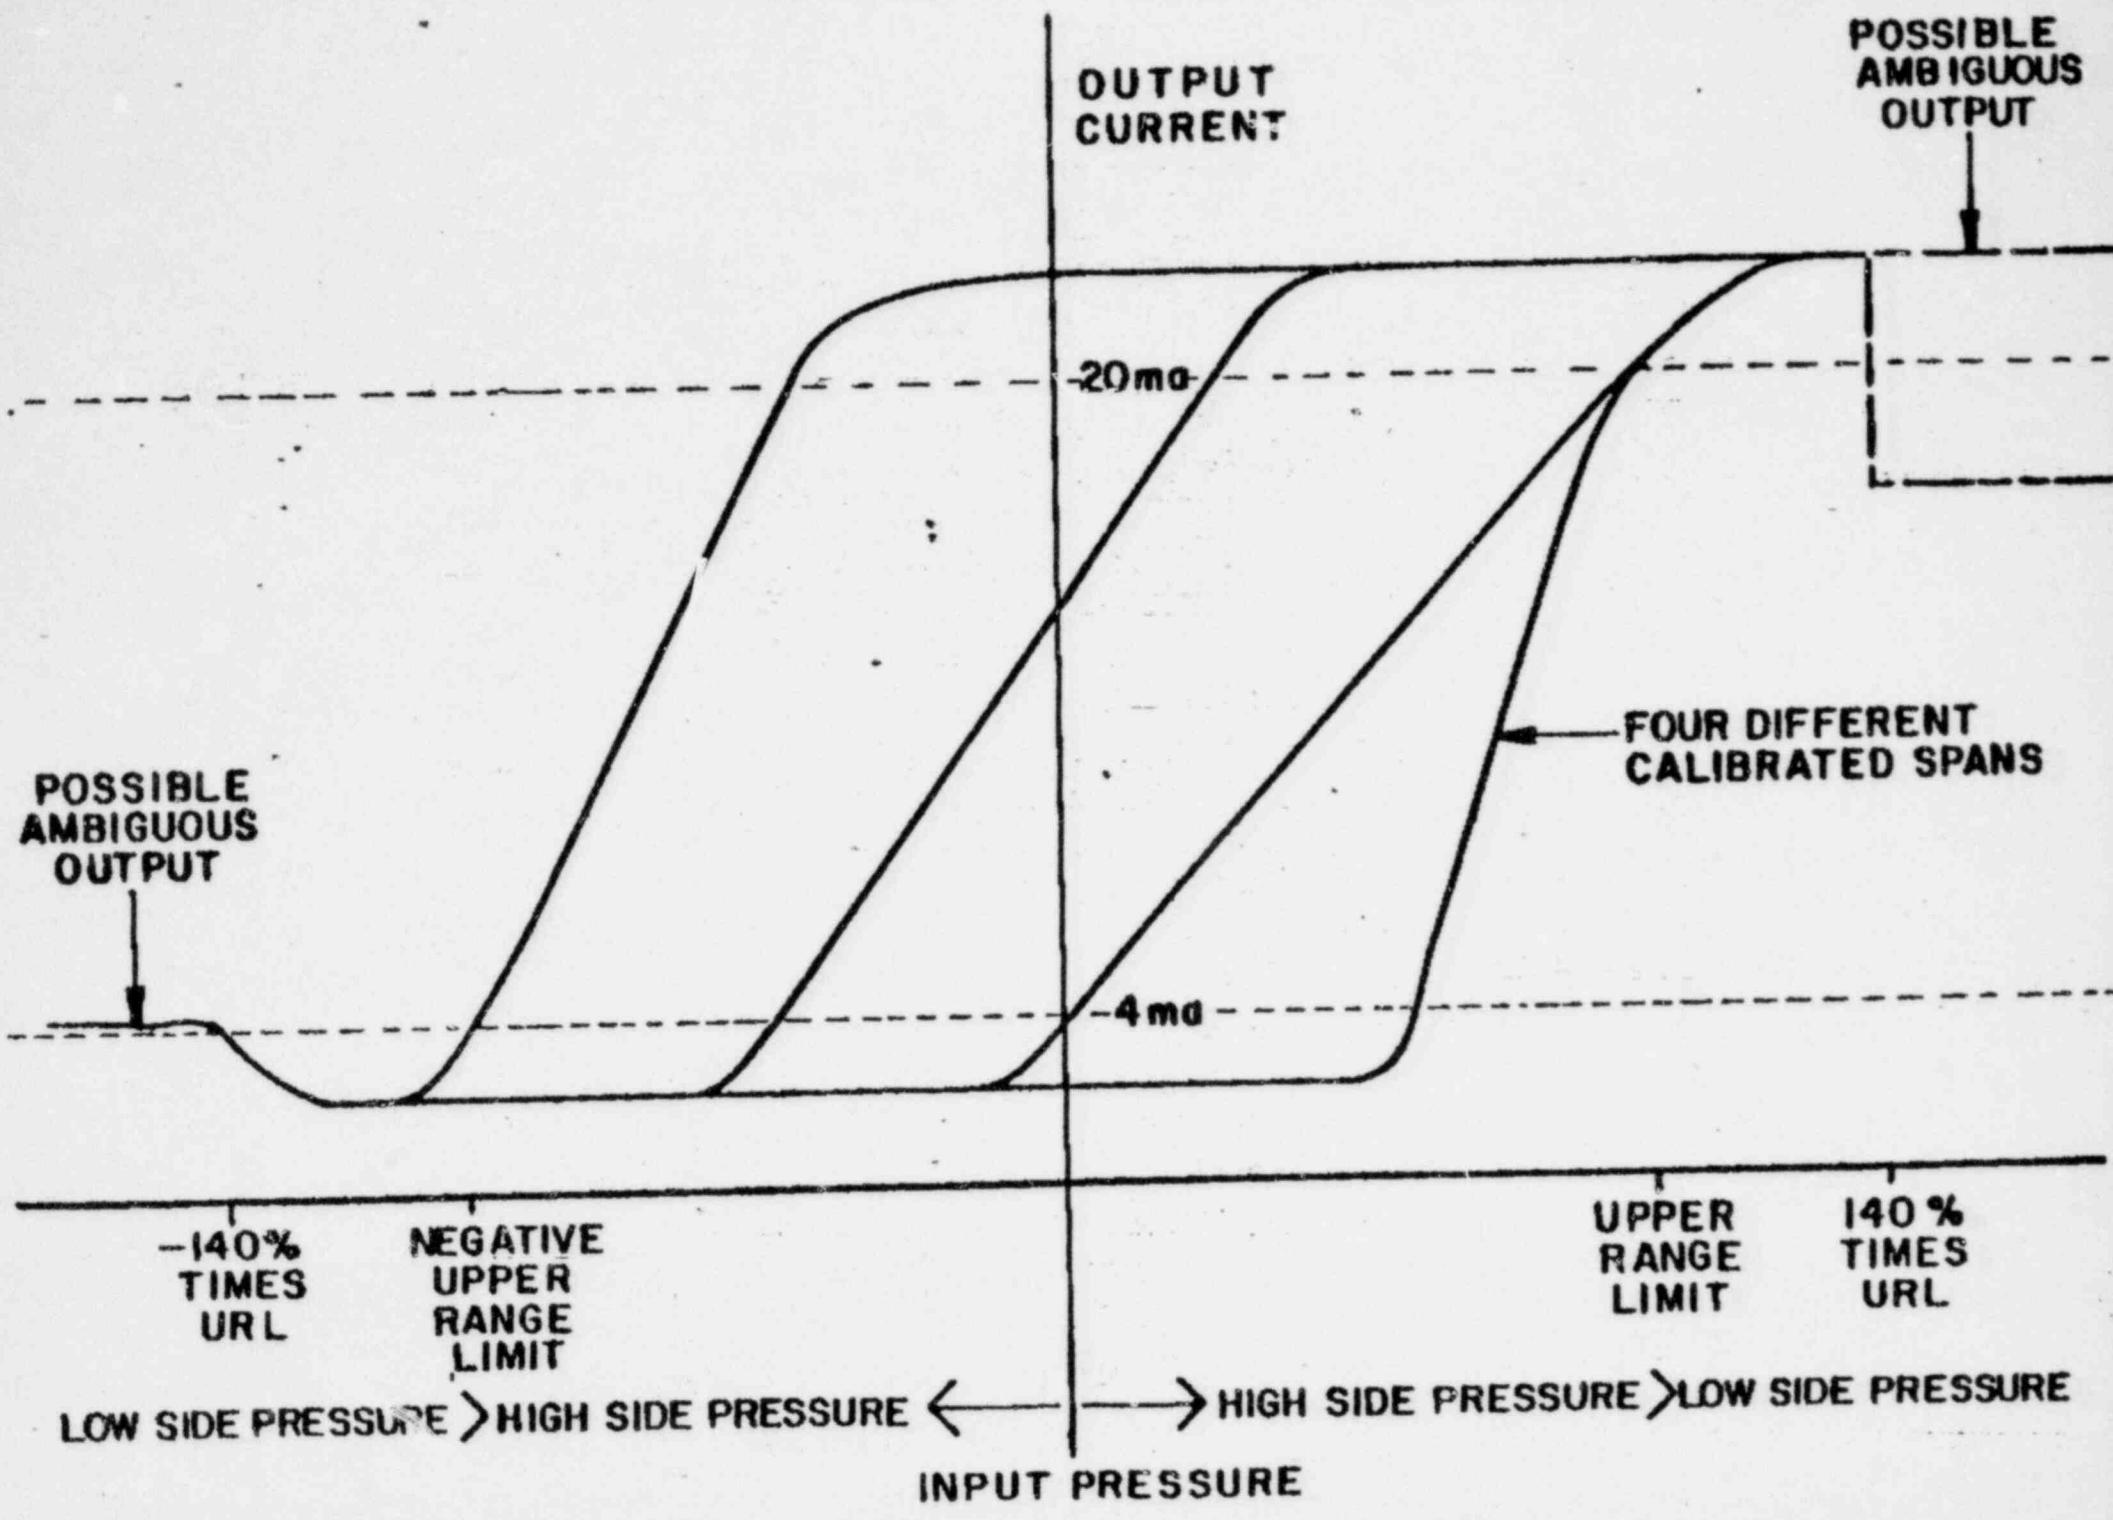
Attachment:

Enclosure 1 contains Rosemount Inc.'s technical description of the potential application problems for Pressure Transmitters Model 1152. This information is applicable to Model 1151 Pressure Transmitters also. This information includes the reasons for the maloperation of the transmitters, a typical pressure versus current output curve and examples of the results of the maloperations. Available information indicates that the problem was reported to each customer who was furnished the subject transmitters by Rosemount Inc.

Rosemount's Model 1152 pressure transmitter provides a specified linear output of 4 to 20 mA throughout the calibrated range of operation. The transmitter output is not specified by Rosemount for pressures outside of the calibrated range of operation. It has been observed in a limited number of transmitters that an output between 4 and 20 mA can occur with certain input pressures outside of the calibrated range. These ambiguous outputs can occur in both an over pressure condition and a reverse pressure condition. Both conditions arise when the center diaphragm of the pressure sensor bottoms out against either of the fixed capacitor plates. In each case the normal capacitance signal becomes a very high capacitance signal which affects the operation of the electronic circuit.

For the over pressure condition, the effect of the high capacitance from the sensor is a modulated output on the oscillator circuit which may cause the output current of the transmitter to drop below 20 mA. In a limited sample size, the ambiguous output during this over pressure condition occurred in 5% of the transmitters at ambient conditions. Referring to the attached graph, this does not occur until the over pressure condition is $\geq 140\%$ of the upper range limit regardless of span. At that point a discontinuity can occur with the output current instantaneously decreasing to less than 20 mA. As an example of this potential applications problem, the upper range limit of a range 5 1152 differential pressure transmitter (Model 1152DP5A22) is 750" H₂O. The range of this pressure transmitter can be set from 0 to 150" H₂O. If the ambiguous output in the over pressure condition is to occur, it will occur at 140% or more of the upper range limit or, in this case, at pressures ≥ 1050 " H₂O (750" H₂O x 1.4). The transmitter then could give an output less than 20 mA at a pressure that is, in this example, seven

times (1050"H₂O + 150"H₂O) the upper range value. Note that the significant figure for use in determining the pressure above which an ambiguous output can occur is the specified upper range limit (750" H₂O in this example) not the customer selected upper range value (150"H₂O in this example).

For the reverse pressure condition, the effect of the high capacitance from the sensor is the oscillator circuit drawing more current which may cause the output current of the transmitter to exceed 4 mA. In a limited sample size, the ambiguous output during this reverse pressure condition occurred in 55% of the transmitters at ambient conditions. Referring to the attached graph, this does not occur until the reverse pressure condition exceeds 140% of the upper range limit regardless of the span. At this point the output may exceed 4 mA. As an example of this potential applications problem consider the range 5 differential transmitter in the previous paragraph. If the ambiguous output in the reverse pressure condition is to occur, it will occur at 140% or more of the upper range limit, or in this case at reversed pressures $\geq 1050"$ H₂O (750"H₂O x 1.4). The transmitter then could give an output greater than 4 mA at a pressure that is, in this example, seven times (1050" H₂O + 150" H₂O) the upper range value, but reversed. Also note that with absolute pressure units a reverse pressure is not possible since the low pressure side of the cell is evacuated. With gage units a reverse pressure is possible only if a vacuum is present on the connected part since the low pressure side of the cell is vented to ambient atmosphere. Since the maximum reverse pressure would be one atmosphere, only range 3 and 4 gage units could obtain a reverse pressure exceeding 140% of the upper range limit.

The safety system should be analyzed in view of this supplementary report to determine if a potential application problem exists and appropriate corrections to the safety system should be implemented.
