IE Bulletin No. 80-16

POTENTIAL MISAPPLICATION OF ROSEMOUNT INC. MODELS 1151 AND 1152 PRESSURE TRANSMITTERS WITH EITHER "A" OR "D" OUTPUT CODES

IE Circular No. 80-16

OPERATIONAL DEFICIENCIES IN ROSEMOUNT MODEL 510DU TRIP UNITS AND MODEL 1152
PRESSURE TRANSMITTERS

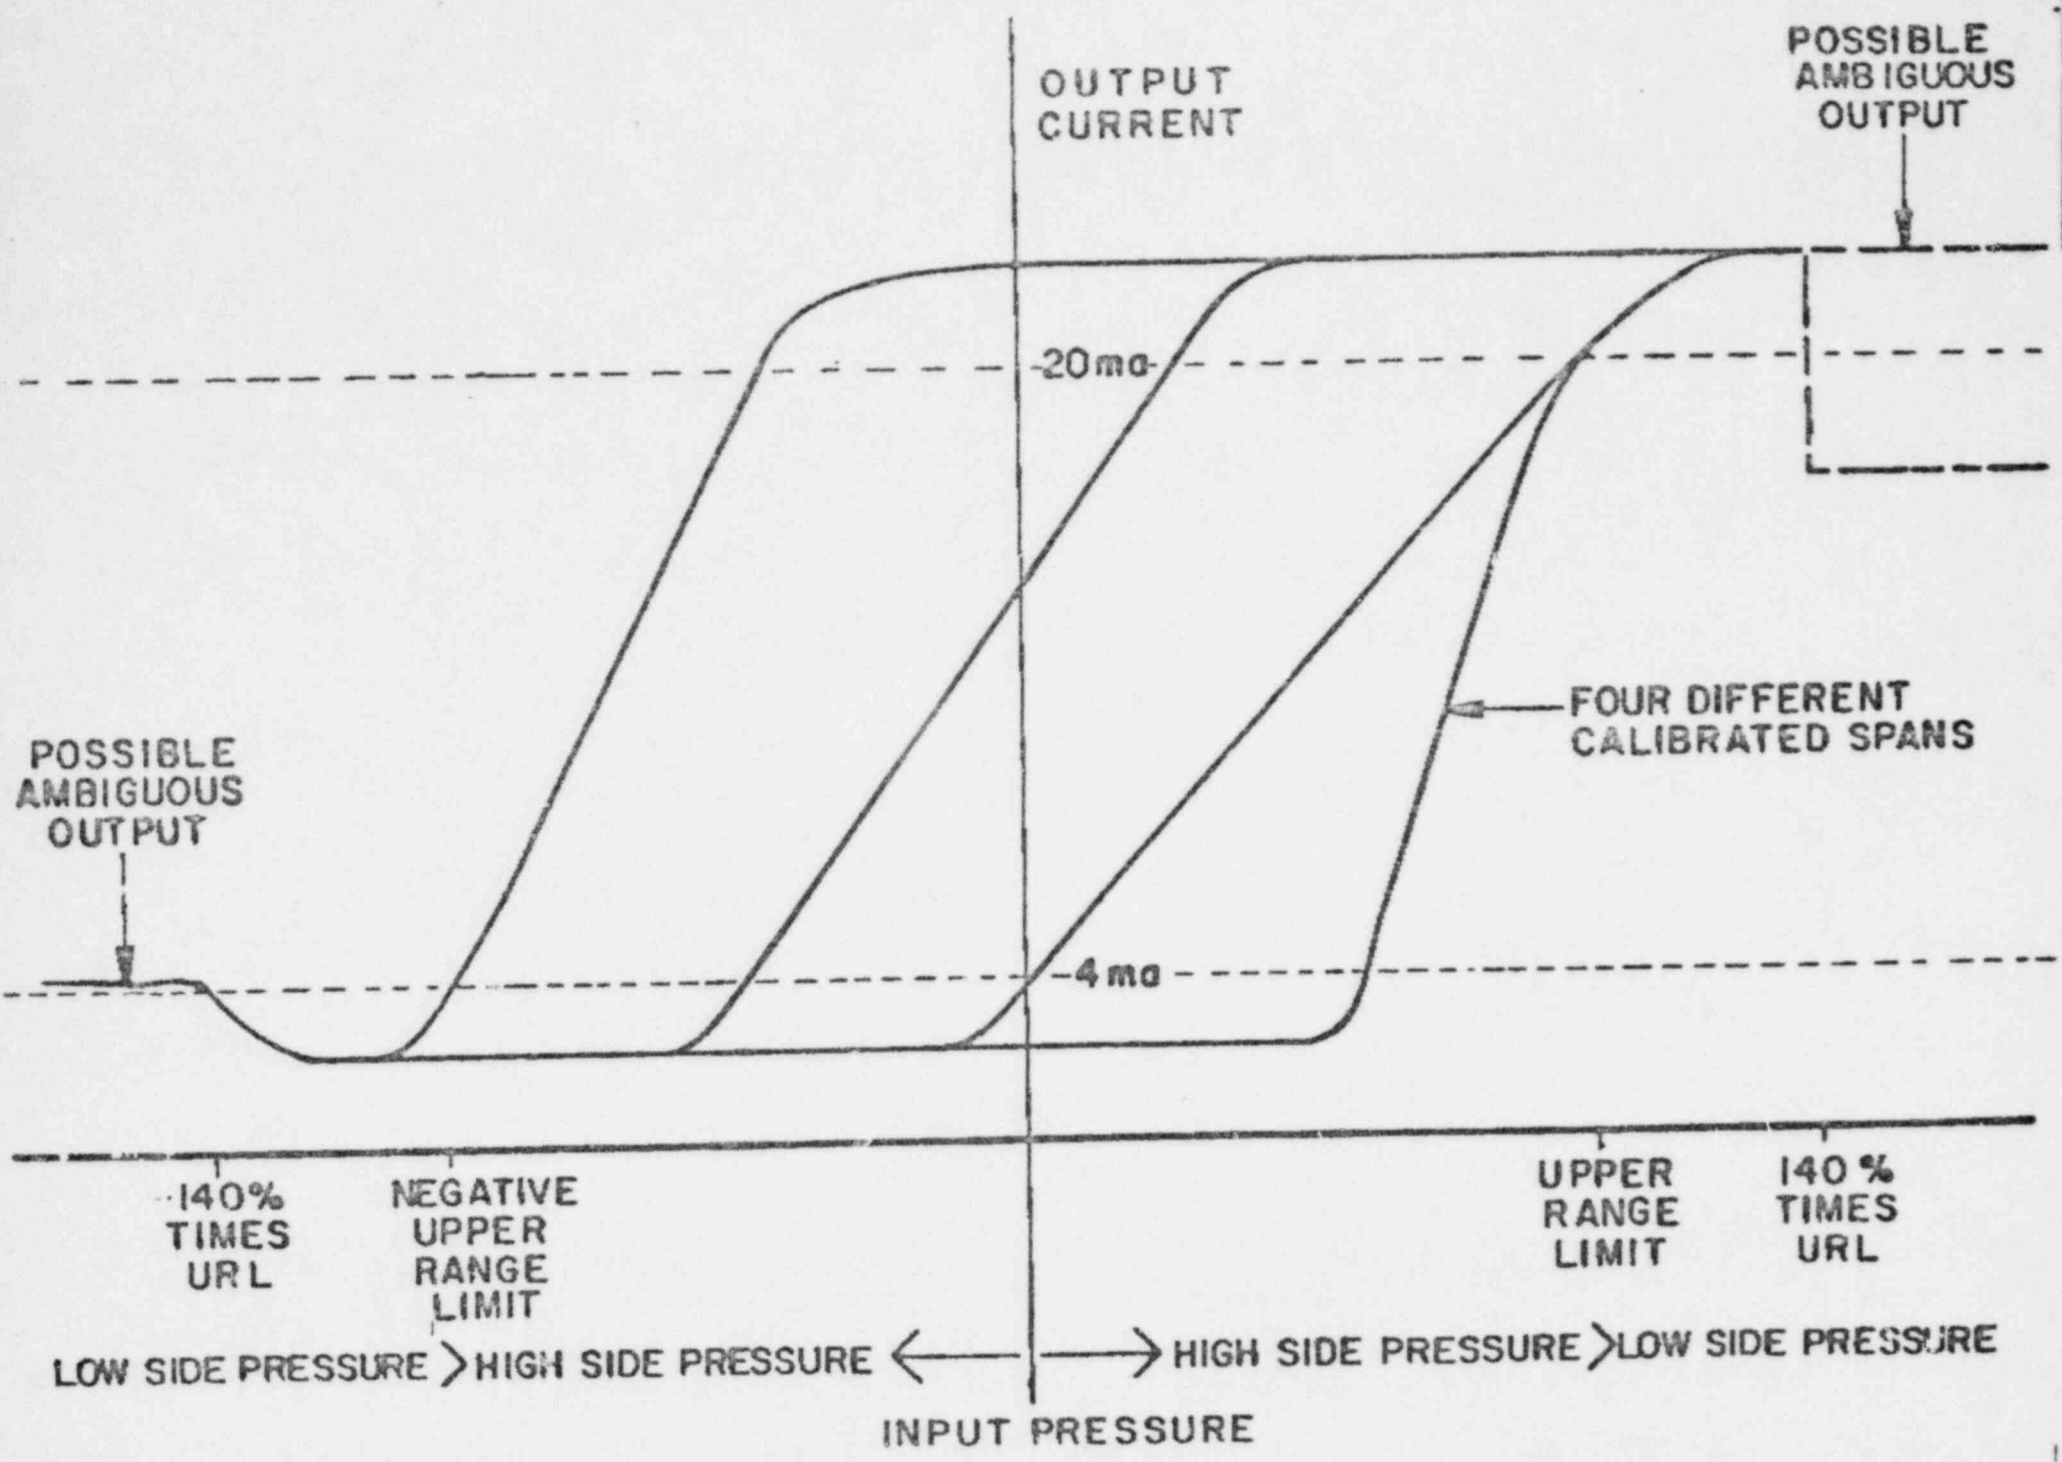
Rosemount's Model 1152 pressure transmitter provides a specified linear output of 4 to 20 mA throughout the calibrated range of operation. The transmitter output is not specified by Rosemount for pressures outside of the calibrated range of operation. It has been observed in a limited number of transmitters that an output between 4 and 20 mA can occur with certain input pressures outside of the calibrated range. These ambiguous outputs can occur in both an over pressure condition and a reverse pressure condition. Both conditions arise when the center diaphragm of the pressure sensor bottoms out against either of the fixed capacitor plates. In each case the normal capacitance signal becomes a very high capacitance signal which affects the operation of the electronic circuit.

For the over pressure condition, the effect of the high capacitance from the sensor is a modulated output on the oscillator circuit which may cause the output current of the transmitter to drop below 20 mA. In a limited sample size, the ambiguous output during this over pressure condition occurred in 5% of the transmitters at ambient conditions. Referring to the attached graph, this does not occur until the over pressure condition is 140% of the upper range limit regardless of span. At that point a discontinuity can occur with the output current instantaneously decreasing to less than 20 mA. As an example of this potential applications problem, the upper range limit of a range 5 1152 differential pressure transmitter (Model 1152DP5A22) is 750" H₂O. The range of this pressure transmitter can be set from 0 to 150" H₂O. If the ambiguous output in the over pressure condition is to occur, it will occur at 140% or more of the upper range limit or, in this case, at pressures 1050" H₂O (750" H₂O x 1.4). The transmitter then could give an output less than 20 mA at a pressure that is, in this example, seven

times (1050" H₂O ' 150" H₂O) the upper range value. Note that the significant figure for use in determining the pressure above which an ambiguous output can occur is the specified upper range limit (750" H₂O in this example) not the customer selected upper range value (150" H₂O in this example).

For the reverse pressure condition, the effect of the high capacitance from the sensor is the oscillator circuit drawing more current which may cause the output current of the transmitter to exceed 4 mA. In a limited sample size, the ambiguous output during this reverse pressure condition occurred in 55% of the transmitters at ambient conditions. Referring to the attached graph, this does not occur until the reverse pressure condition exceeds 140% of the upper range limit regardless of the span. At this point the output may exceed 4 mA. As an example of this potential applications problem consider the range 5 differential transmitter in the previous paragraph. If the ambiguous output in the reverse pressure condition is to occur, it will occur at 140% or more of the upper range limit, or in this case at reversed pressures $\frac{1}{J}$ 1050" H₂O (750" H₂O x 1.4). The transmitter then could give an output greater than 4 mA at a pressure that is, in this example, seven times (1050" H₂O ' 150" H₂O) the upper range value, but reversed. Also note that with absolute pressure units a reverse pressure is not possible since the low pressure side of the cell is evacuated. With gage units a reverse pressure is possible only if a vacuum is present on the connected part since the low pressure side of the cell is vented to ambient atmosphere. Since the maximum reverse pressure would be one atmosphere, only range 3 and 4 gage units could obtain a reverse pressure exceeding 140% of the upper range limit.

The safety system should be analyzed in view of this supplementary report to determine if a potential application problem exists and appropriate corrections to the safety system should be implemented.
