IE Bulletin No. 80-16

POTENTIAL MISAPPLICATION OF ROSEMOUNT INC. MODELS 1151 AND 1152 PRESSURE TRANSMITTERS WITH EITHER "A" OR "D" OUTPUT CODES

IE Circular No. 80-16

OPERATIONAL DEFICIENCIES IN ROSEMOUNT MODEL 510DU TRIP UNITS AND MODEL 1152  
PRESSURE TRANSMITTERS

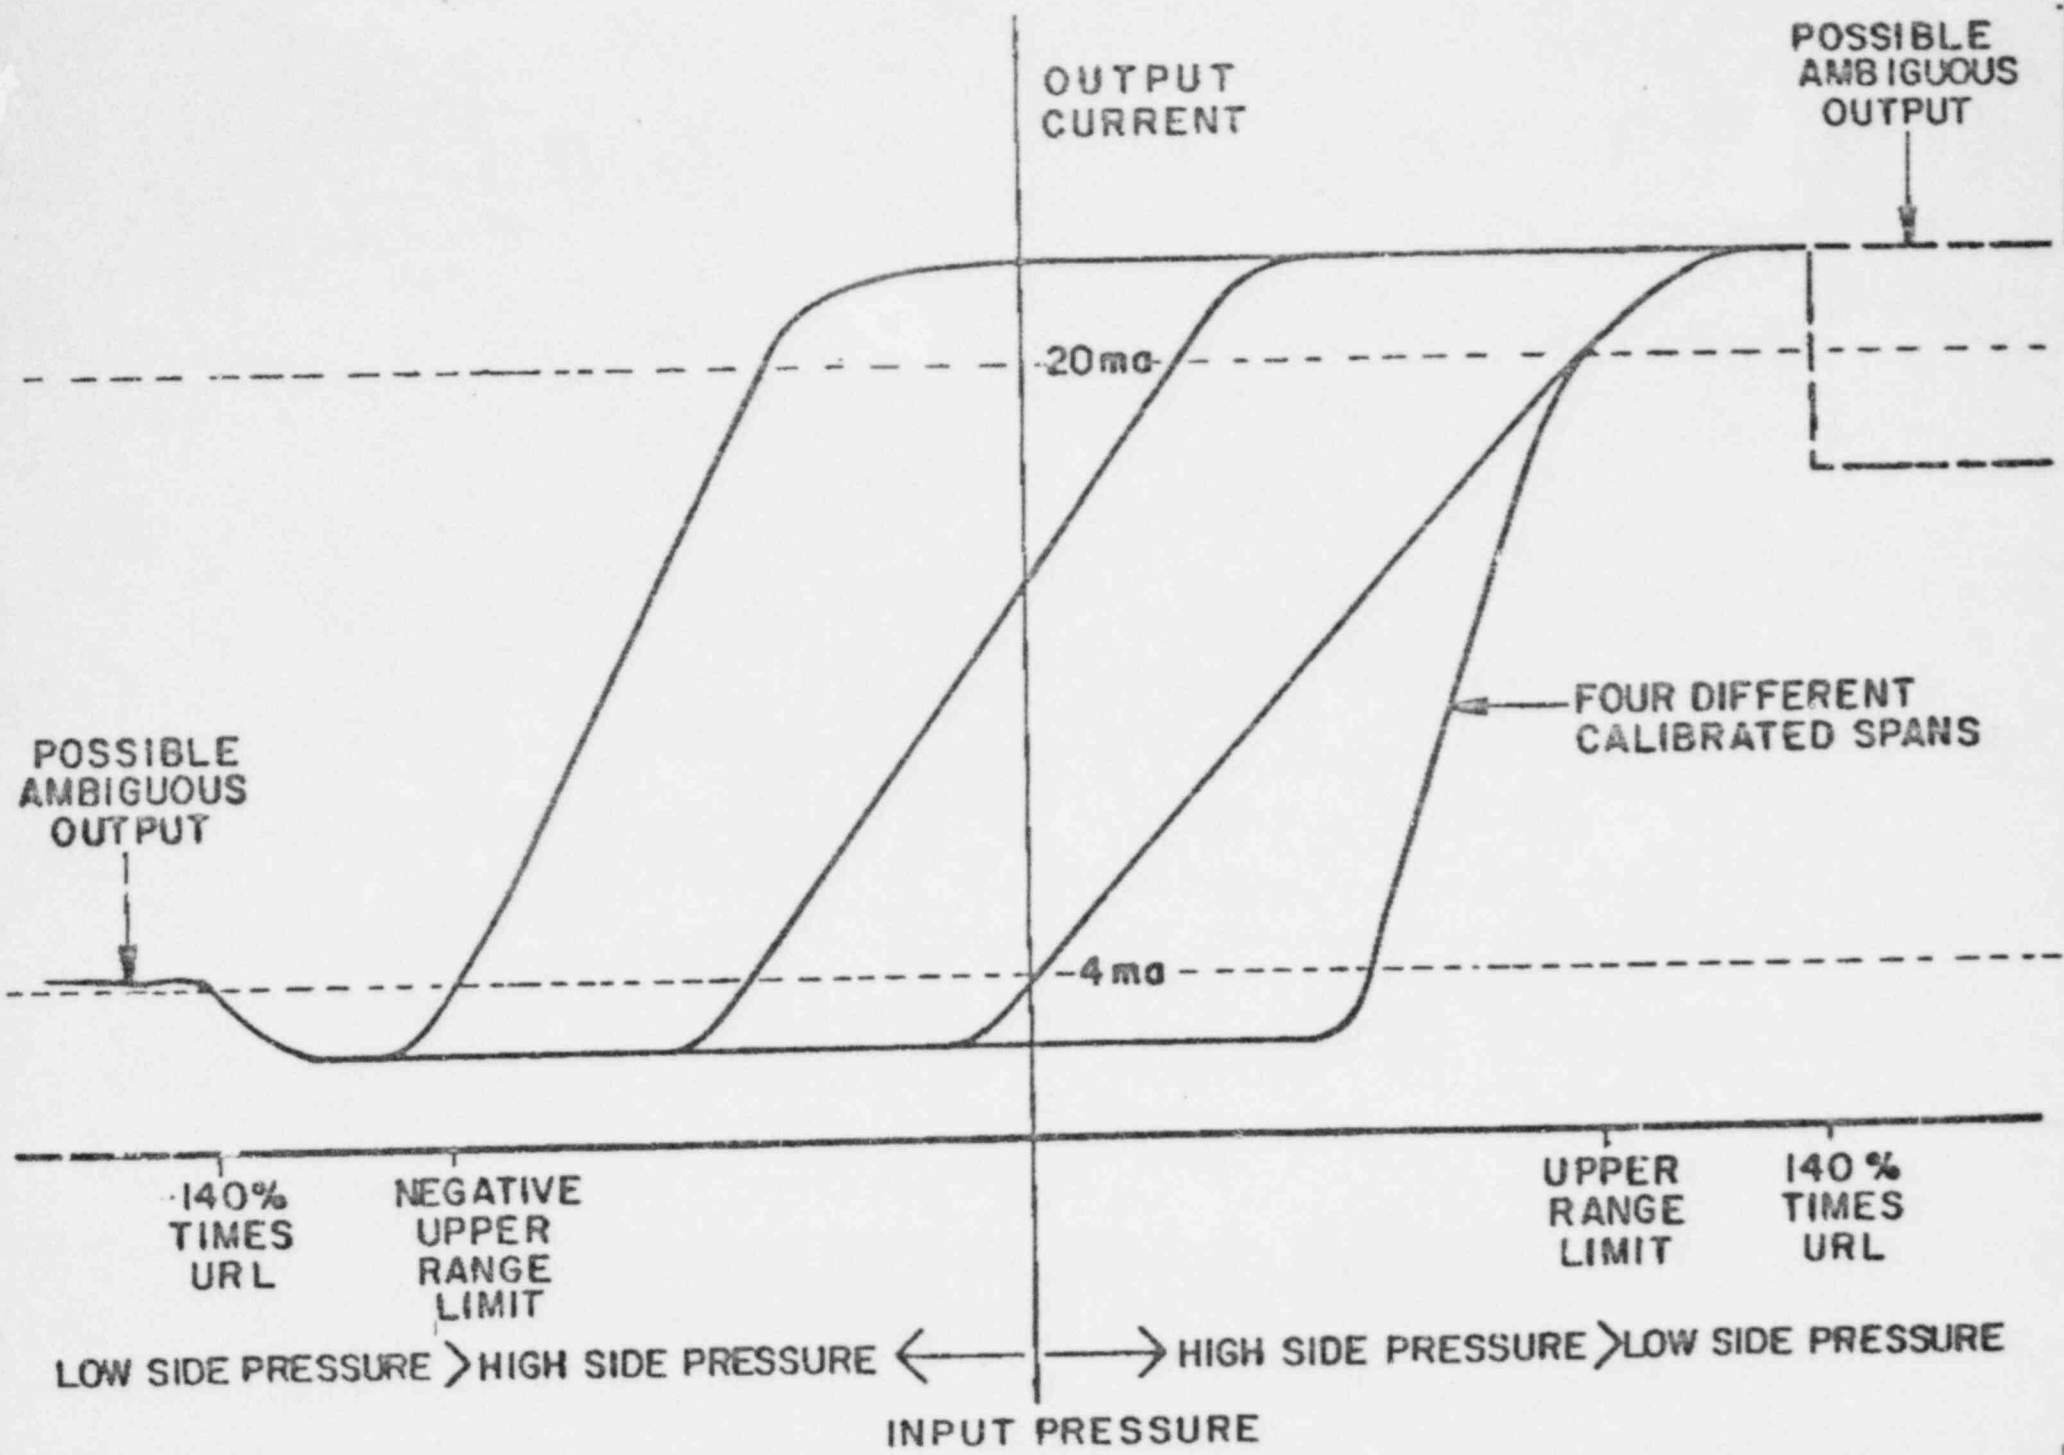
For the over pressure condition, the effect of the high capacitance from the sensor is a modulated output on the oscillator circuit which may cause the output current of the transmitter to drop below 20 mA. In a limited sample size, the ambiguous output during this over pressure condition occurred in 5% of the transmitters at ambient conditions. Referring to the attached graph, this does not occur until the over pressure condition is J 140% of the upper range limit regardless of span. At that point a J discontinuity can occur with the output current instantaneously decreasing to less than 20 mA. As an example of this potential applications problem, the upper range limit of a range 5 1152 differential pressure transmitter (Model 1152DP5A22) is 750"H<sub>2</sub>O. The range of this pressure transmitter can be set from 0 to 150"H<sub>2</sub>O. If the ambiguous output in the over pressure condition is to occur, it will occur at 140% or more of the upper range limit or, in this case, at pressures J 1050"H<sub>2</sub>O (750"H<sub>2</sub>O x 1.4). The transmitter then could give an output less than 20 mA at a pressure that is, in this example, seven

times (1050" H<sub>2</sub>O ' 150" H<sub>2</sub>O) the upper range value. Note that the significant figure for use in determining the pressure above which an ambiguous output can occur is the specified upper range limit (750" H<sub>2</sub>O in this example) not the customer selected upper range value (150" H<sub>2</sub>O in this example).

For the reverse pressure condition, the effect of the high capacitance from the sensor is the oscillator circuit drawing more current which may cause the output current of the transmitter to exceed 4 mA. In a limited sample size, the ambiguous output during this reverse pressure condition occurred in 55% of the transmitters at ambient conditions. Referring to the attached graph, this does not occur until the reverse pressure condition exceeds 140% of the upper range limit regardless of the span. At this point the output may exceed 4 mA. As an example of this potential applications problem consider the range 5 differential transmitter in the previous paragraph. If the ambiguous output in the reverse pressure condition is to occur, it will occur at 140% or more of the upper range limit, or in this case at reversed pressures  $\underline{J}$  1050" H<sub>2</sub>O (750" H<sub>2</sub>O x 1.4). The transmitter then could give an output greater than 4 mA at a pressure that is, in this example, seven times (1050" H<sub>2</sub>O ' 150" H<sub>2</sub>O) the upper range value, but reversed. Also note that with absolute pressure units a reverse pressure is not possible since the low pressure side of the cell is evacuated. With gage units a reverse pressure is possible only if a vacuum is present on the connected part since the low pressure side of the cell is vented to ambient atmosphere. Since the maximum reverse pressure would be one atmosphere, only range 3 and 4 gage units could obtain a reverse pressure exceeding 140% of the upper range limit.

POSSIBLE AMBIGUOUS OUTPUT

FOUR DIFFERENT CALIBRATED SPANS

140% TIMES URL

NEGATIVE UPPER RANGE LIMIT

UPPER RANGE LIMIT

LOW SIDE PRESSURE > HIGH SIDE PRESSURE < ———> HIGH SIDE PRESSURE > LOW SIDE PRESSURE

The safety system should be analyzed in view of this supplementary report to determine if a potential application problem exists and appropriate corrections to the safety system should be implemented.
