Docket No. 50-312

IE Bulletin No. 80-16

POTENTIAL MISAPPLICATION OF ROSEMOUNT INC. MODELS 1151 AND 1152 PRESSURE TRANSMITTERS WITH EITHER "A" OR "D" OUTPUT CODES

IE Circular No. 80-16

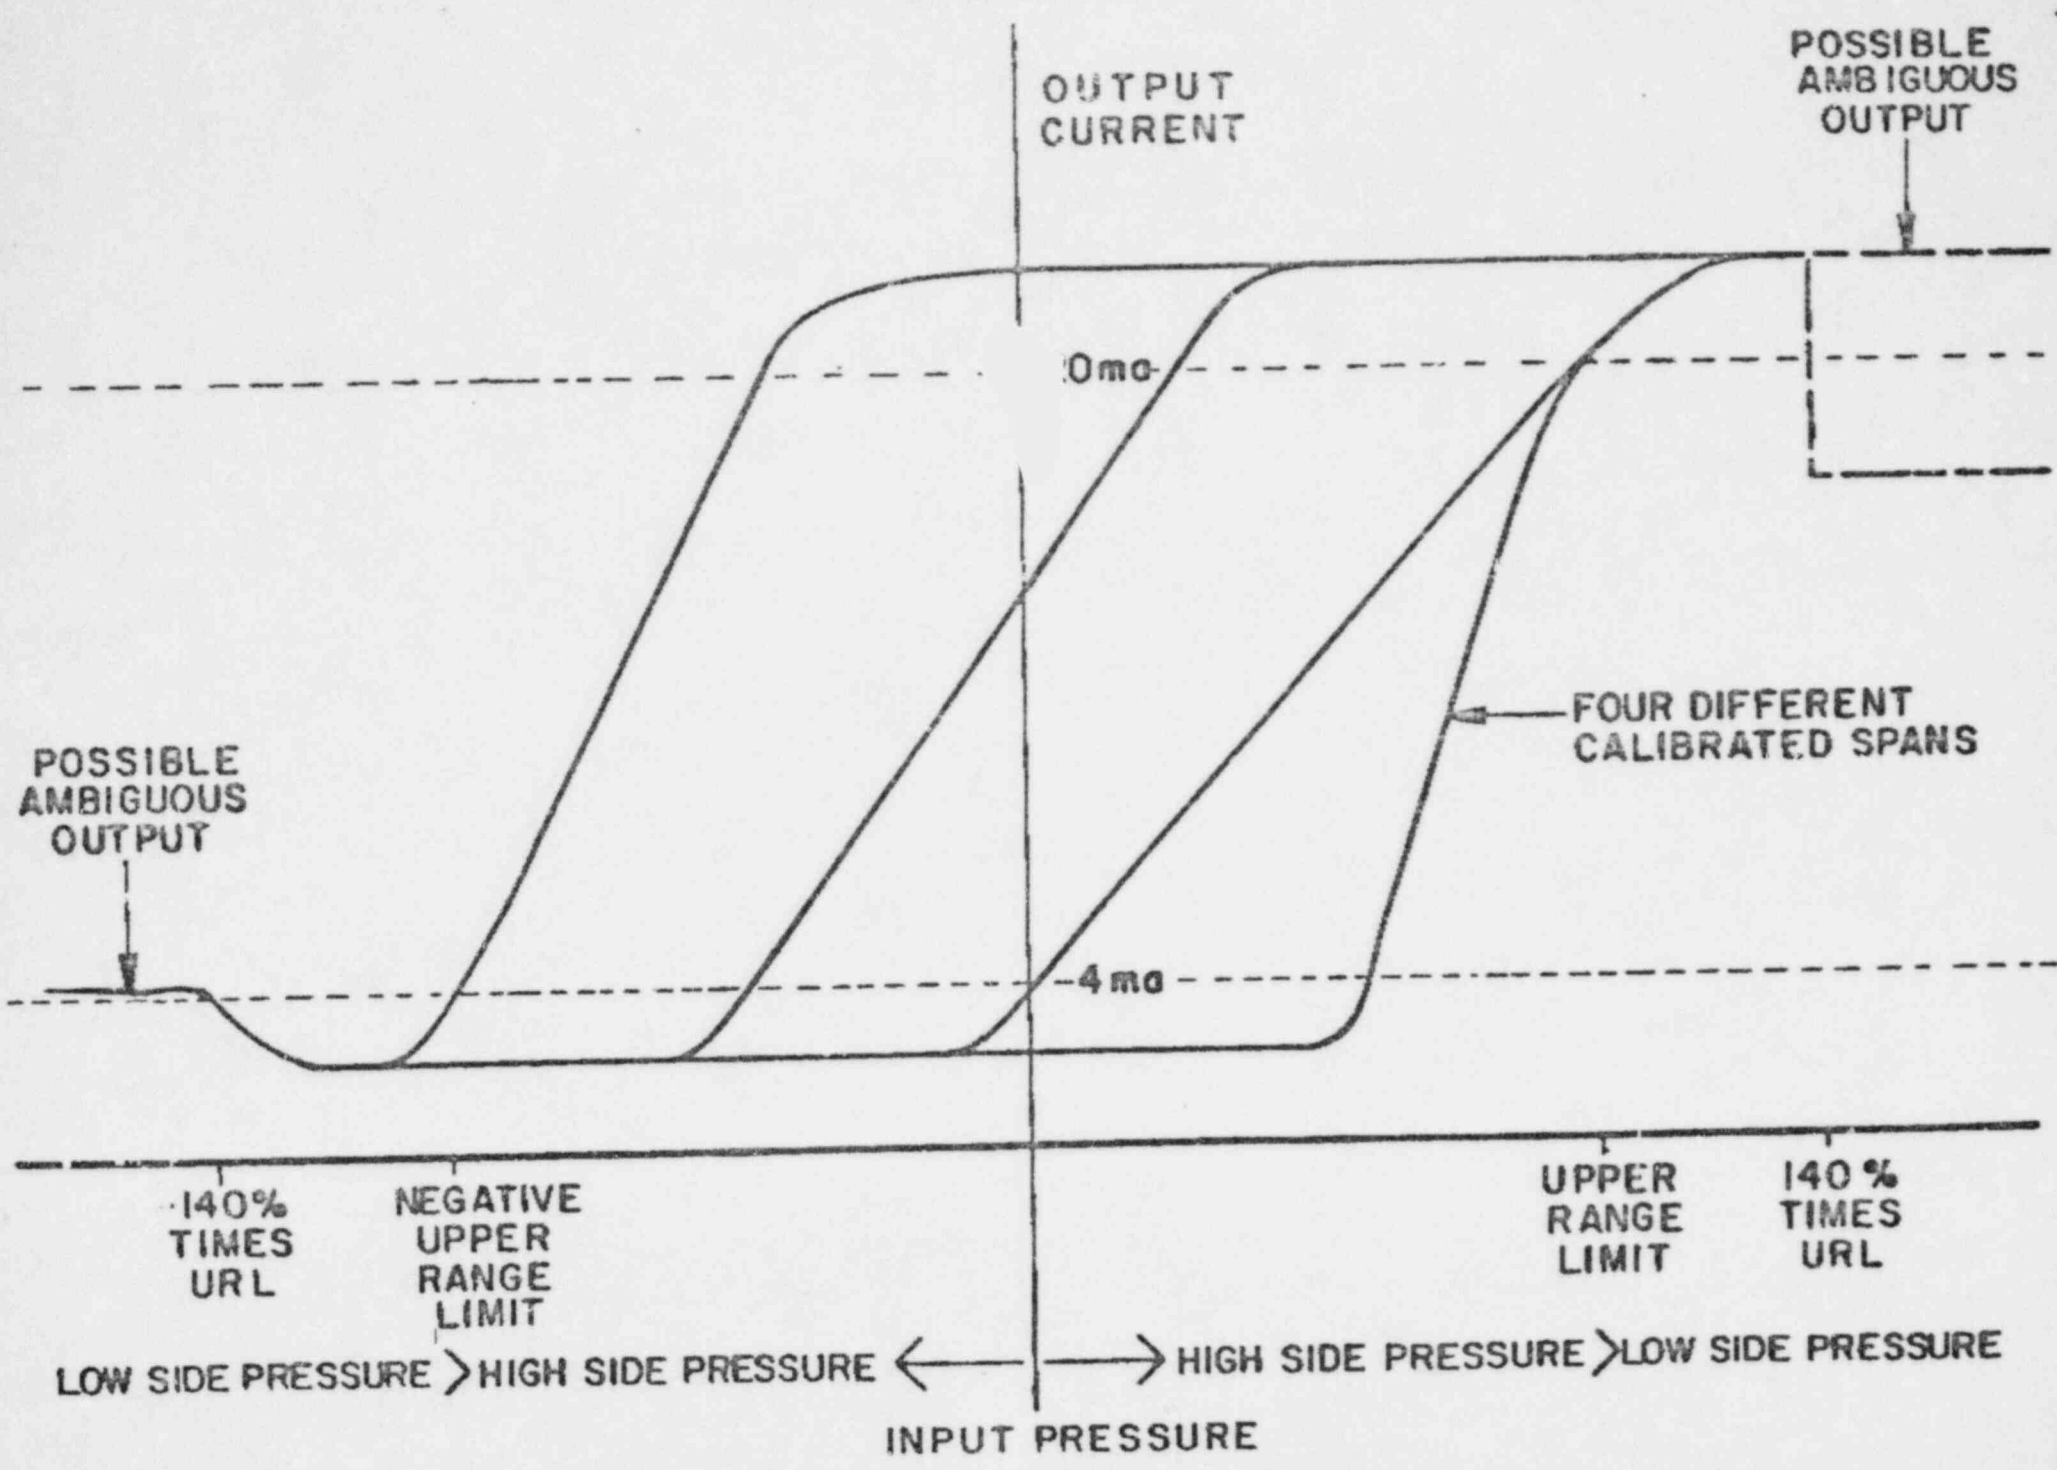
Enclosure 1 contains Rosemount Inc.'s technical description of the potential application problems for Pressure Transmitters Model 1152. This information is applicable to Model 1151 Pressure Transmitters also. This information includes the reasons for the maloperation of the transmitters, a typical pressure versus current output curve and examples of the results of the mal-operations. Available information indicates that the problem was reported to each customer who was furnished the subject transmitters by Rosemount Inc.

Rosemount's Model 1152 pressure transmitter provides a specified linear output of 4 to 20 mA throughout the calibrated range of operation. The transmitter output is not specified by Rosemount for pressures outside of the calibrated range of operation. It has been observed in a limited number of transmitters that an output between 4 and 20 mA can occur with certain input pressures outside of the calibrated range. These ambiguous outputs can occur in both an over pressure condition and a reverse pressure condition. Both conditions arise when the center diaphragm of the pressure sensor bottoms out against either of the fixed capacitor plates. In each case the normal capacitance signal becomes a very high capacitance signal which affects the operation of the electronic circuit.

For the over pressure condition, the effect of the high capacitance from the sensor is a modulated output on the oscillator circuit which may cause the output current of the transmitter to drop below 20 mA. In a limited sample size, the ambiguous output during this over pressure condition occurred in 5% of the transmitters at ambient conditions. Referring to the attached graph, this does not occur until the over pressure condition is J 140% of the upper range limit regardless of span. At that point a J discontinuity can occur with the output current instantaneously decreasing to less than 20 mA. As an example of this potential applications problem, the upper range limit of a range 5 1152 differential pressure transmitter (Model 1152DP5A22) is 750"H<sub>2</sub>O. The range of this pressure transmitter can be set from 0 to 150"H<sub>2</sub>O. If the ambiguous output in the over pressure condition is to occur, it will occur at 140% or more of the upper range limit or, in this case, at pressures J 1050"H<sub>2</sub>O (750"H<sub>2</sub>O x 1.4). The transmitter then could give an output less than 20 mA at a pressure that is, in this example, seven

times (1050" H<sub>2</sub>O ' 150" H<sub>2</sub>O) the upper range value. Note that the significant figure for use in determining the pressure above which an ambiguous output can occur is the specified upper range limit (750" H<sub>2</sub>O in this example) not the customer selected upper range value (150" H<sub>2</sub>O in this example).

For the reverse pressure condition, the effect of the high capacitance from the sensor is the oscillator circuit drawing more current which may cause the output current of the transmitter to exceed 4 mA. In a limited sample size, the ambiguous output during this reverse pressure condition occurred in 55% of the transmitters at ambient conditions. Referring to the attached graph, this does not occur until the reverse pressure condition exceeds 140% of the upper range limit regardless of the span. At this point the output may exceed 4 mA. As an example of this potential applications problem consider the range 5 differential transmitter in the previous paragraph. If the ambiguous output in the reverse pressure condition is to occur, it will occur at 140% or more of the upper range limit, or in this case at reversed pressures J 1050" H<sub>2</sub>O (750" H<sub>2</sub>O x 1.4). The transmitter then could give an output greater than 4 mA at a pressure that is, in this example, seven times (1050" H<sub>2</sub>O ' 150" H<sub>2</sub>O) the upper range value, but reversed. Also note that with absolute pressure units a reverse pressure is not possible since the low pressure side of the cell is evacuated. With gage units a reverse pressure is possible only if a vacuum is present on the connected part since the low pressure side of the cell is vented to ambient atmosphere. Since the maximum reverse pressure would be one atmosphere, only range 3 and 4 gage units could obtain a reverse pressure exceeding 140% of the upper range limit.

The safety system should be analyzed in view of this supplementary report to determine if a potential application problem exists and appropriate corrections to the safety system should be implemented.
