July 15, 1980
Fort St. Vrain
Unit No. 1
P-80212

REPORTABLE OCCURRENCE 80-32
ISSUE 0

FORT ST. VRAIN NUCLEAR GENERATING STATION
PUBLIC SERVICE COMPANY OF COLORADO
16805 WELD COUNTY ROAD 19 1/2
PLATTEVILLE, COLORADO 80651

REPORT NO. 50-267/80-32/03-L-0

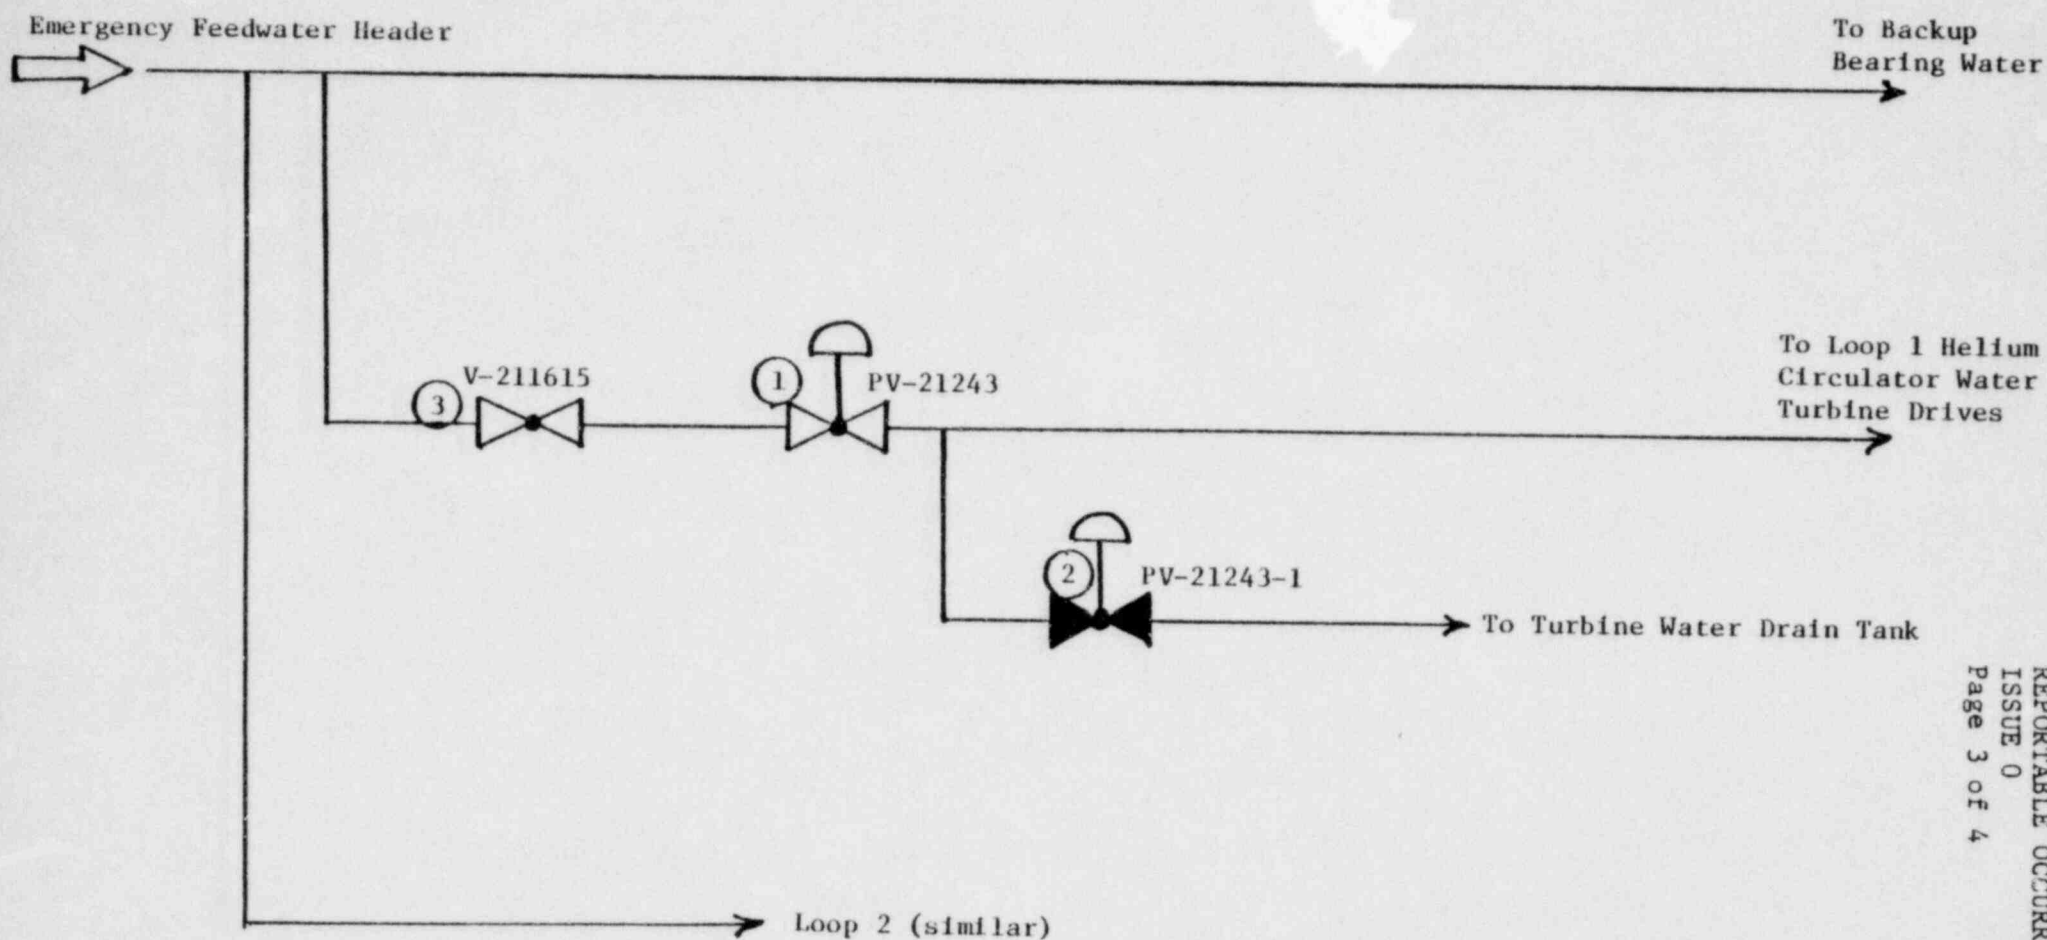
FIGURE 1

Refer to Figure 1. The Loop 1 pressure control system consists of two valves (① and ②). Main pressure control valve PV-21243 (① of Figure 1) is designed to control feedwater supply pressure under flow conditions. Secondary valve PV-21243-1 (② of Figure 1) is provided to bleed off leakage from the main valve to the turbine water drain tank under the no-flow conditions which normally exist.

The Loop 1 emergency feedwater header supply was isolated via V-211615 (③ of Figure 1) at 0830 hours on June 17 for repair of the problems noted above. Because the reactor was not at power, no LCO 4.2.2 degraded mode operation occurred. However, by 2115 hours all preparations for return to power operation had been completed, and reactor power was increased to greater than 2%. Because PV-21243 repair was not complete, the Loop 1 emergency feedwater supply was still isolated. This constitutes operation in a degraded mode of LCO 4.2.2(a).

System isolation was necessary to replace a leaking elbow on the 1" line downstream of PV-21243-1 and to repair PV-21243 to alleviate valve leakage. At the time the reactor was returned to power operation, the repair of PV-21243 was not complete; thus the system was still isolated.

Loop 1 Emergency Feedwater Pressure Control

Problems with pressure control and leakage on PV-21243 were alleviated by applying devcon to the area under the seal ring gasket.

Valve repair was completed on June 18, 1980, and the system returned to service.
