BAW-1623

June 1980

CONTROL ROD GUIDE TUBE WEAR
MEASUREMENT PROGRAM

Prepared for
The B&W Mk-B User's Group

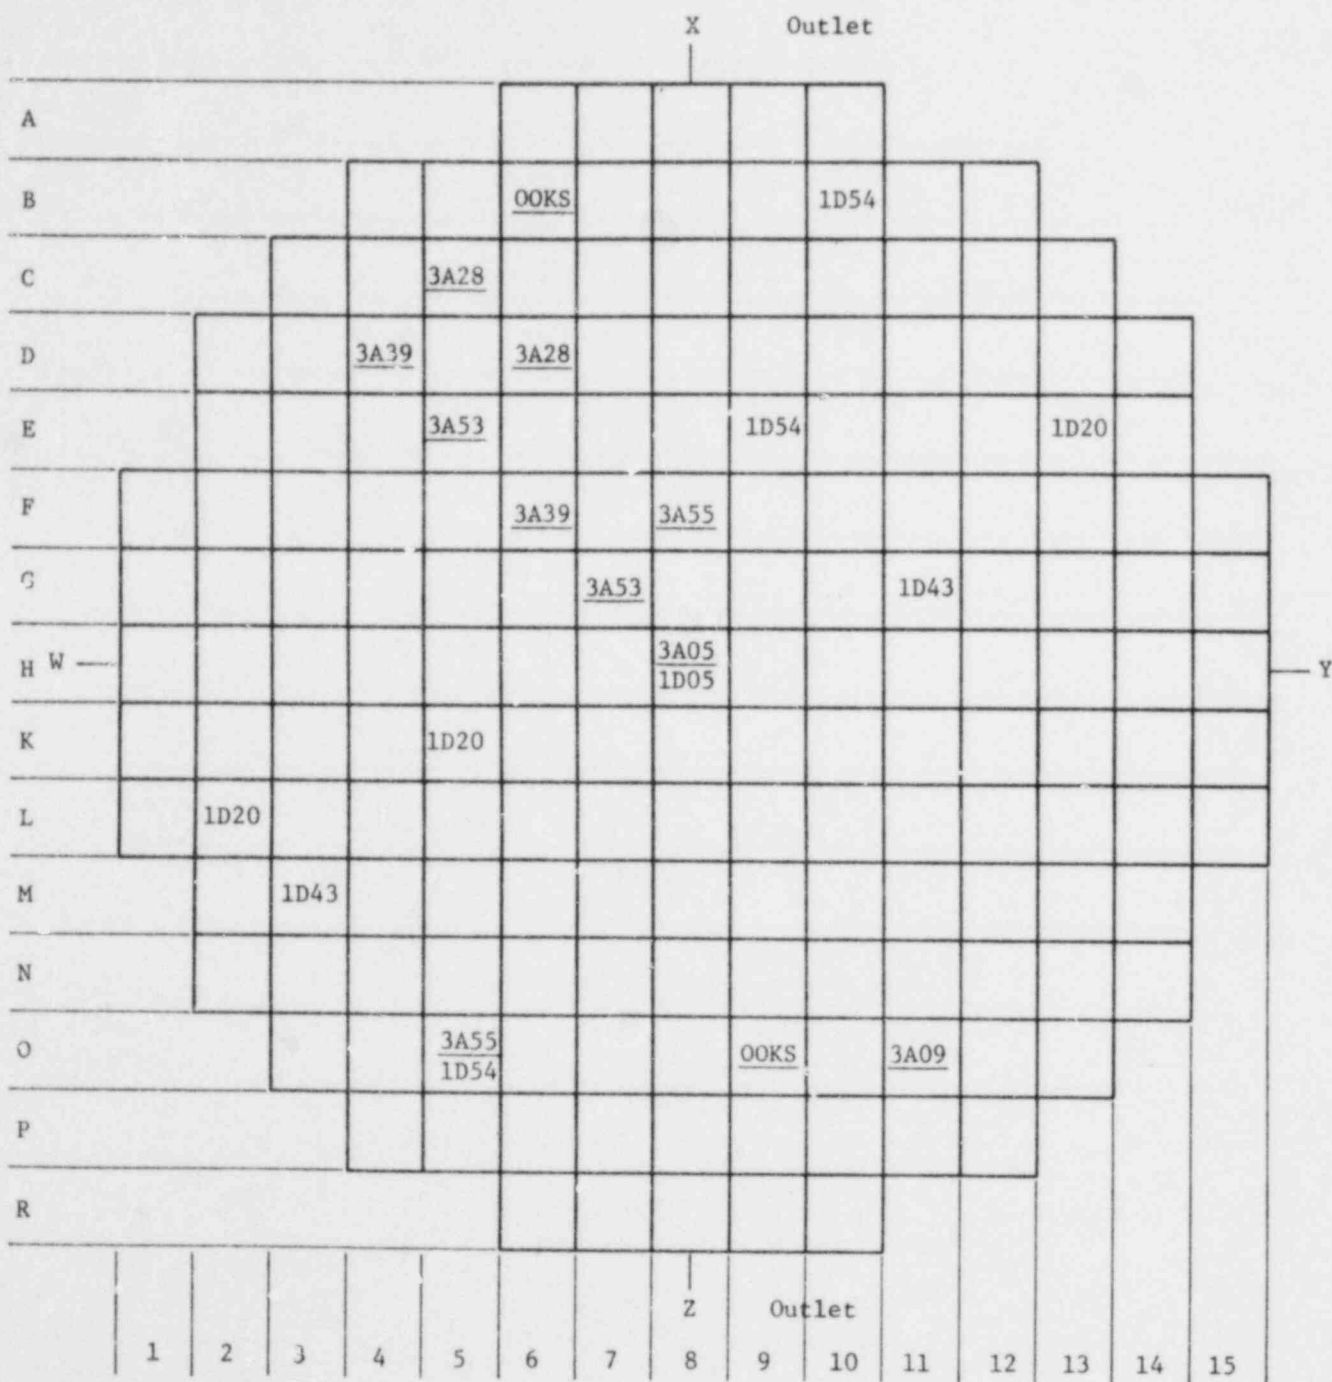
Figure 3-1. Core Location of Fuel Assemblies Examined at Oconee 1 and Oconee 3

Table 3-1 lists the fuel assemblies selected from the three reactors. Figures 3-1 and 3-2 show the core locations of the fuel assemblies inspected. Table 3-1 also gives the operating histories of the fuel assemblies examined.

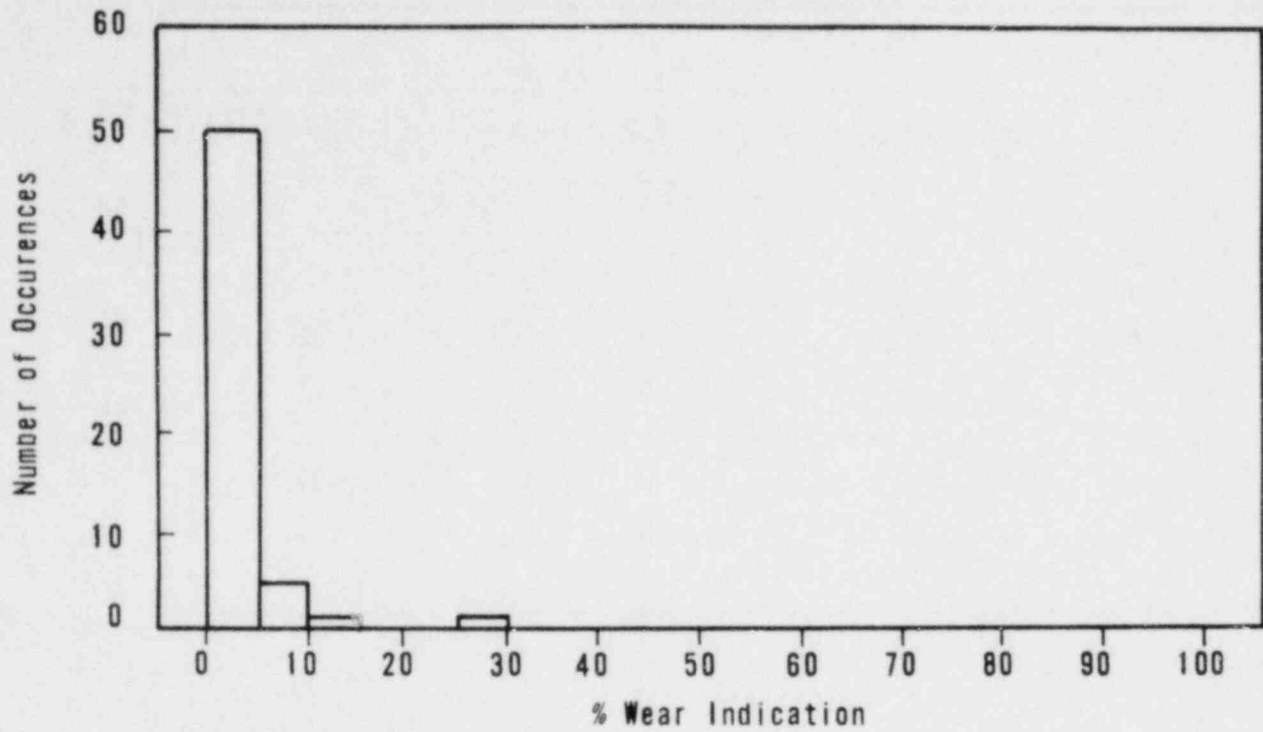
Figure 4-1. Oconee Wear Amplitude

The results from the Oconee examination (low flow rates) indicate less wear than Rancho Seco, with a maximum measured indication of 27% (in Oconee 3). The average wear for each Oconee fuel assembly was low, with a maximum of 6.7%. Table 4-2 shows the wear indication for each tube measured.

The results of both the Oconee and SMUD measurements show small average wear with the maximum average of 14.9% for one SMUD assembly with 1½ cycles of operation. The 14.9% was one-sided wear which is compared to an allowable wear of 100%. The distribution of wear indications is plotted in Figures 4-1 and 4-2.

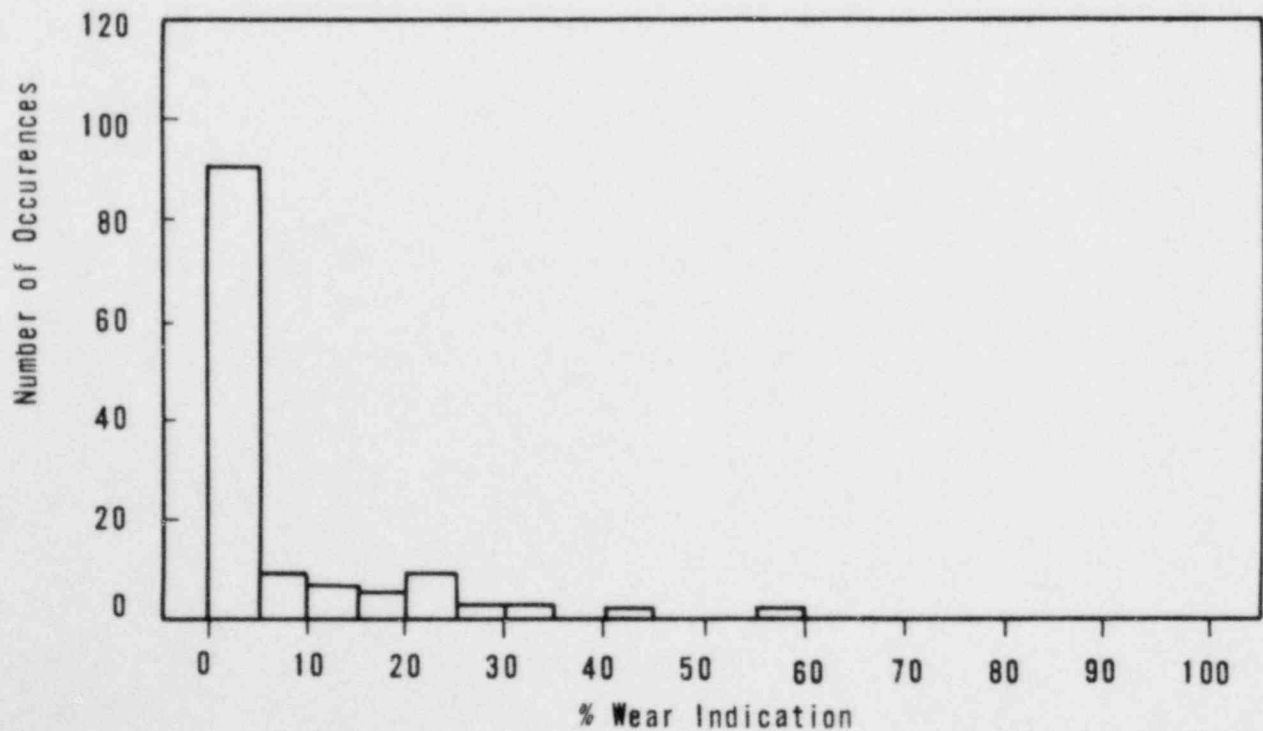
Figure 4-2. Rancho Seco Wear Amplitude

The results from the Rancho Seco examination (high flow rate) indicates that the largest measured wear was 57% (through-wall wear). In general, the wear was located approximately 9 inches down from the top of the guide tube, which corresponds to the location of the lower tip of the control rods of the safety banks in their park position. This location also corresponds to the control rod park position for control banks in some reactors. Four Rancho Seco fuel assemblies indicated wear ranging from 6.9 to 14.9% for one and one half cycles of operation. The other five assemblies examined indicated no wear. Table 4-1 shows the wear indication for each tube measured.

Wear indications from the Rancho Seco examination were ranked according to percent wear indication and plotted on probability paper. These results indicate that for wear indications above 5% the wear appears random and agrees with the first assumption.

The results from the Rancho Seco statistical analysis indicate the probability of one guide tube wearing a hole is very low and is not expected. The probability that a hole will occur in 150 weeks of operation is 0.000011. The results from this analysis also indicate that the probability of the average of 16 tubes in one assembly reaching 55% wear is also very low and is not expected. The probability of the average of 16 tubes reaching 55% wear is 0.000001 for 150 weeks of operation. This case assumes uniform circumferential wear, which is not expected. The more likely case is wear occurring on only one side of the guide tube. This case has a higher allowable wear (100% versus 55%) and hence a significantly smaller probability of reaching this wear.
