THREE MILE ISLAND-1

FILE: 13-5-322
CONTRACT NO: 620-00 OS
SPR 322 REV. 1
TITLE Low PRESS.
LEVEL FOLLOWING
REACTOR TRIP
DATE: 6-25-76

SITE PROBLEM REPORT

TITLE ICS PERFORMANCE FOLLOWING GENERATOR-REACTOR TRIP

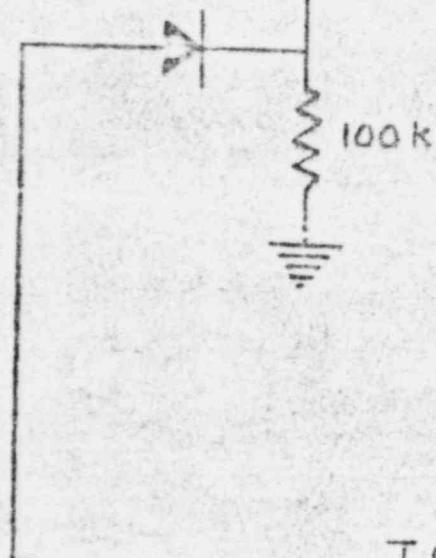
FEEDWATER PUMP SPEED "KICKER"
MODIFICATION TO THE ICS

The purpose of the Pump Speed "Kicker" Circuit is to enable the feedwater flow control system to continue to deliver a high level of flow to each Steam Generator, even though the steam outlet pressure has suddenly increased approximately 130 psi. The modification originated and implemented at TMI-1 improved the overall plant performance by directly increasing feedwater pump speed more rapidly than could be accomplished by the combined action of the feedwater control valve and pump speed controllers in the ICS.

Route an additional wire from the turbine header pressure error signal (IC/B on Drawing Unit #1) to two summers which are shown on Drawing D8032313F. The particular summers are FW28.8B(6-1-3) and FW28.12B(6-2-1) and the new signal is to be connected to each summer. In the new line also install a diode and a 100 k ohm resistor in a path to ground. Refer to the attached schematic.

Any signal below 0.5 Volts will be blocked by the diode in the new line.

REMOVE BIAS SIGNAL ON
PIN 14 OF 6-2-1 COMING
FROM MODULE 4-10-9
PIN 4 AND RE-CONNECT
IT THROUGH A 1 MEG
OHM RESISTOR TO PIN
21 ON MODULE 6-2-1.

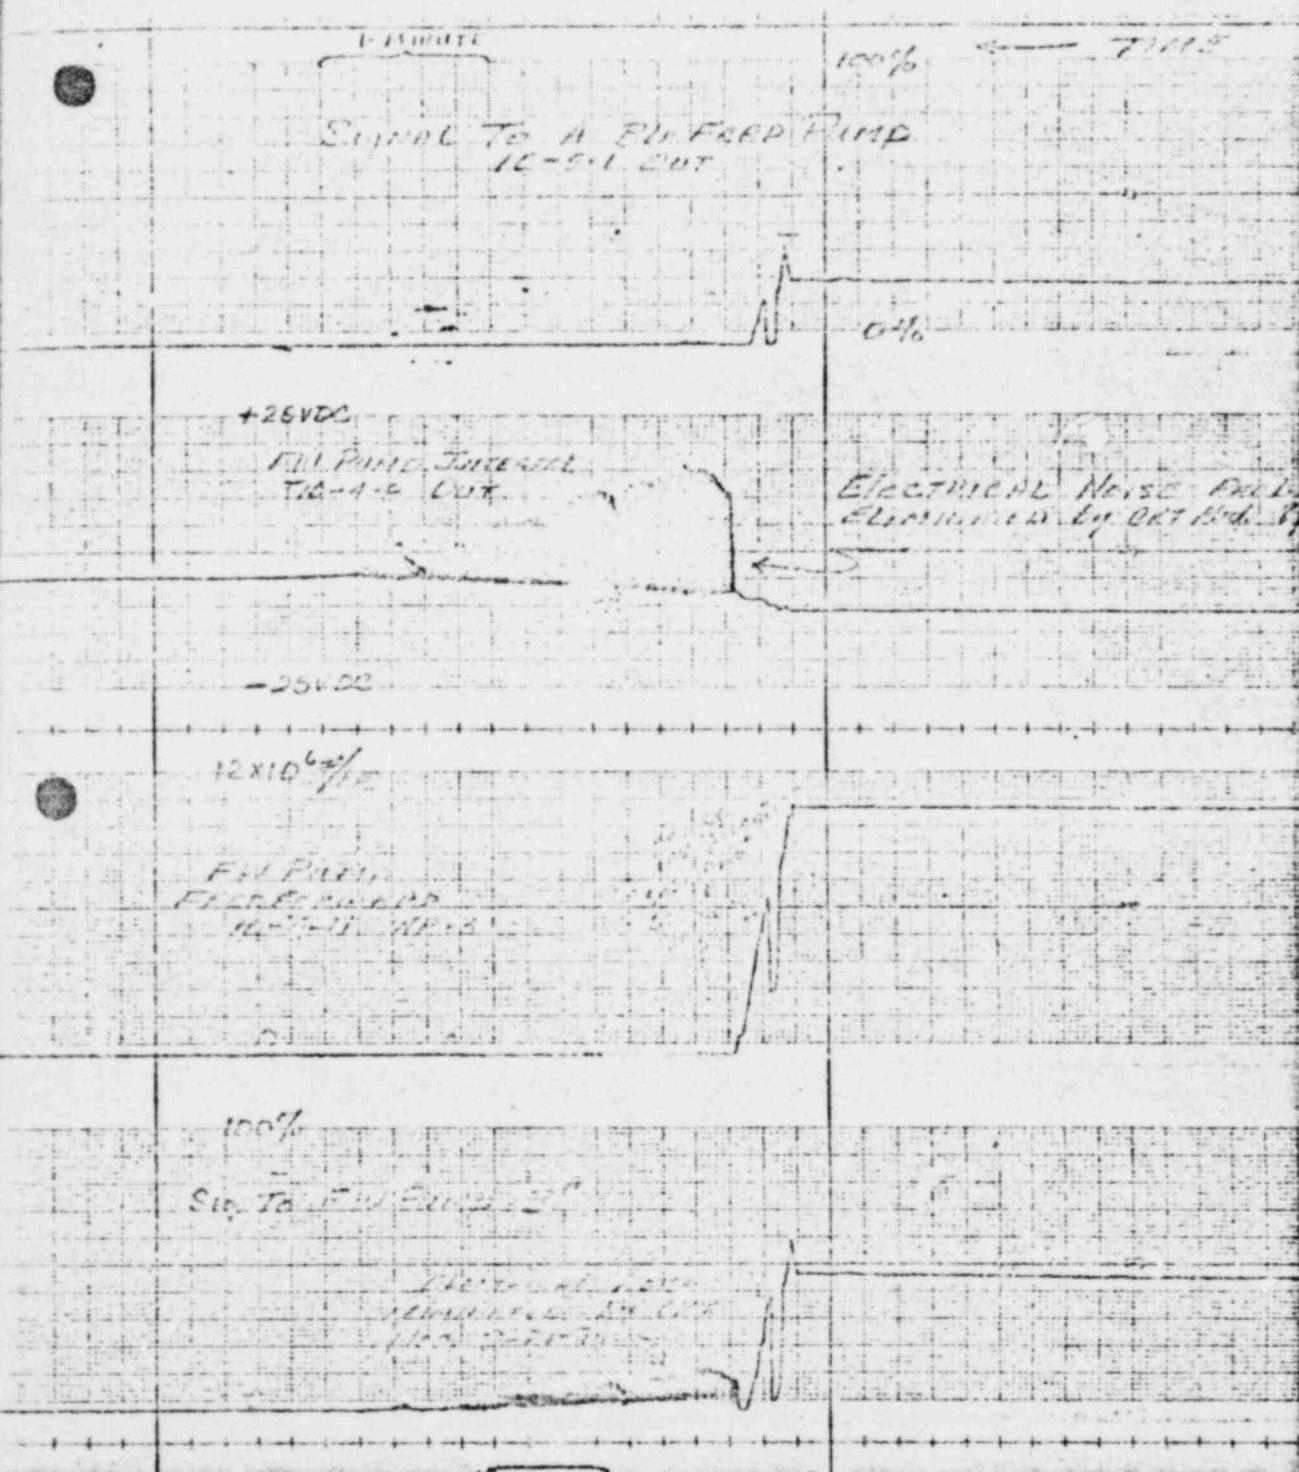
Generator Trip Test from 100% of

Attached please find charts recorded during a generator trip test conducted 8-13-74 which resulted in a reactor trip. From these charts and table 1 it can be noted that while there was flow through the line there was a pressure drop i.e., SG pressure is 30 psi higher than THP, immediately after the trip with no pressure drop due to flow the pressures equalized. For the next 3.5 min. the SG pressure is less than THP. Also note the waves in the SG pressure recorded during the first minute are not present in the THP pressure. These conditions seem to be a good indication that the check valves did close.

On August 13 the generator breaker trip from 100% power transient was tested. The Reactor tripped on high RC pressure four seconds after the generator trip. After analysis of Reactimeter data it was observed that the system came very close to NOT tripping the reactor. We had previously sustained two turbine trips from 76% power without tripping the reactor. (The reactor did trip on the second turbine trip but not until the reactor had run all the way back to 20% power and this trip was due to operator error.) The most important item to be worked on to prevent reactor trip would be to reduce the maximum steam generator pressure immediately after the generator trip. This might be achieved by lowering the popping pressure on the last two banks of safety valves. In addition, the Emergency Relief Valve control could be modified to utilize the emergency relief valves (atmospheric dump valves) as additional steam relief capability. Presently the B1U limits as specified by BIA call for immediate reduction of feedwater flow demand to approximately 60% due to the rise in steam generator pressure from 910 psig to 1070 psig on a turbine trip. The elimination or delay of the B1U limits in this situation would help to maintain the required feedwater flow which would in turn tend to prevent overheating the primary coolant and to prevent the Reactor tripping on high RC pressure.
